Memorandum

SHOREPLAN

Date: September 29, 2021

Re: Harbour Infrastructure Repairs
Fuel Dock Inspection Cobourg Harbour
Our File: 21-3500

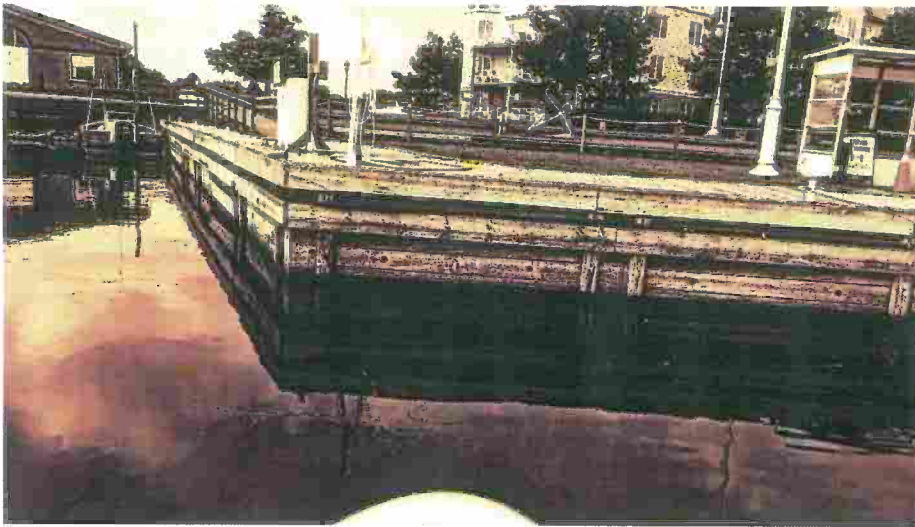
Photo 1 - Fuel Dock

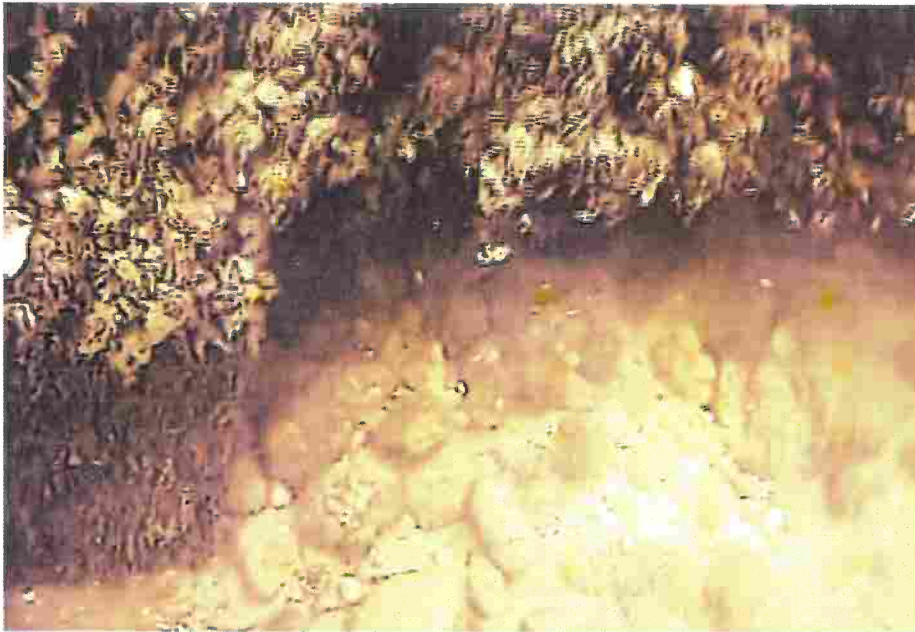
During the dive it was noted that the timber lagging extends down to the lakebed along the south facing wall and north end of the east facing wall, however along the east facing wall, adjacent to the fuel pump, there is a gap at the base of the wall. The gap varies but is approximately 300 to 400mm high at its worst and extends towards the north wall with only a small gap, less than 50mm, at the north end. A board from the timber deck just to the north of the pump was lifted and it was noted that the earth fill behind the wall is missing in the area directly behind the wall. It is our opinion that it is being lost through the bottom of the wall where the timbers do not meet the lakebed.

Photo 2 - Gap at Bottom of East Facing Wall

Given that there is a sheet pile wall solution for the north and east basin walls being implemented, we suggest a similar solution here. This would involve driving sheet piles in front of the existing timber lagging structure, removing the deck, installing anchors and filling to grade before replacing the deck. We would suggest adding a concrete cap along the water's edge to match the north and east walls. This option would allow for the deck to be raised above design high water level so that it does not flood during high water events. The current deck is below this elevation. A sketch of the proposed work can be seen in Figure 1.

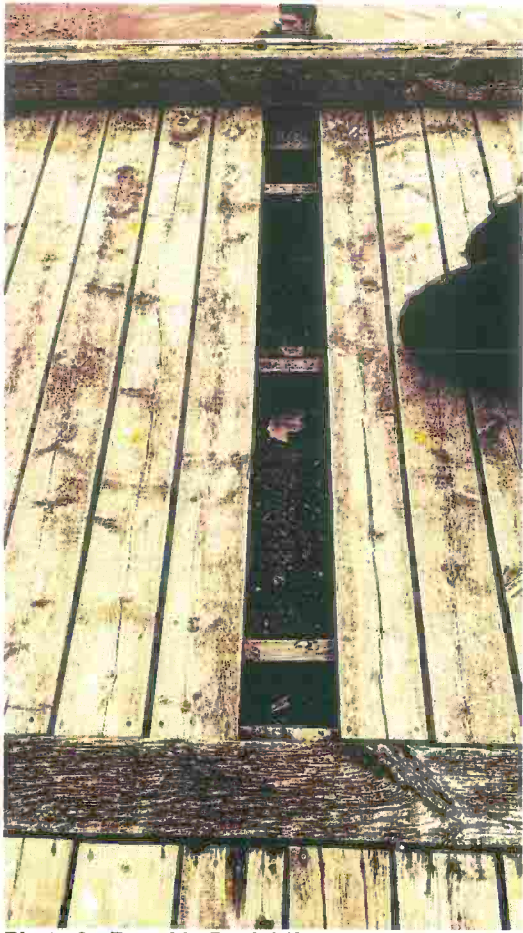
Photo 3 - Board in Deck Lifted
