Cobourg Harbour

Breakwaters and Basin Walls Condition Assessment

November 2020

**Cobourg Harbour
Breakwaters and Basin Walls Condition Assessment
2019**

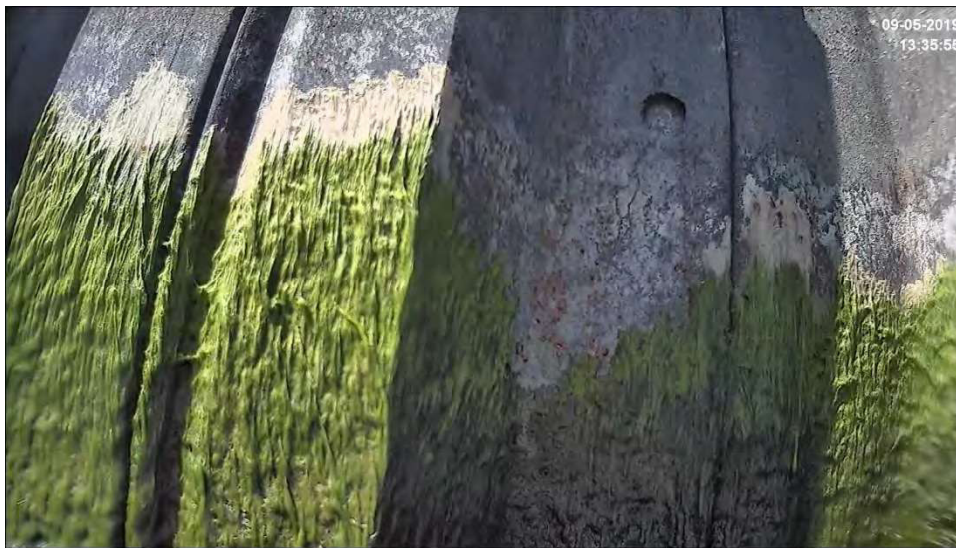
Photo 2 - East Breakwater, East Face Small Hole

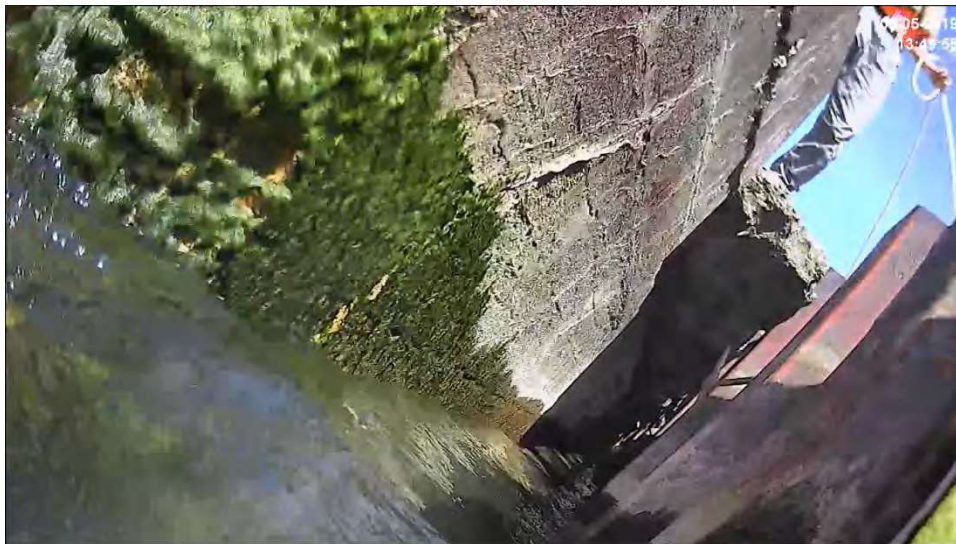
Photo 4 - East Breakwater, East Face Transition to Timber Cribs 0+075

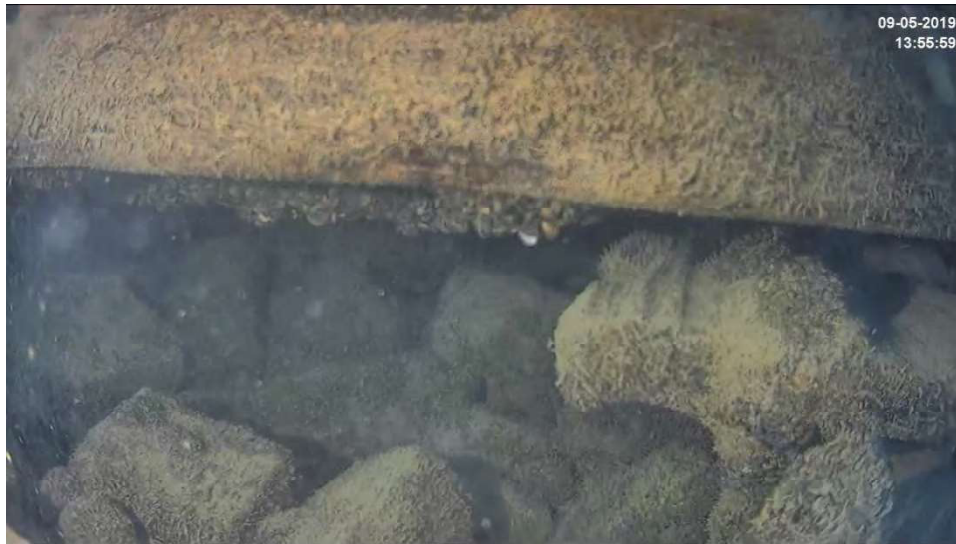
Photo 5 - East Breakwater, East Face Gap and Visible Fill Material

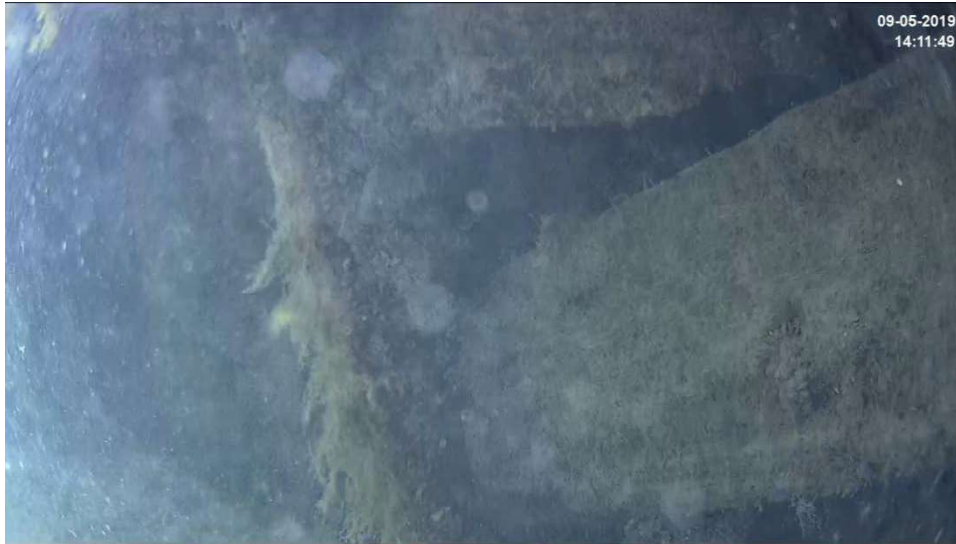
Photo 7 - East Breakwater, East Face Missing Top Two Timbers

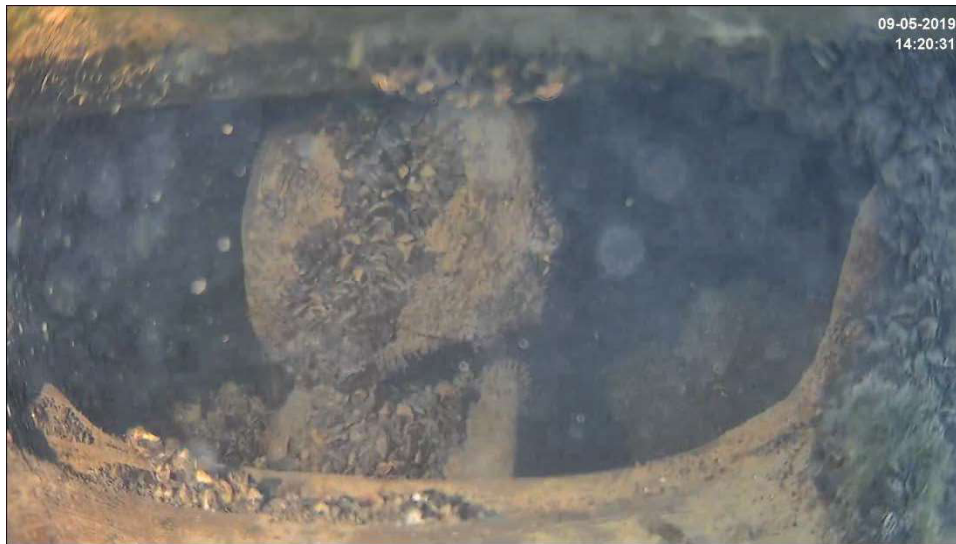
Photo 8 - East Breakwater, East Face Gap and Cross Members

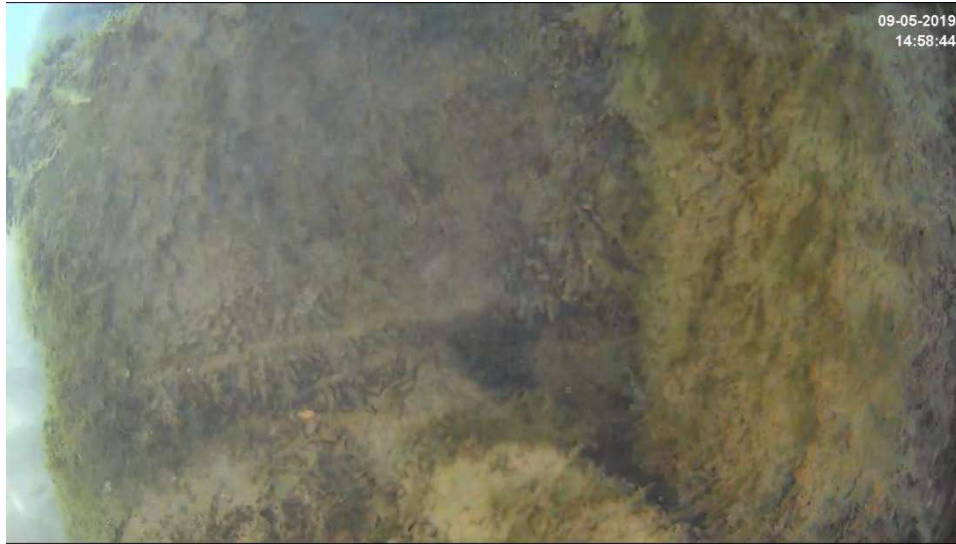
Photo 9 - East Breakwater, East Face Cross Member Coming Through

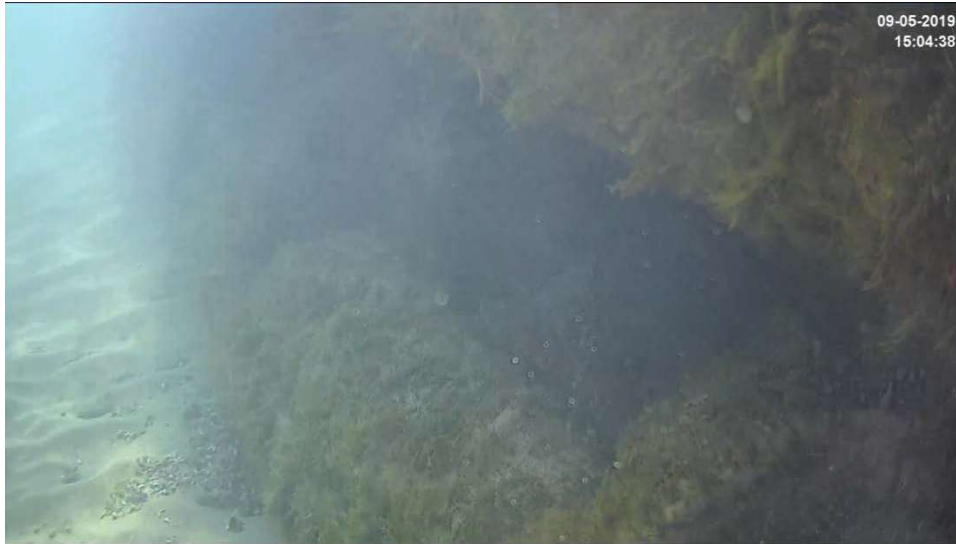
Photo 11 - East Breakwater East Face Top Two Timbers Missing 0+158

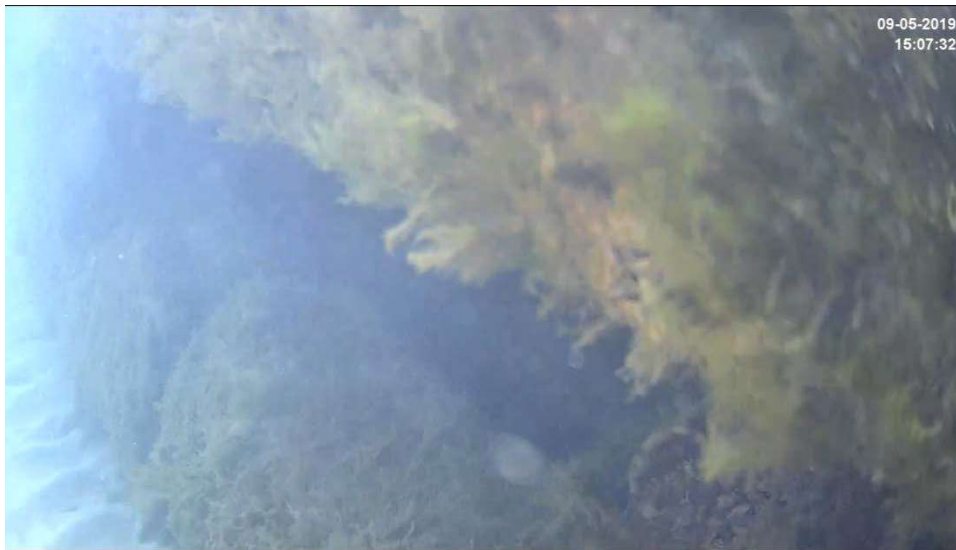
Photo 12 - East Breakwater East Face Top Two Timbers Missing 0+173

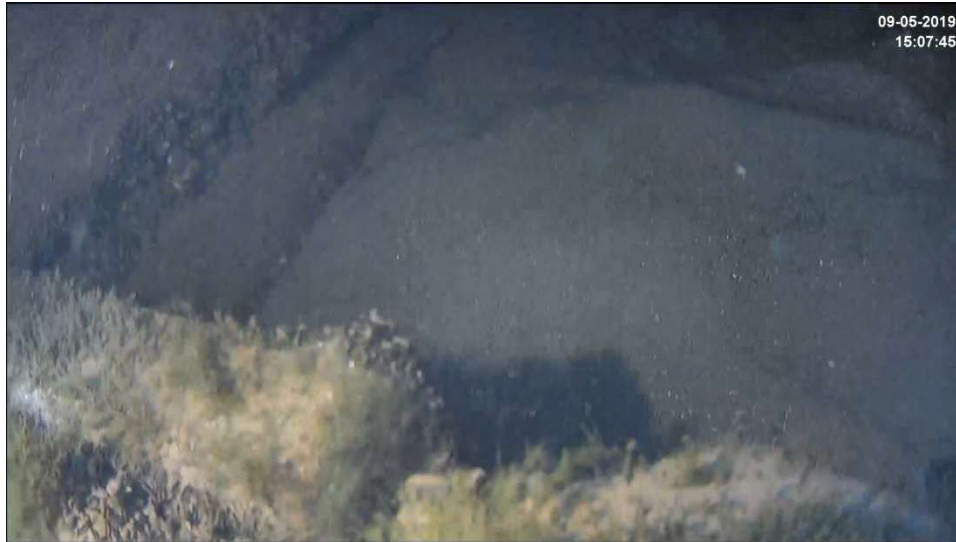
Photo 13 - East Breakwater East Face Gap Between Cribs No Fill

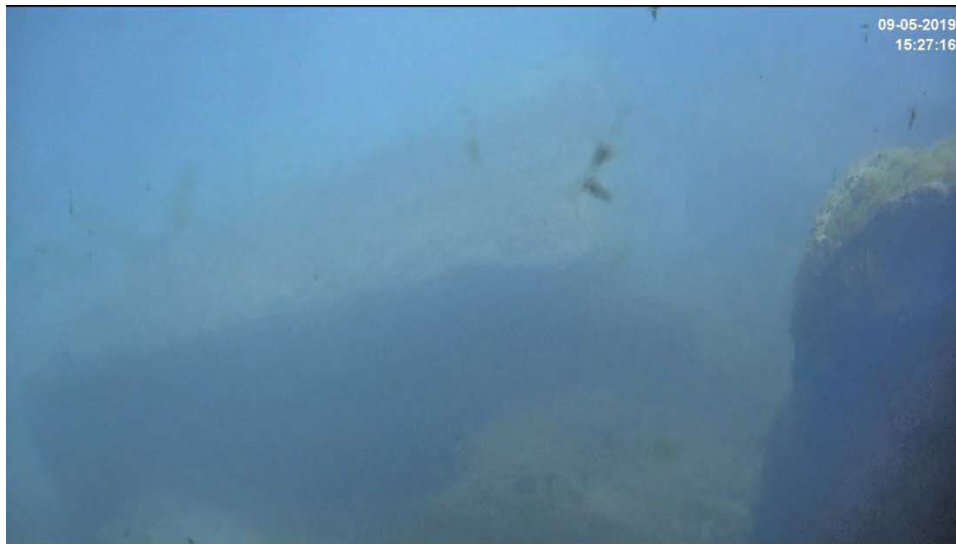
This breakwater consists of sections of steel sheet pile wall, timber cribs with a concrete cap and a section of armour stone revetment at the opening to the harbour and inner face. The steel sheet pile wall is in good condition with only minor signs of deterioration. The timber cribs are showing severe deterioration. Timber sections are missing 1/2 to 3/4 of the vertical face on the outside east facing crib wall. Fill material inside the cribs no longer touches the underside of the cap with visible gaps of 20cm 80cm between the cap and the top of fill. The cap is supported by timber cross members, many of which are showing signs of disintegration. On the surface of the breakwater, large sections of the cap have spawled away. Sections of concrete are also missing from the cap at the waterline. This may be due to damage caused by ice. A large section of concrete over 2m wide previously forming part of the cap appears to have rolled into the lake near the lighthouse.

Photo 16 - Concrete Sections On Lakebed Adjacent to Lighthouse

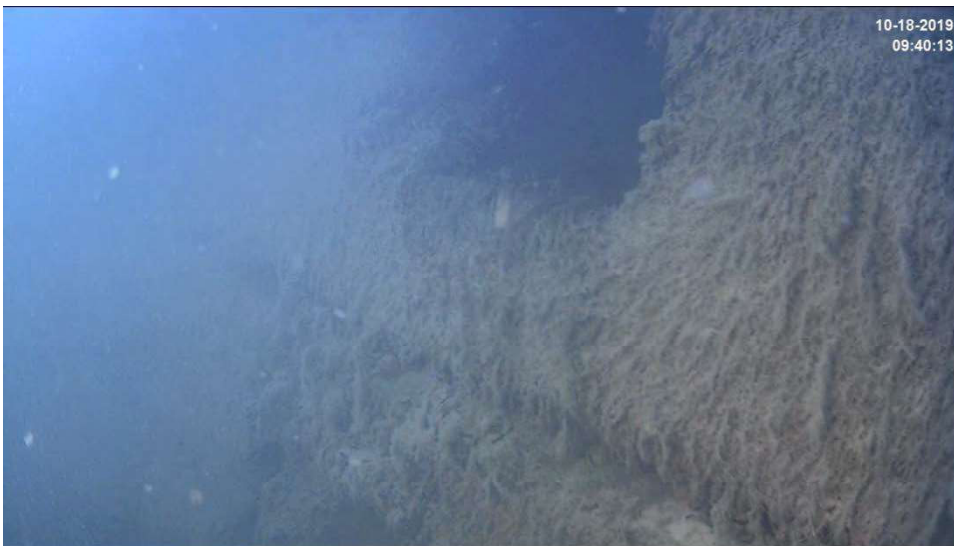
Photo 20 - East Breakwater West Face Crib, Example of Cross Timber Stopping Short of Wall

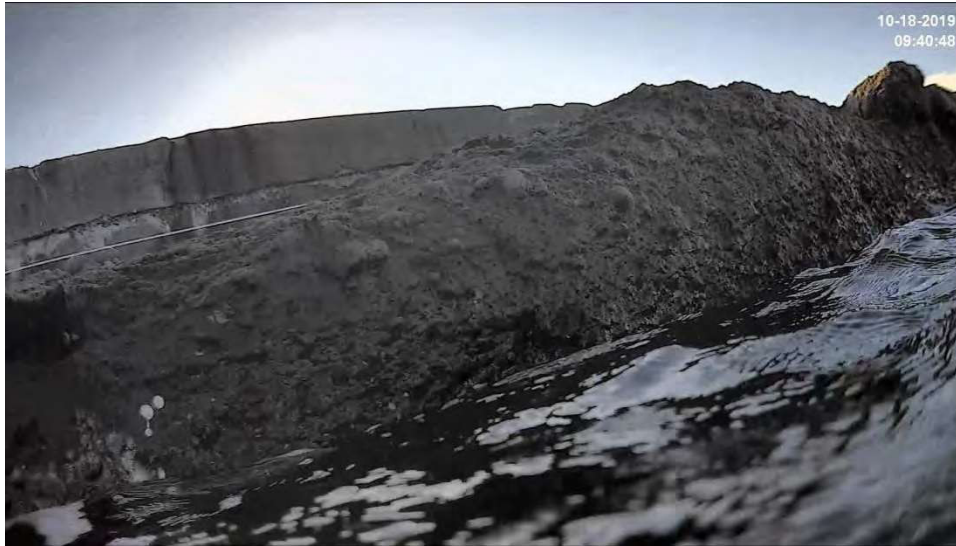
Photo 21 - East Breakwater West Face - Spawling in Cap 0+97 South

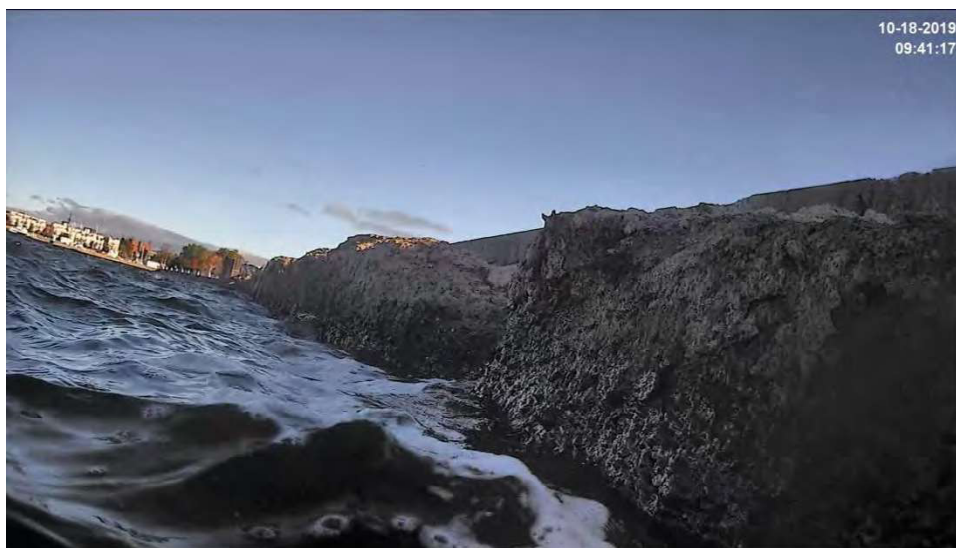
Photo 22- East Breakwater West Face - Spawling in Cap 0+97 North

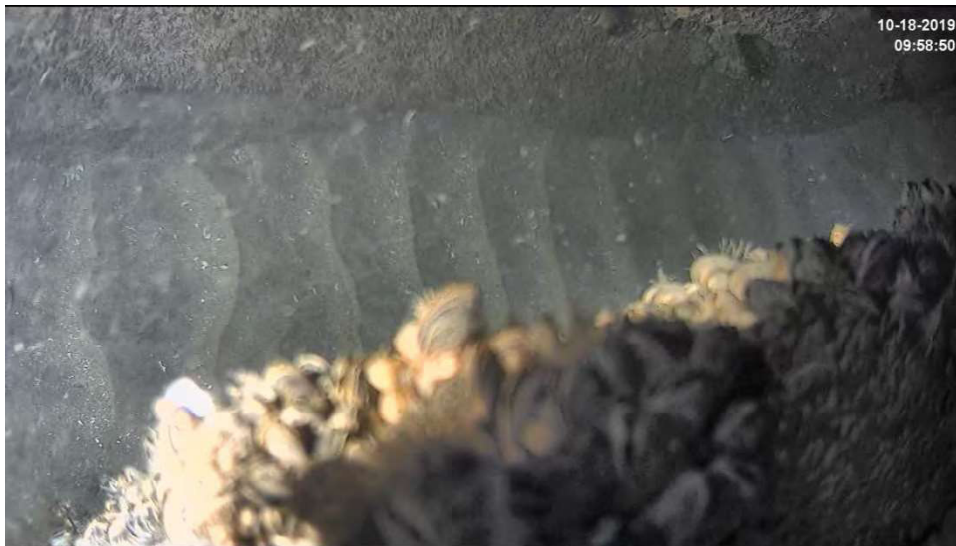
During our site visit we observed flow through the breakwater, indicating notable voids in the core. It is our opinion that the structure should be rated 4 – Worst as it requires significant repairs to maintain its effectiveness and long term performance.

Photo 24 - East Breakwater West Face - Void between Cribs and SSP Flow E to W

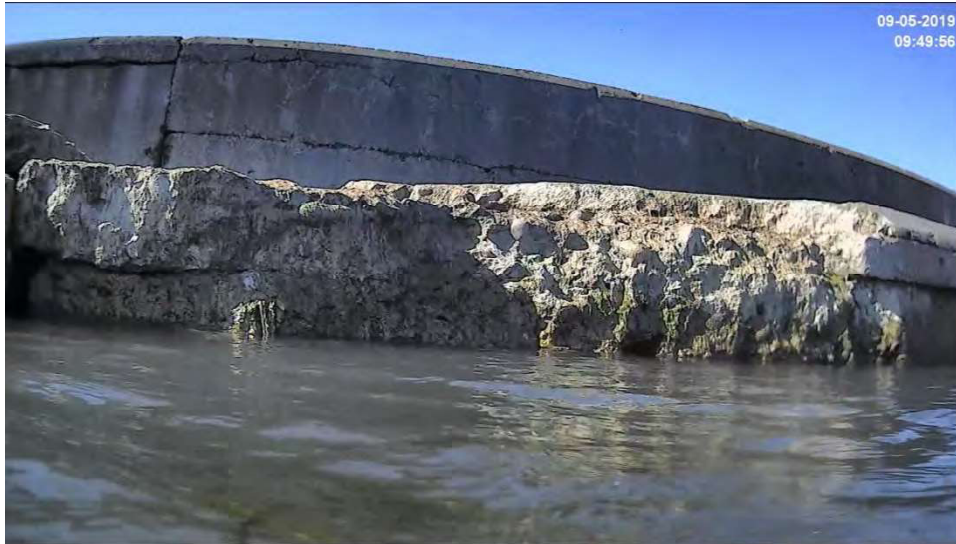
Photo 31 - West Breakwater North Side, Damage to Concrete Cap 0+20

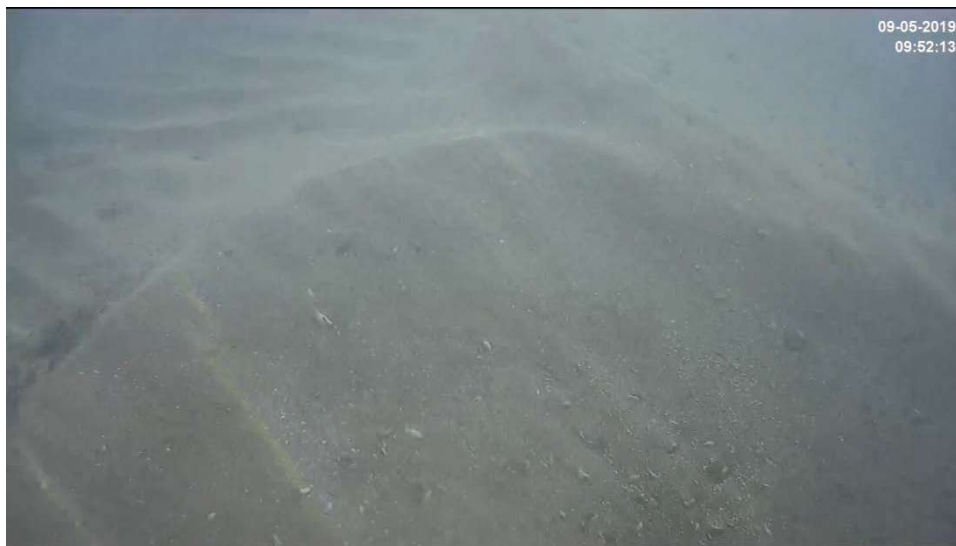
Photo 32 - West Breakwater North Side, Sand Pushed Away at Toe Void

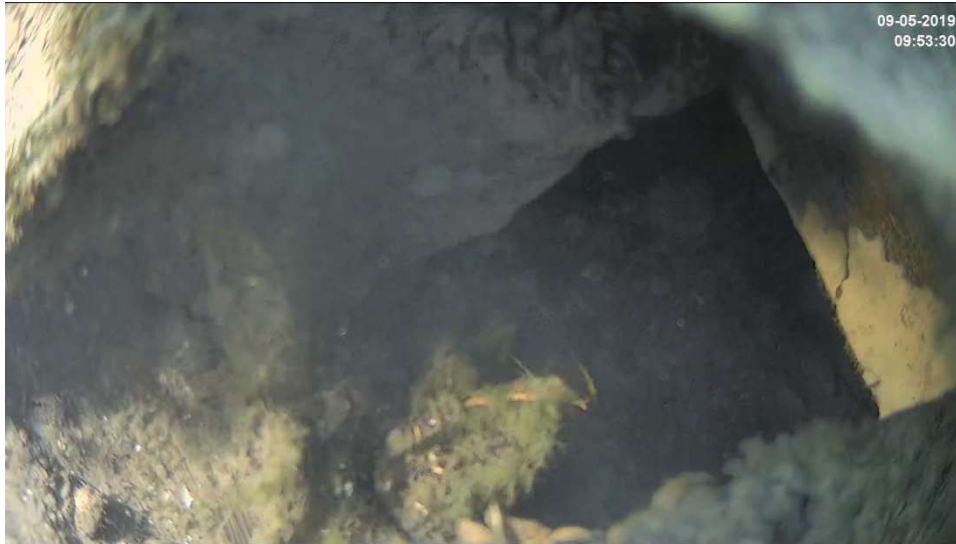
Photo 33 - West Breakwater North Side, Example Gap at Toe

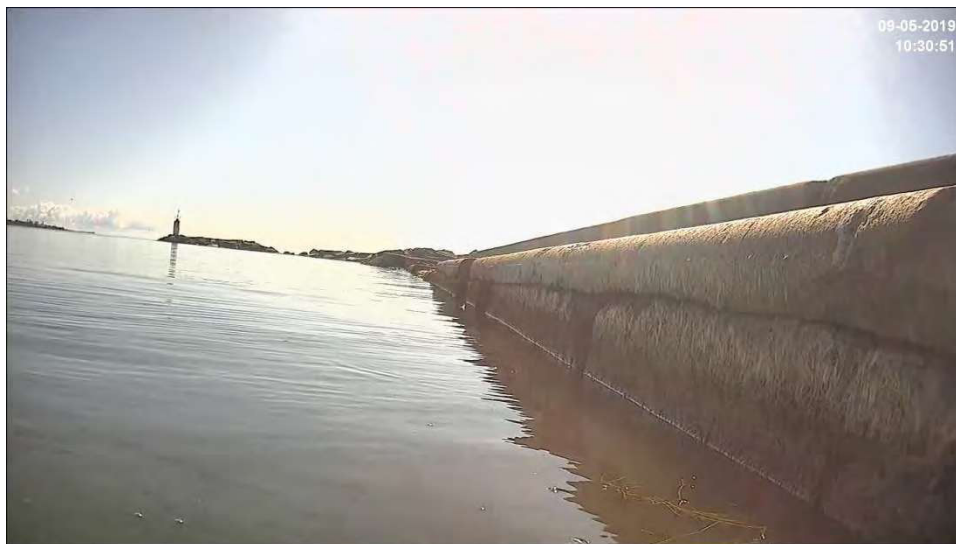
Photo 34 - West Breakwater North Side, Form Joints & Cracks in Cap

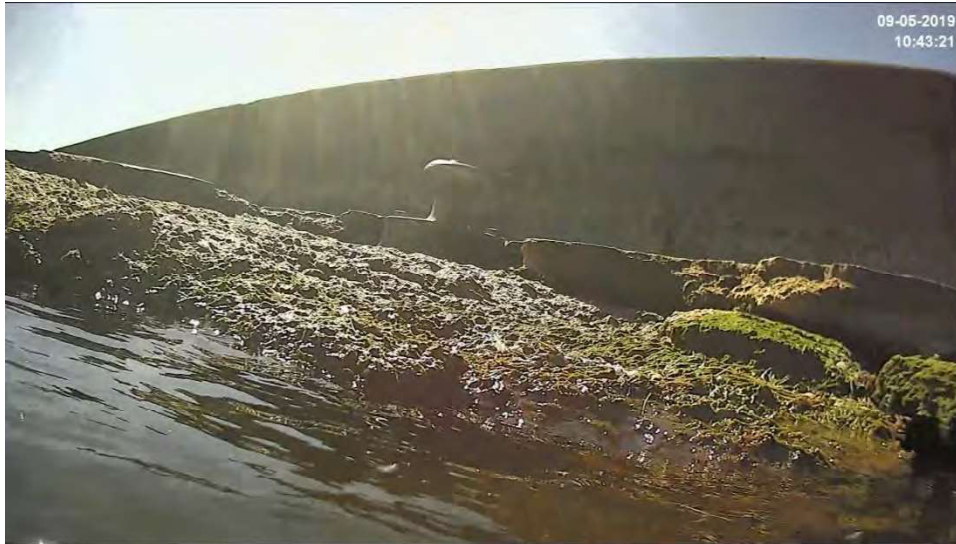
Photo 35- West Breakwater North Side, Large Section of Cap Damage 0+70

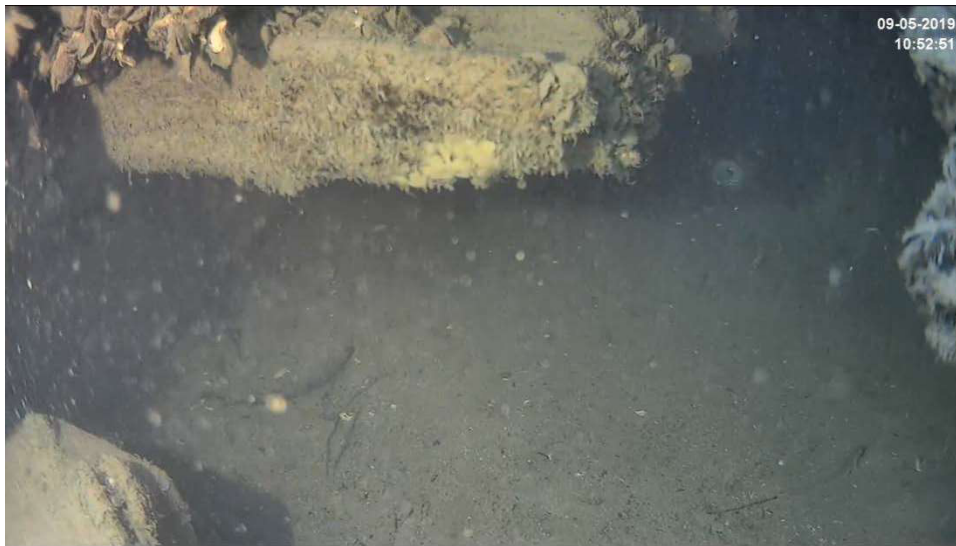
Photo 36 - West Breakwater North Side, Large Gap Between Cribs 0+84

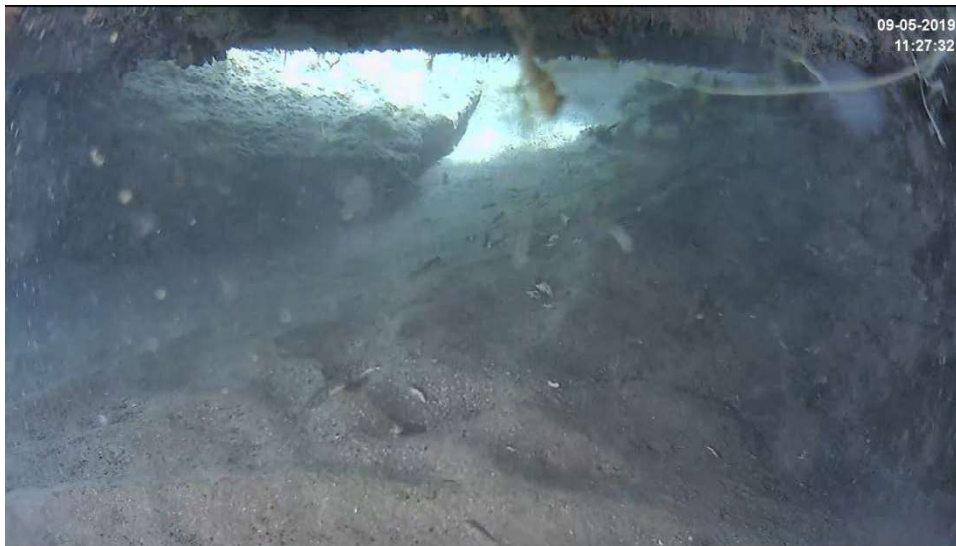
Photo 40 - West Breakwater North Side, Gap between Stones in Revetment Toe

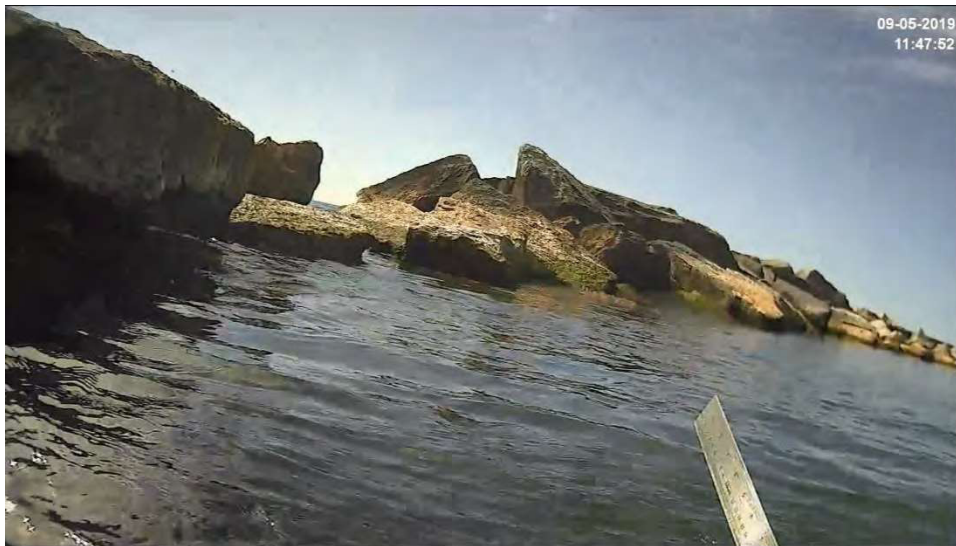
Sections of the stone revetment are showing signs of damage. We observed large gaps between stones and missing stones that have likely rolled off the top or the slope of the protection. There is a gap in the crest of the stone material for 20-25m starting at approximately chainage 0+185. We found armour stones located 10 to 15m offshore from the toe of the breakwater. These stone were likely placed on the structure and removed by wave action. This has left gaps in the stone material above as well as below water. Placement of stone in areas with no obvious voids and gaps appears to be random with smaller gaps between stones.

Photo 42 - West Breakwater North Side, Gap in Revetment

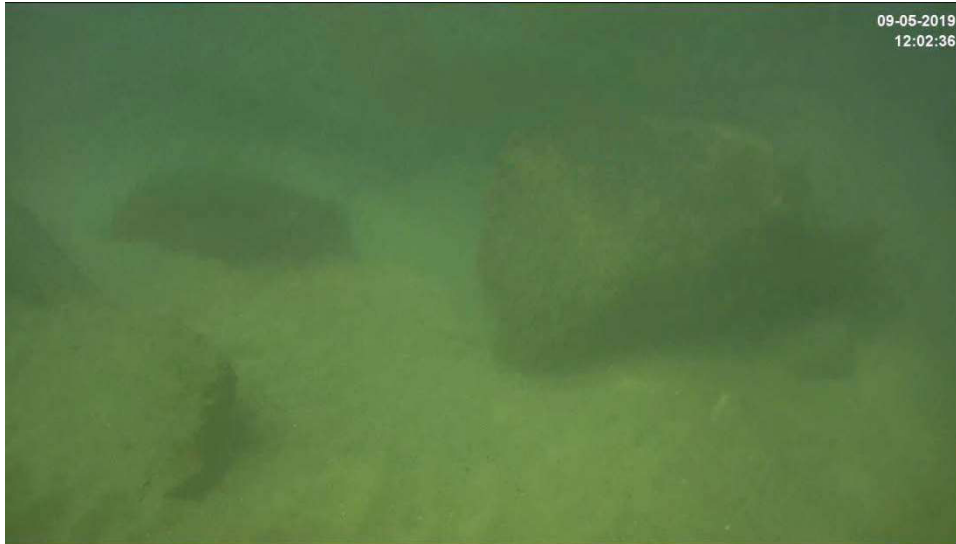
Photo 43 - West Breakwater South Side, Scattered Stone Offshore of 0+228

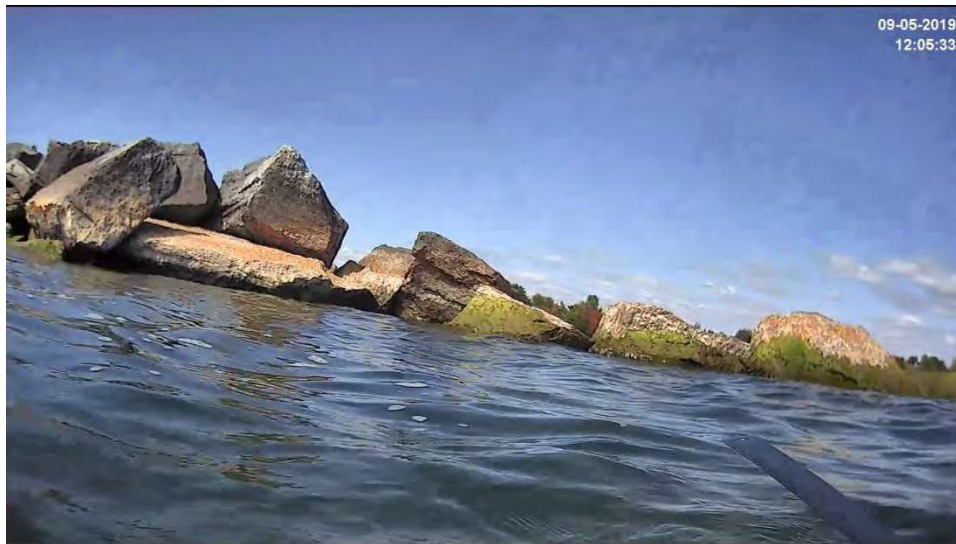
Photo 44 - West Breakwater South Side, Gap in Revetment

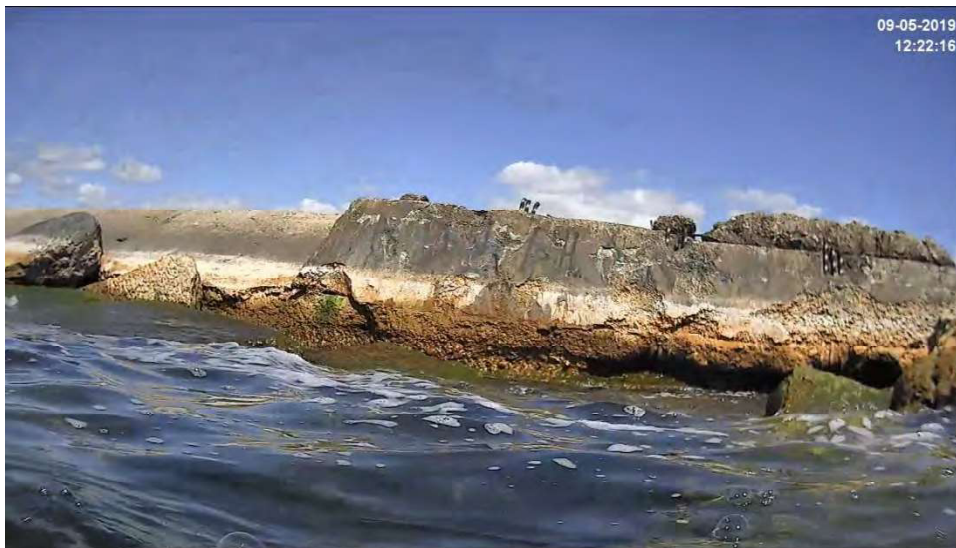
Photo 46 - West Breakwater South Side, Missing Stone at Concrete East End

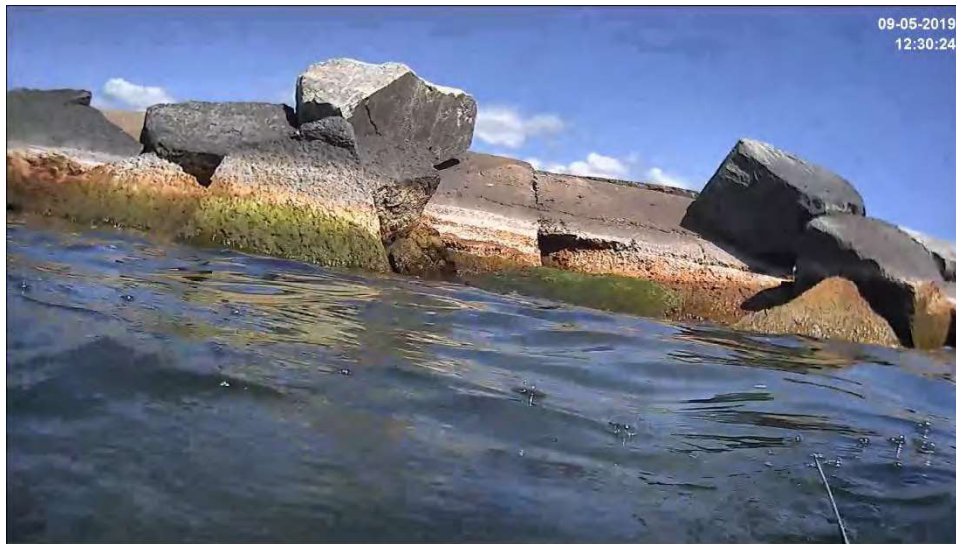
Photo 48 - West Breakwater South Side, Small Gap Onshore 0+30

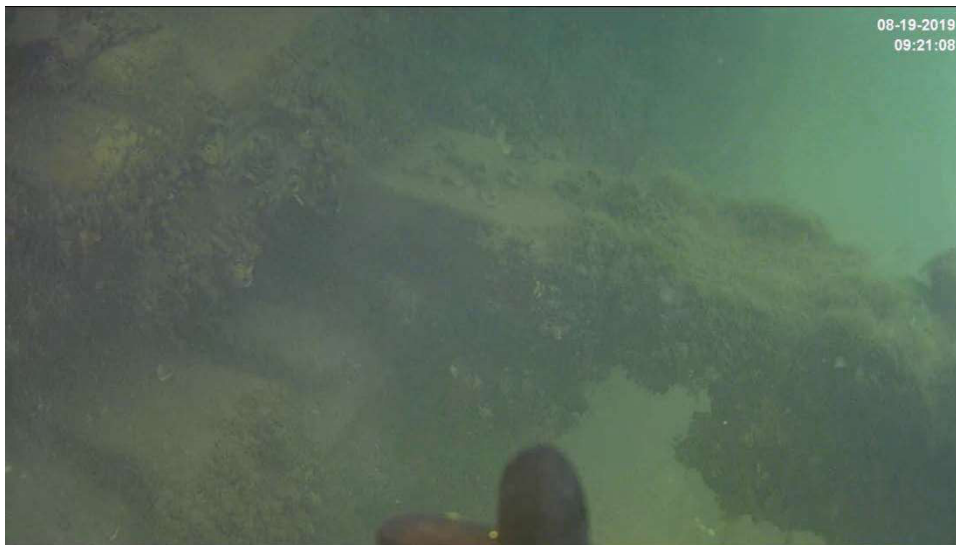
Photo 50 – North Wall - Timber Pulled Out From Wall 0+06

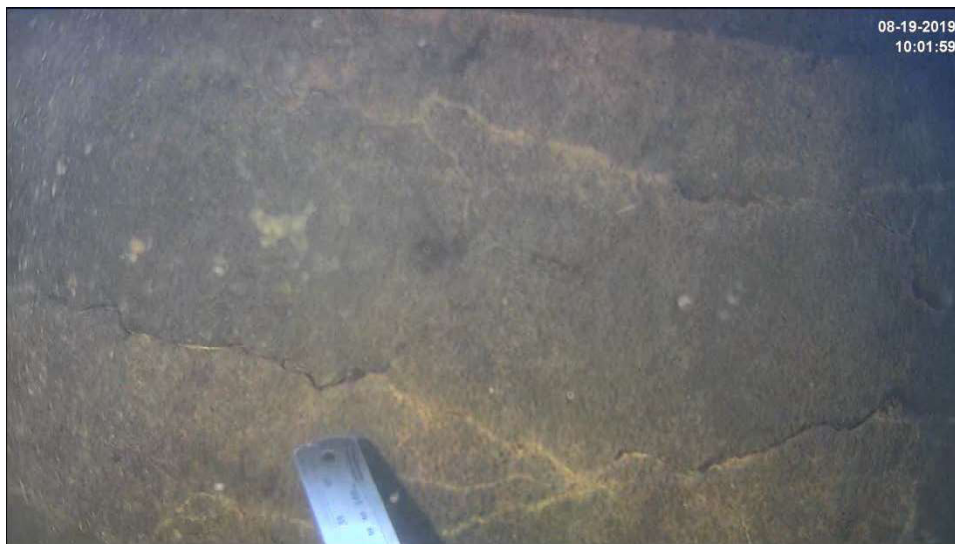
Cracks in the concrete and spawling were observed along the entire wall and was most severe at locations between chainage 0+15 and 0+25, at 0+41 and between 0+135 and 0+185.

Photo 56 - North Wall Example of Cracking in Concrete Blocks

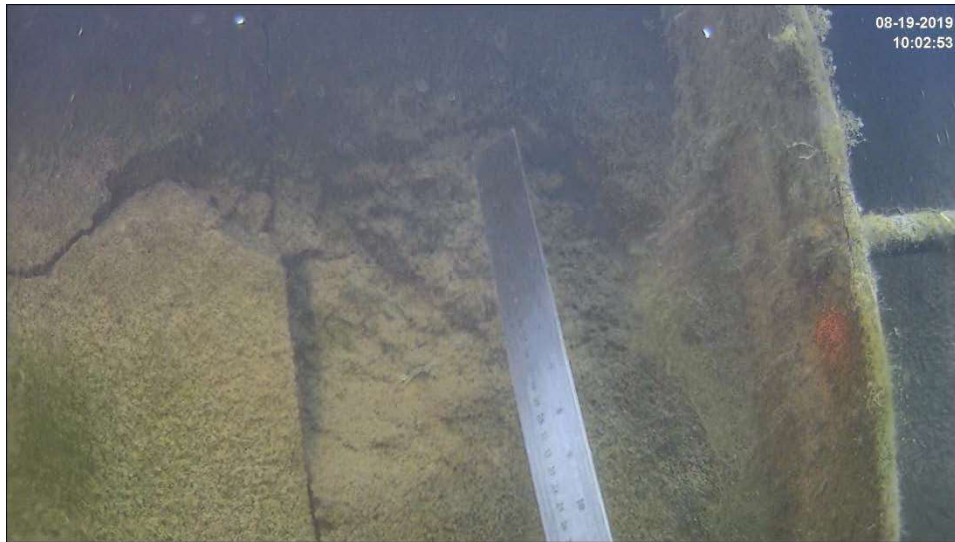
Photo 57 - North Wall Spawling in Concrete Block 0+42

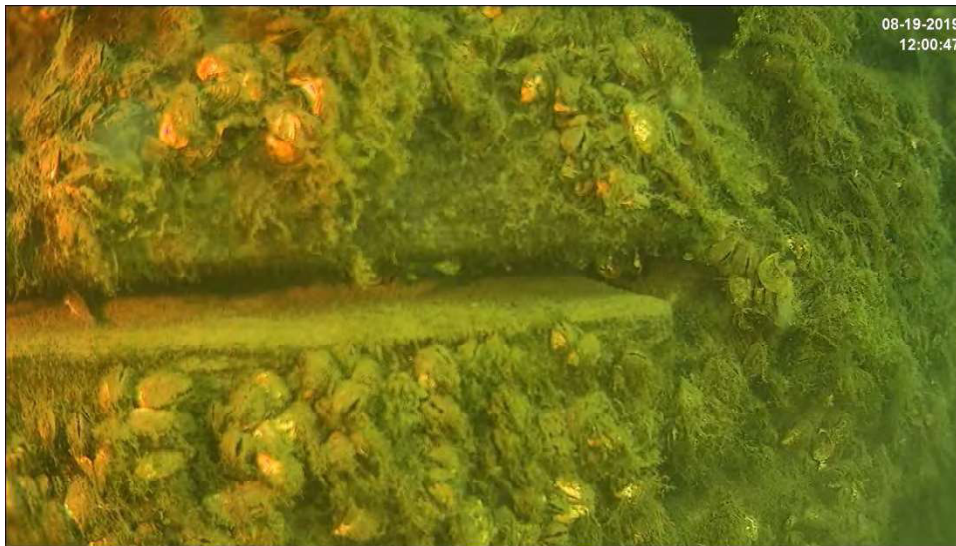
Photo 60 - North Wall Typical Gap Between Timbers 0+135

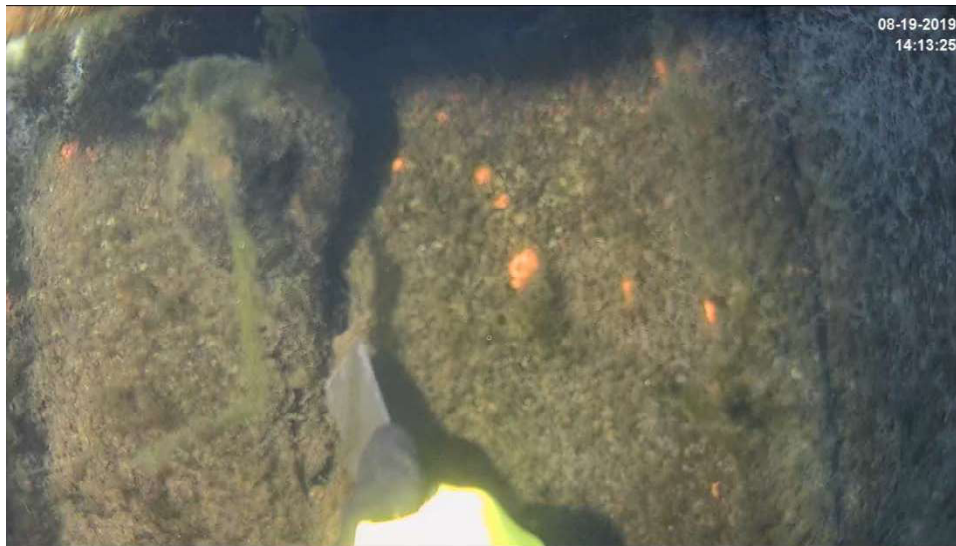
Many small holes were found in the SSP approximately 5cm in diameter. They appeared to be cut into the SSP wall and were present above and below waterline but mostly near the top of the wall. Some of the holes had eye-bolts in them or a rod like element, while others were free from obstruction with sand and sediment behind them. Over 100 were counted along the length of the wall. What appeared to be tie back rods with a plate and nut at their ends were pulled out of the wall and often bent down or to the side. These tie backs were located near the lakebed. Around the tie back rods, holes were observed that were approximately 10cm in diameter. Piles of soft sediment material were noted accumulating in front of the holes in the sheet pile wall. The toe of the wall was observed to be fully embedded during the inspection.

Photo 71 - East Wall Example of Eye Bolt in Wall with Small Gap Around

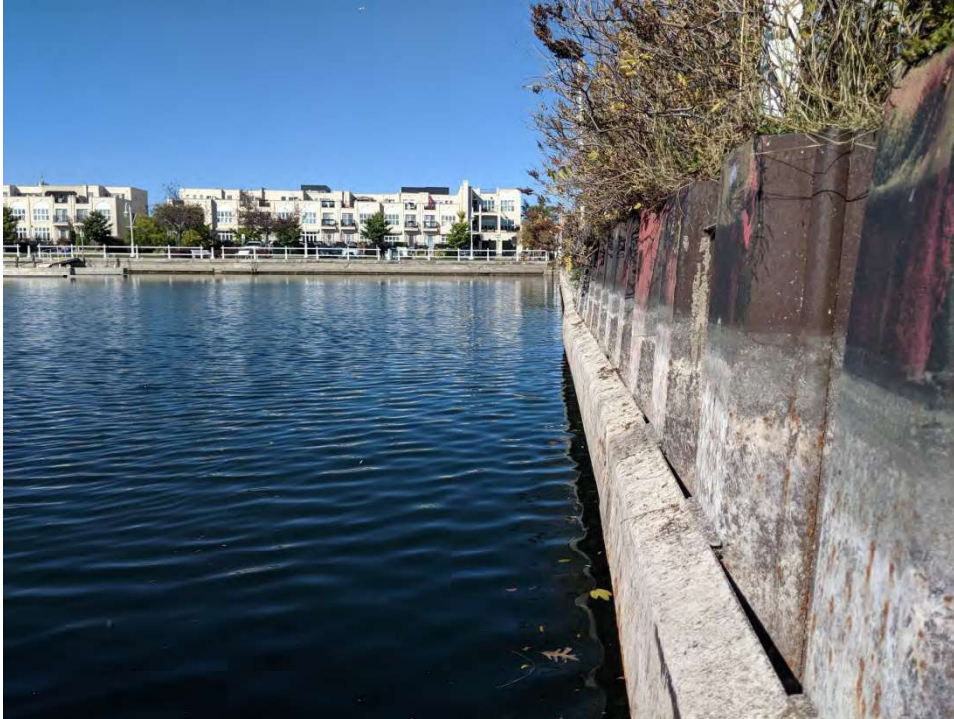
Photo 72 - East Wall Leaning Piles Above Water

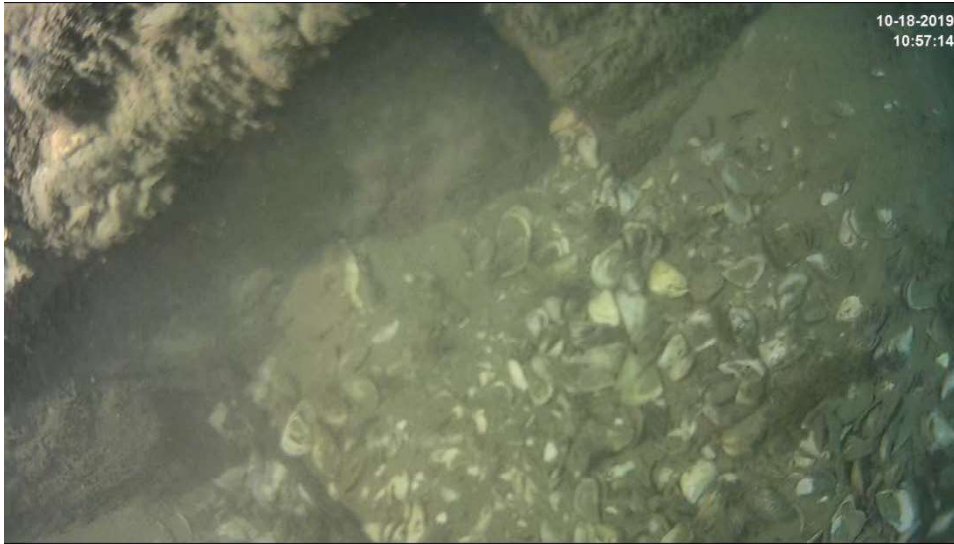
Photo 75 - Centre Pier West Face Gap at Toe With Flow 0+47

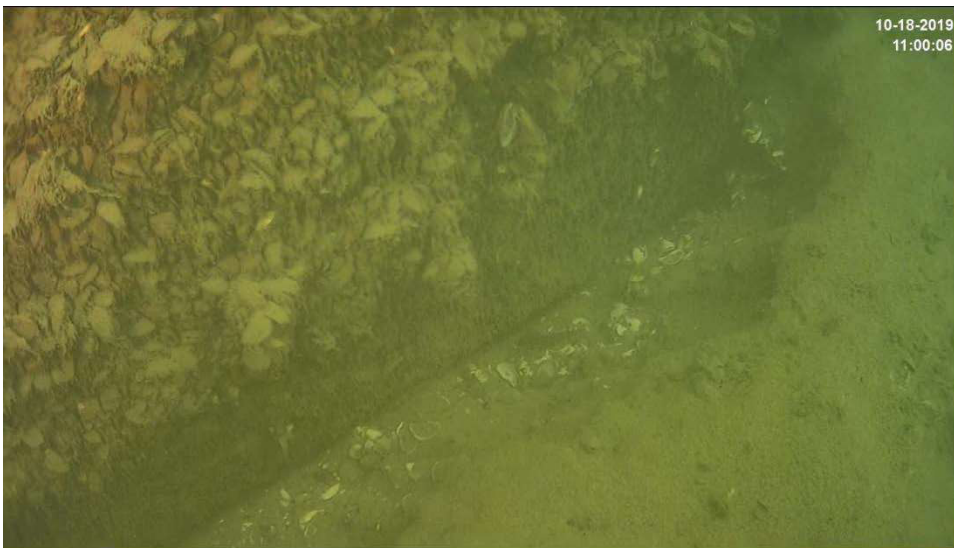
Photo 76 - Centre Pier West Face Scour from Flow Through Wall

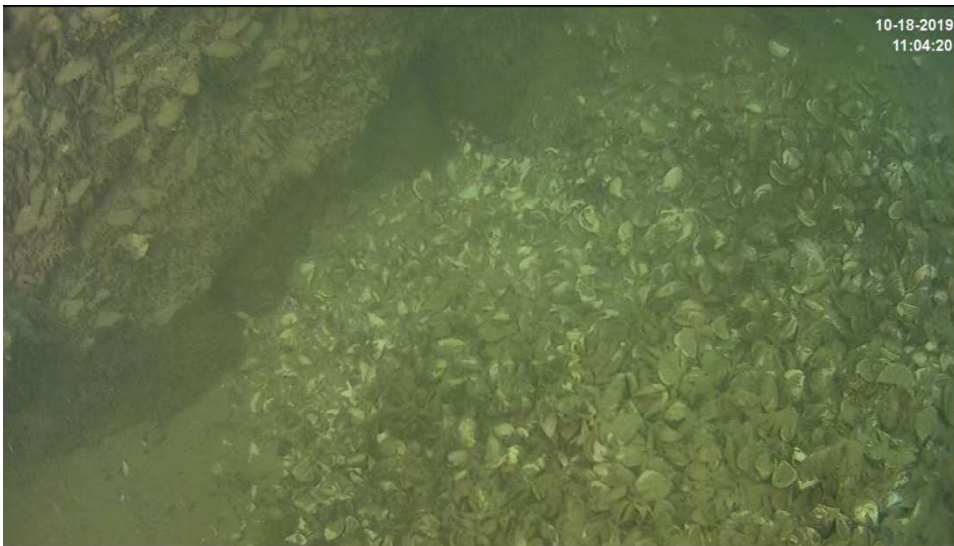
Photo 78 - Centre Pier West Face Typical Scour at Toe Due to Small Gaps

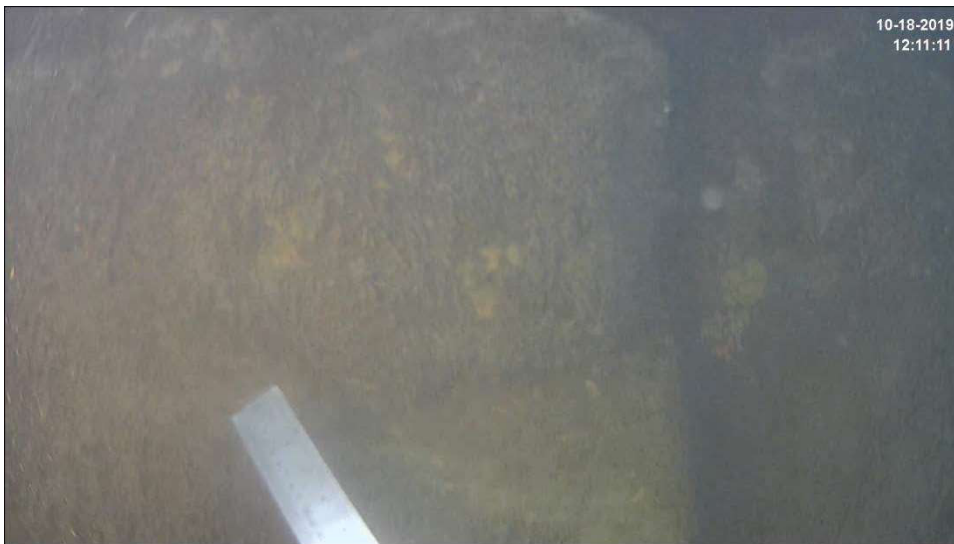
Photo 82 - Centre Pier Crack and Spawling in Cap
