# STAFF REPORT

THE CORPORATION OF THE TOWN OF COBOURG

**Subject/Title:** Notice of Demolition of a Listed Property – 205 Forth Street (DeJong)

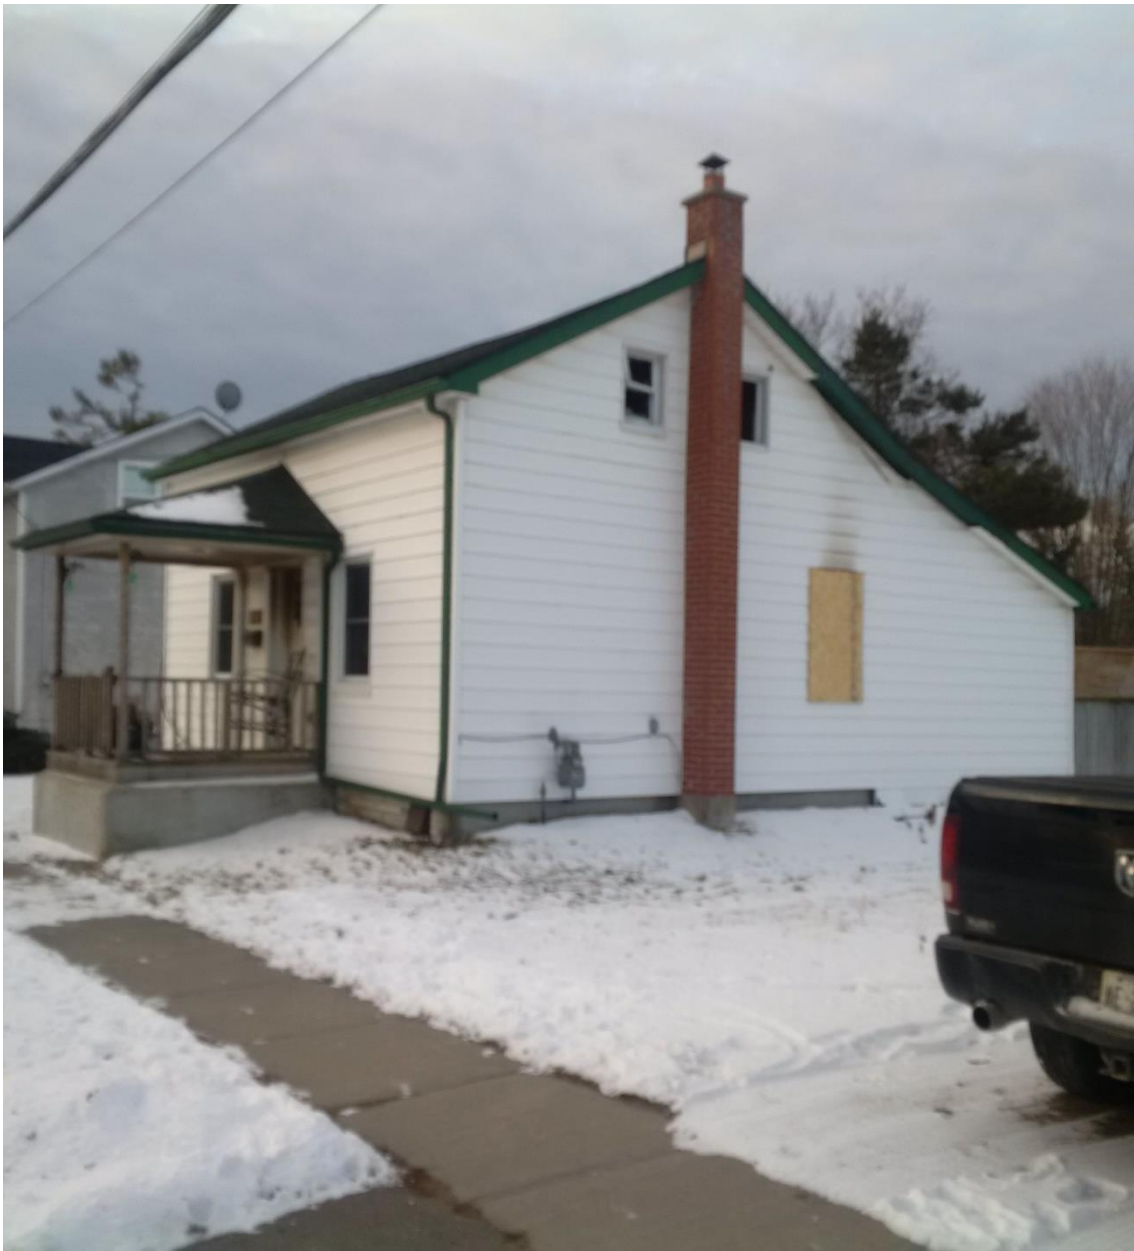
**Figure 2: 205 Forth St. Notice the fire damage on the boarded-up side window, sunlight and snow visible through holes in the roof west side**
