DEJONG DWELLING FIRE DAMAGE ASSESSMENT

Insured:	Jodi & Michael Dejong
Loss Address:	205 Forth Street Cobourg, ON
Date of Loss:	December 11, 2020
Claim Number:	001878252
JENSEN HUGHES File Number:	4T2008160

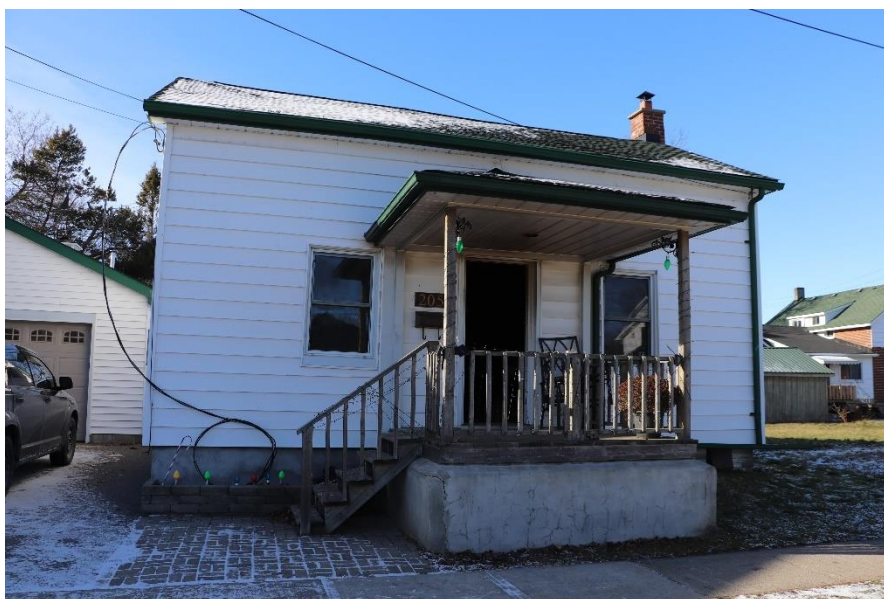
1. The structure is a one and a half storey, detached, single family dwelling constructed over a crawlspace area (Photograph 1).

Photograph 1 – East (front) elevation

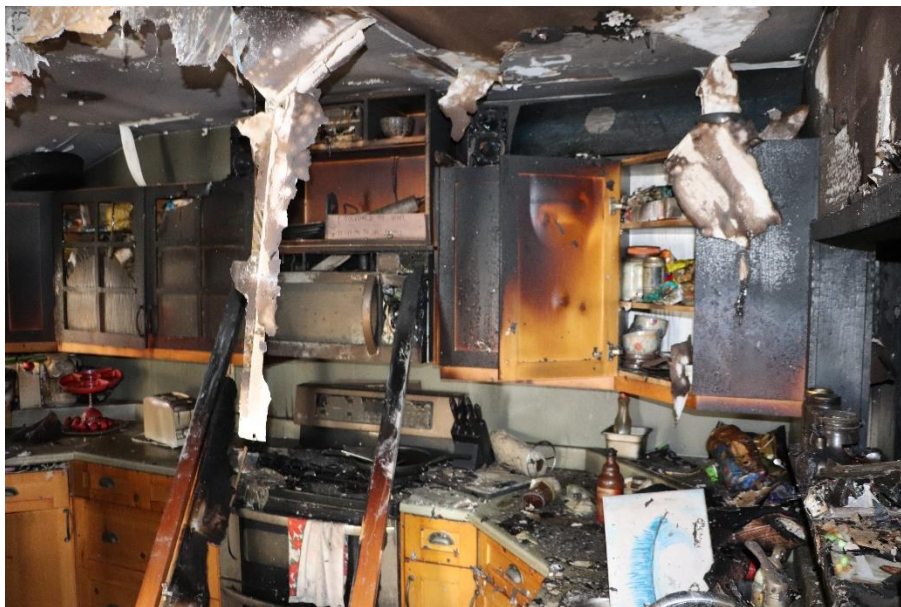
9. There was significant smoke contamination and a smoke odour throughout the interior of the dwelling. The smoke contamination and odour was present throughout the crawlspace, the main floor and the upper floor. An example of the fire damage and smoke contamination to the interior of the dwelling is illustrated in Photograph 2.

Photograph 2 – Sample of fire damage and smoke contamination

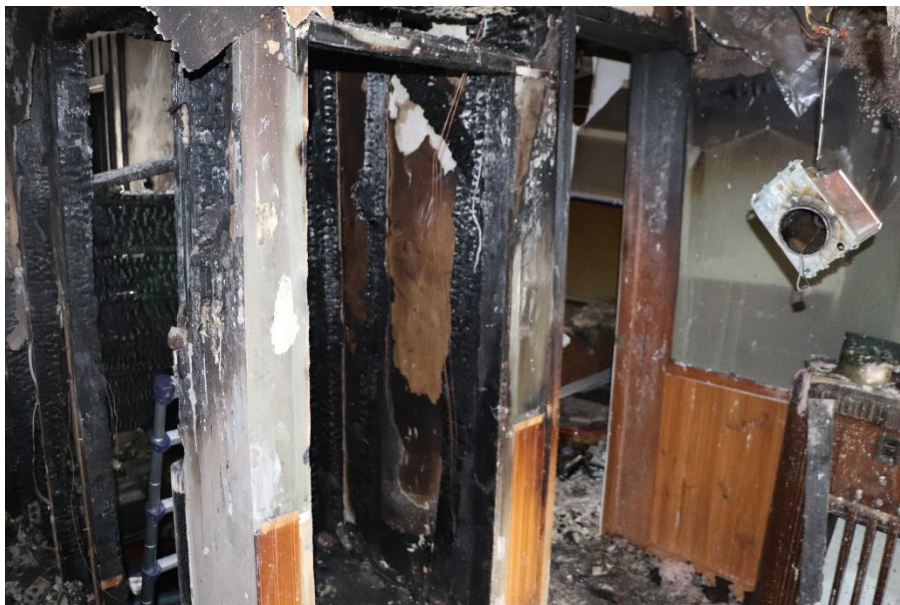
10. The fire likely originated around the central stairway area that provided access to the crawlspace below and to the upper floor above. The structural framing surrounding the staircase contained significant charring (Photograph 3).

Photograph 3 – Fire damage concentrated around central stairway

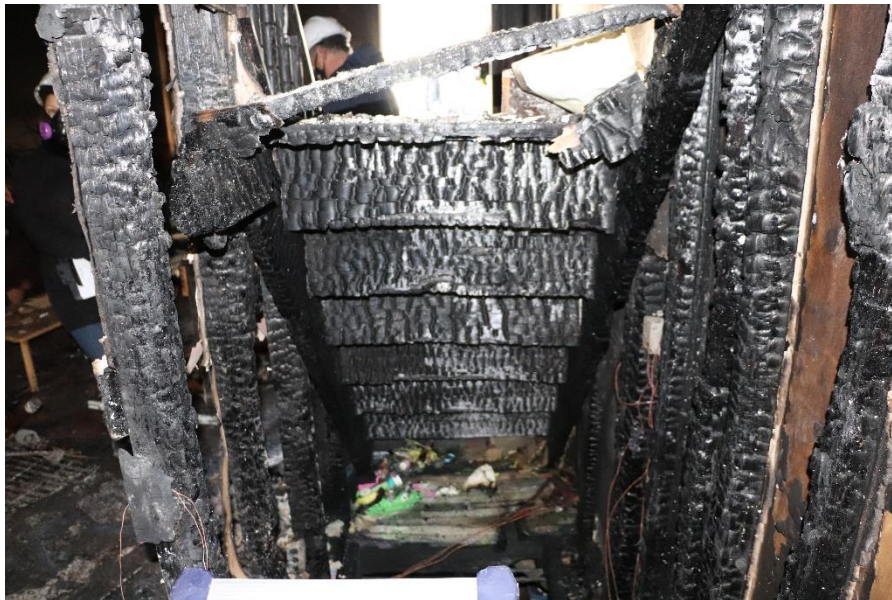
11. The exposure to the fire consumed the top portion of the staircase that provided access to the upper floor (Photograph 4).

Photograph 4 – Staircase to upper floor partially consumed by fire

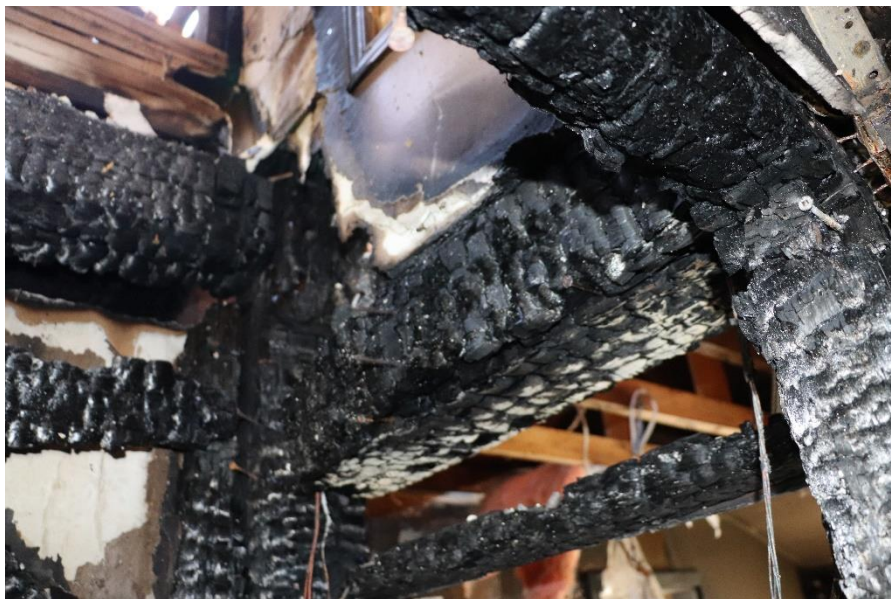
12. The fire migrated upward and resulted in fire damage to the timber floor beam and timber column that enclosed the central stairway (Photograph 5).

Photograph 5 – Fire damage to timber floor beam and timber columns above

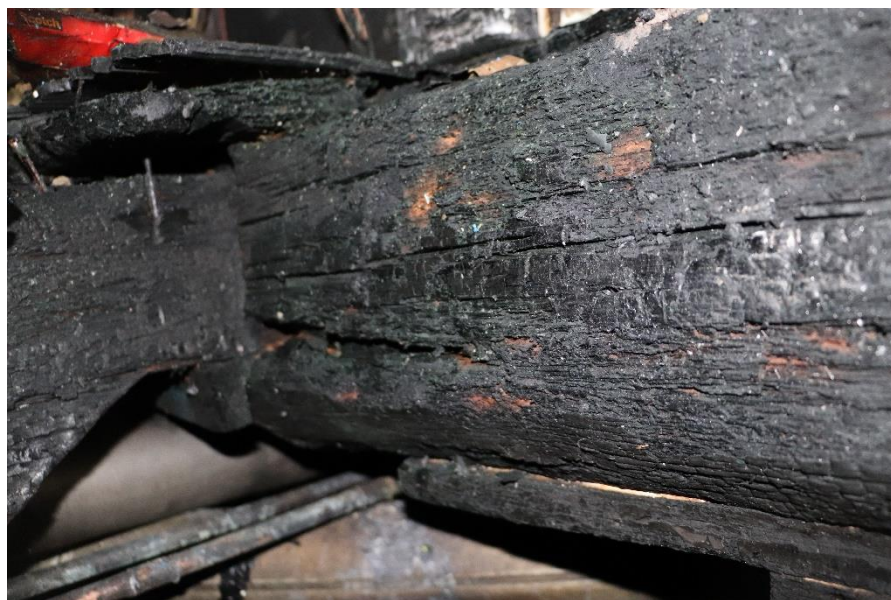
13. The fire also migrated to the timber floor beam and timber column below the main floor. The central timber floor beam was oriented in the east-west direction and was continuous full length from the front of the house to the interior foundation wall that was the original depth of the dwelling (Photograph 6).

Photograph 6 – Fire damage to central floor beam above crawlspace

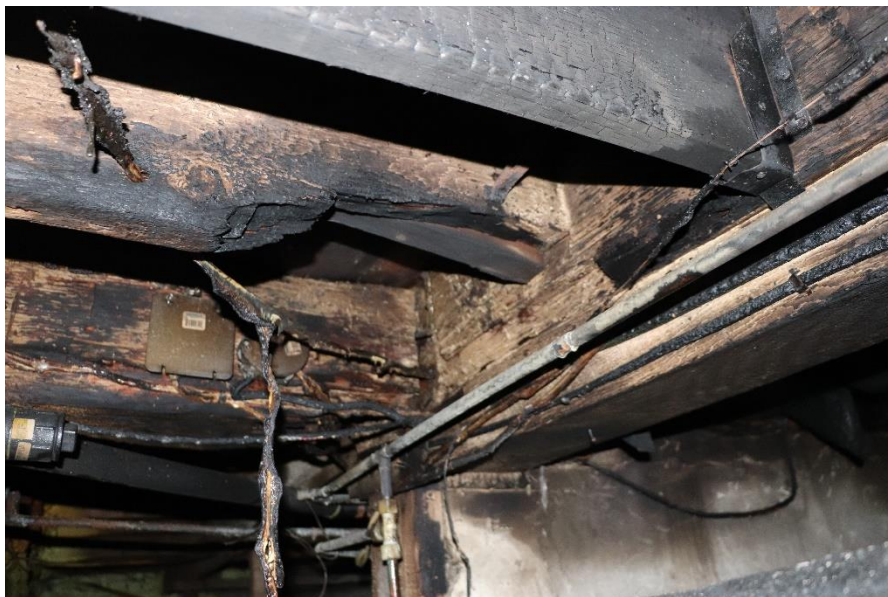
14. The fire damage also extended slightly beyond the crawlspace stairway to the adjacent 2x10 floor joists. The fire damage on the adjacent floor joists was relatively minor (Photograph 7).

Photograph 8 – Fire damage to adjacent 2x10 floor joists above crawlspace

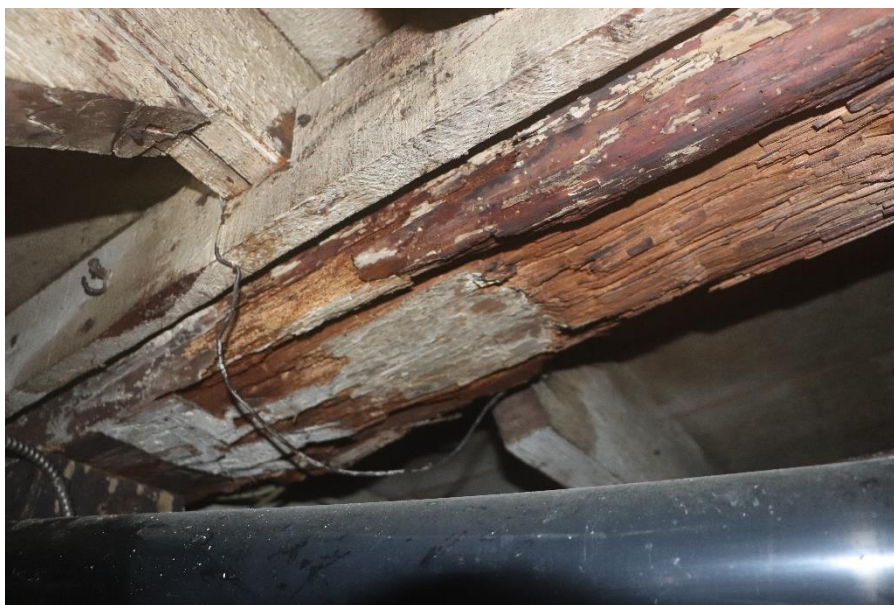
15. The crawlspace area contained significant moisture from the fire fighting activities and the contents within the crawlspace area were still saturated. A review of the existing floor framing throughout the crawlspace area indicated that the floor had sustained long-term and ongoing deflection as intermediate beams and vertical supports had been placed throughout the crawlspace area. A review of some of the timber beams indicated significant deterioration of the timber and it was soft to the touch. The timber could be broken apart by hand (Photograph 9).

Photograph 9 – Existing, long-term deterioration of timber framing

2. There was extensive smoke contamination throughout the remainder of the dwelling interior, including smoke odour throughout.
3. The fire-related damage to the dwelling is repairable; however, due to the significant, long-term deterioration of the structural framing and associated reduction in structural capacity of the structural framing members, it is recommended that the dwelling be demolished to the top of foundation and reconstructed above grade.

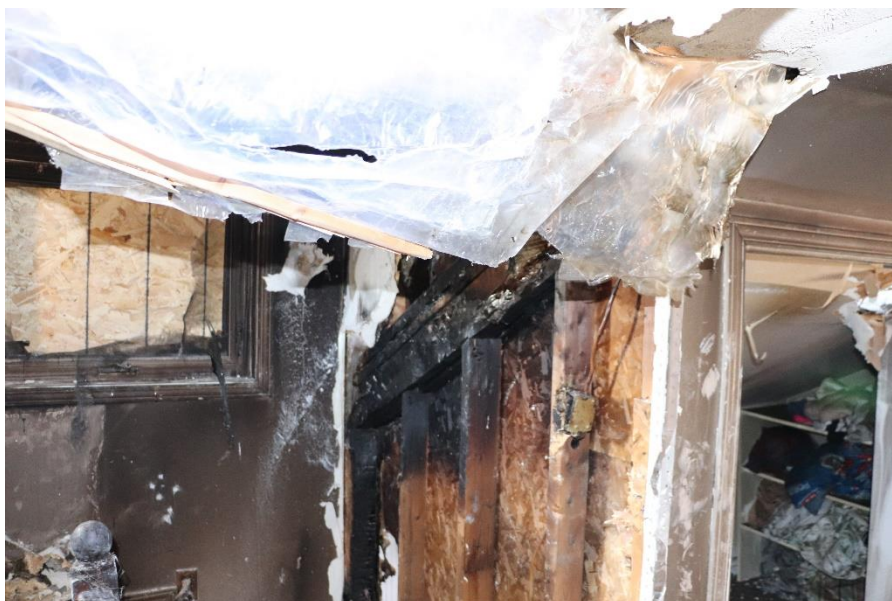
16. Some of the roof framing above the western portion of the dwelling had also sustained fire related damage to some of the 2x4 rafters and interior knee walls (Photograph 10).

Photograph 10 – Fire damage to knee walls and 2x4 rafters on the western portion
