# STAFF REPORT

THE CORPORATION OF THE TOWN OF COBOURG

| <b>Report No.:</b> | HP-2021-009 | | |

**Subject/Title:**      **Roof Replacement – 212 King Street West – Marie Dressler House (Town of Cobourg)**

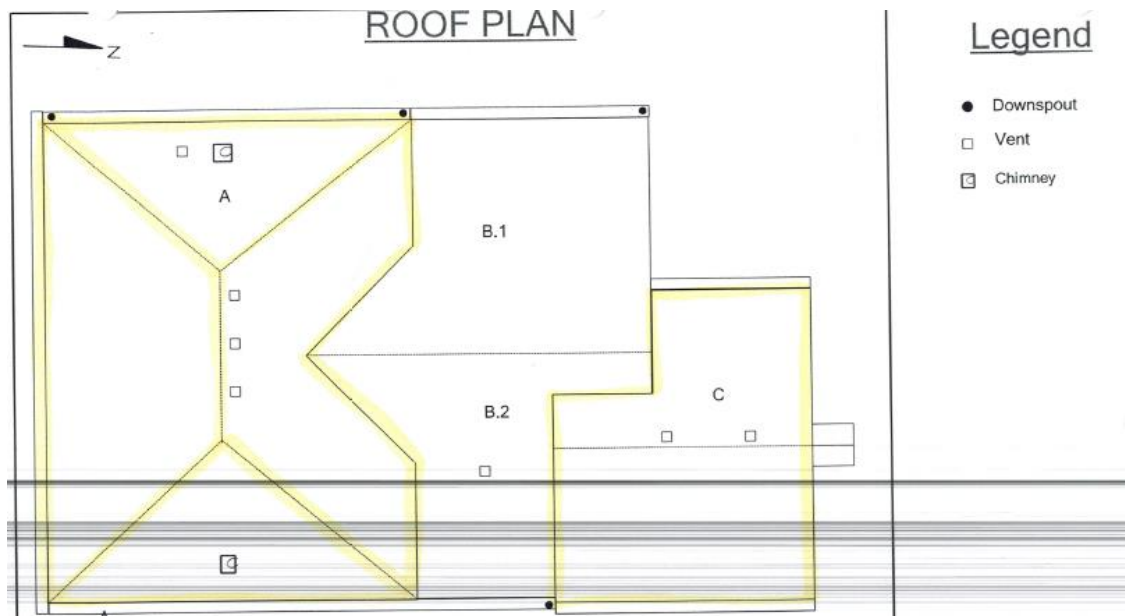
The Town of Cobourg is proposing to replace the current ageing cedar shake roofing system that exists on the front and rear sections of Dressler House as it leaking into the attic (see Figure 12- roof plan below and Figures 13-16). Presently, the Town is proposing a product called "Presidential Shake" which is a fiberglass shingle with the colour to be "weathered wood" (see Figure 17). The new fiberglass shingle is only to replace the existing deteriorated cedar shake shingles on the front primary building and the rear addition (Figure 12). The central portion of the building is currently sheathed with a composite polymer shake material design (see Figure 17). Over the years, it appears that the roofing material on the building has been altered a number of times, including what appears to have been slate, asphalt shingle and cedar wood shake.

Figure 12: 212 King St. W (Dressler House) roof plan – only highlighted areas are to be replaced. Areas B.1 and B.2 have already been replaced with a composite polymer shake style material (see Figure 17).

While fiberglass shingles are considered a composite roof material, and in shake form could be an appropriate replacement product for Dressler House, Heritage and Planning staff do not recommend having two substantially different roofing materials or designs/textures on a heritage structure (fiberglass and polymer shake). Accordingly, it is recommended that a product similar in design, texture, composition and colour as the existing composite polymer shake product be installed to ensure consistency and uniformity with the balance of the building.

It should be noted that the composite polymer shake on the central portion of the existing Dressler House roof that was installed a number of years ago is no longer available. It is the recommendation of staff that a Davinci composite polymer shake product (or equivalent) be implemented in the colour "Chesapeake" as this appears to be the closest matching design and colour to the existing composite roofing material (see Figures 17-18). Additionally, the roofing contractor has indicated that

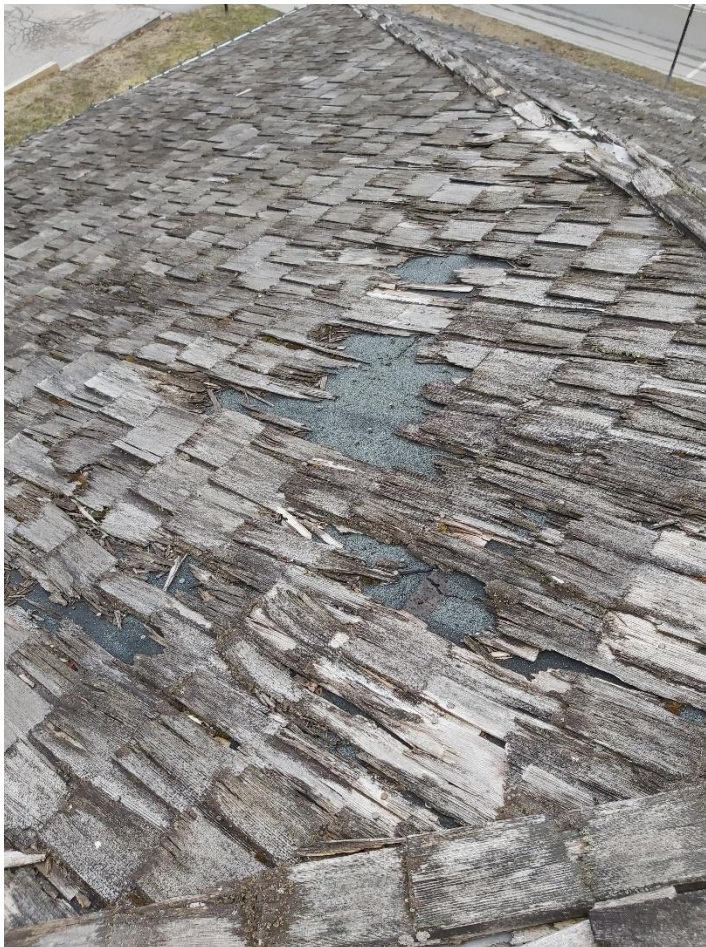
Figure 13: 212 King St. W (Dressler House) roof damage

In summary, Heritage and Planning staff does not recommend using the proposed fibreglass shingle product to replace the existing deteriorating cedar shakes on the front and rear sections of the building, but rather recommends using a composite polymer shake material by Davinci (or equivalent) in “Chesapeake” colour to more closely match the existing polymer shake currently in use on the central section of the building. Staff’s recommended approach for this polymer shake has been evaluated against the West HCD Plan, specifically the policy relating to roofs (4.2), and it is our opinion that the new roof on the front and rear sections of the building (change from cedar wood shake to a polymer shake) is an acceptable, complementary alteration and would be consistent with the central section that already exists today. The roofline and chimneys, and other defined heritage attributes, are not proposed to be changed as a result of this alteration. The applicant has retained Ontario Roofing as the contractor to undertake the proposed alteration.

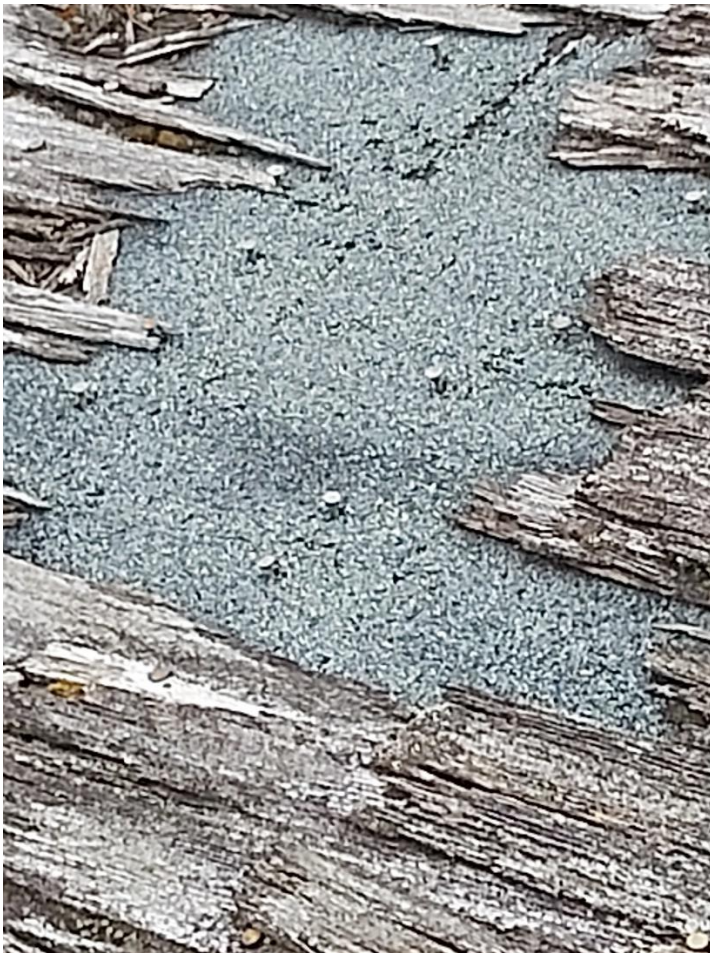
Figure 14: 212 King St. W (Dressler House) roof damage

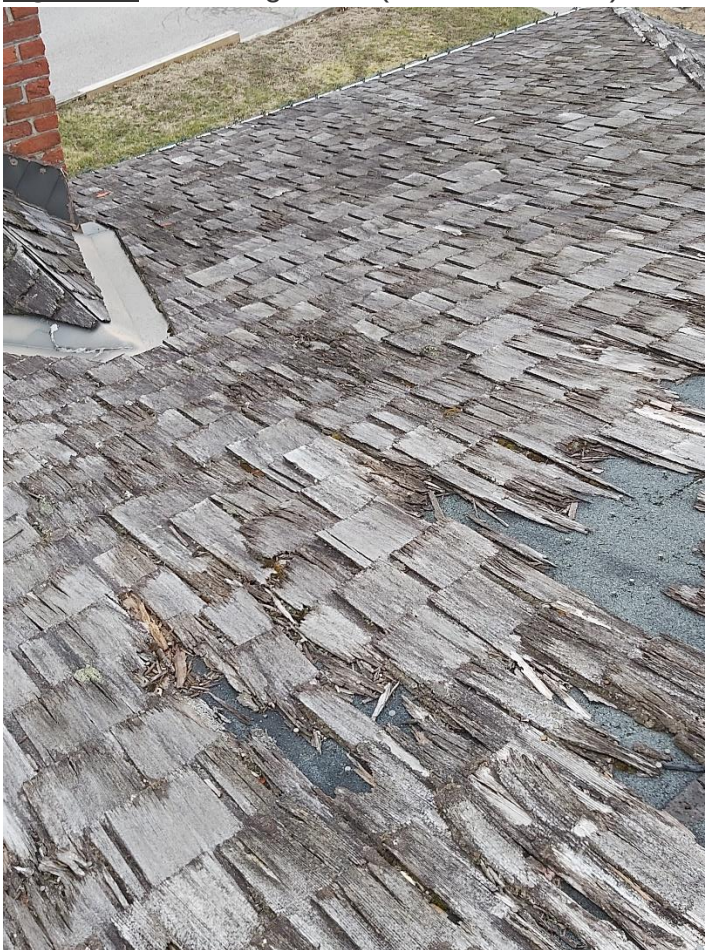
Figure 15: 212 King St. W (Dressler House) roof damage

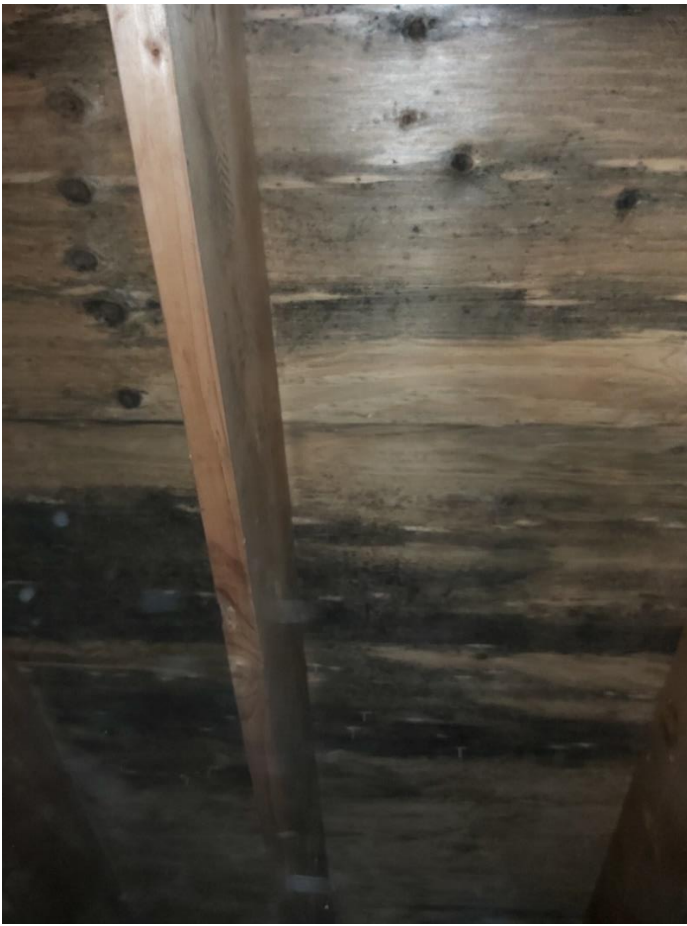
Figure 16: 212 King St. W (Dressler House) interior attic roof damage

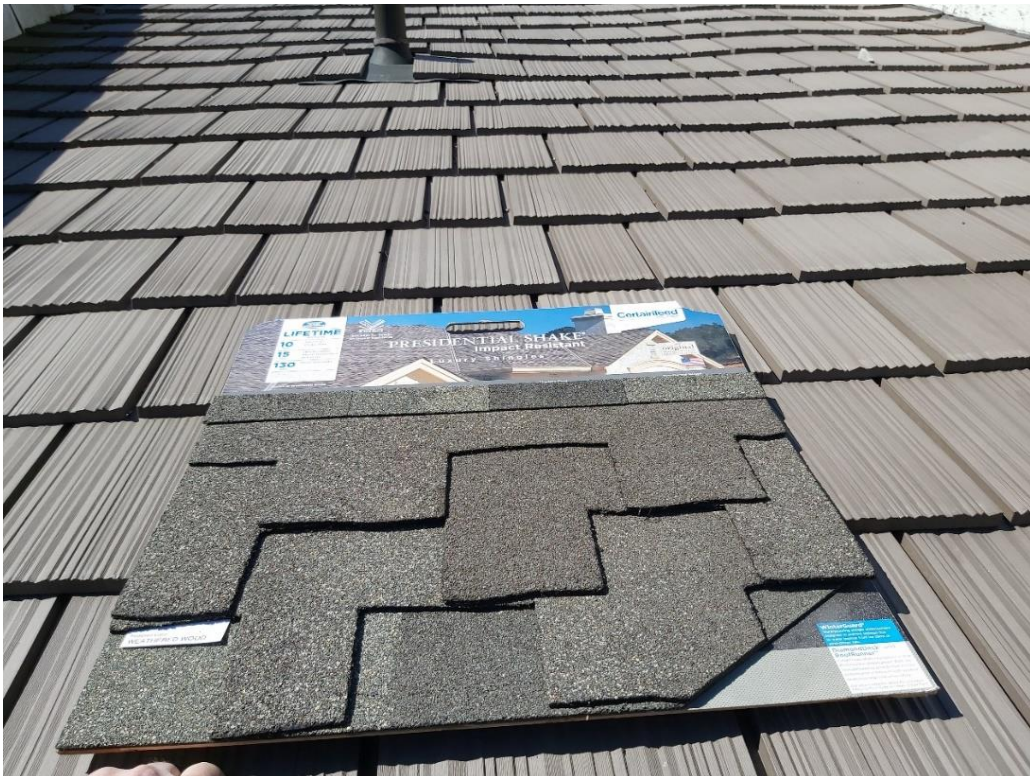
Figure 17: 212 King St. W (Dressler House) existing composite polymer shake roofing material and the proposed Presidential Shake shingle product.

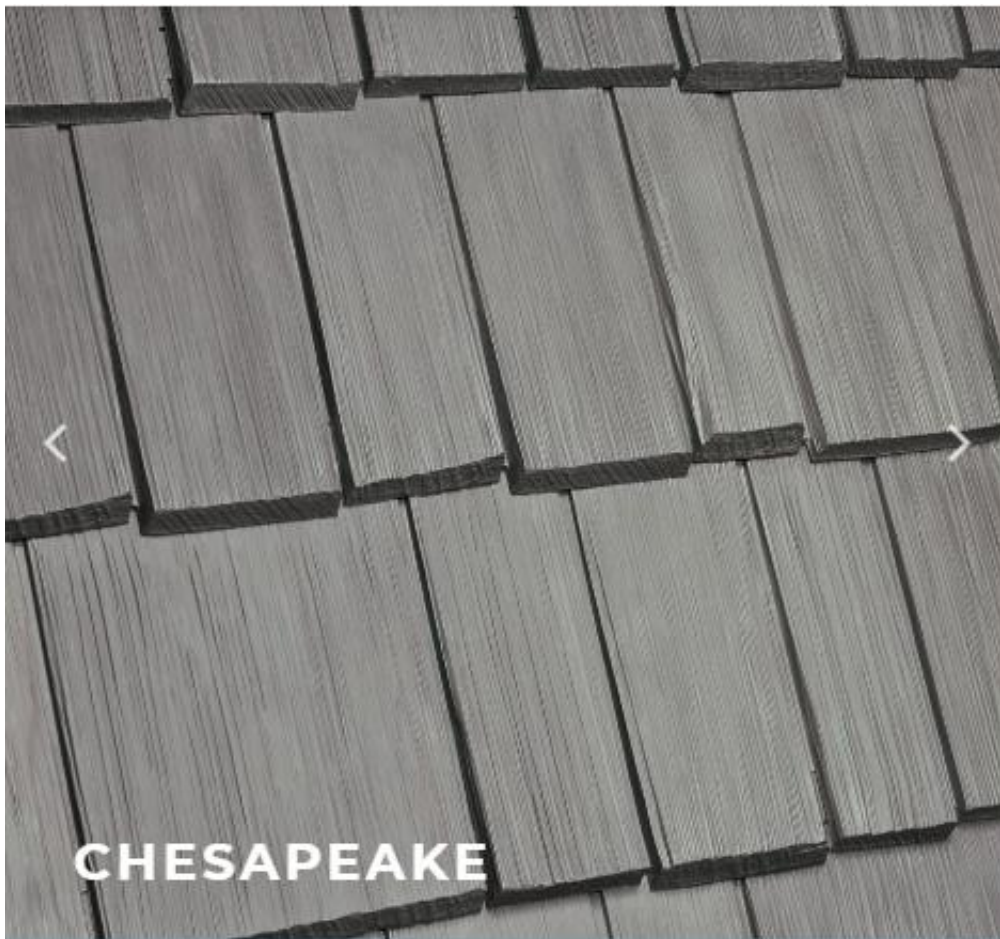
Figure 18: Davinci polymer “cedar shake” shingle in a similar colour to existing.  
<https://www.davinciroofscapes.com/products/shake/bellaforte-shake/>
