The Corporation of The Town of Cobourg SPECIAL COUNCIL MEETING AGENDA

Cobourg Harbour

Breakwaters and Basin Walls Condition Assessment

Shoreplan Engineering Limited

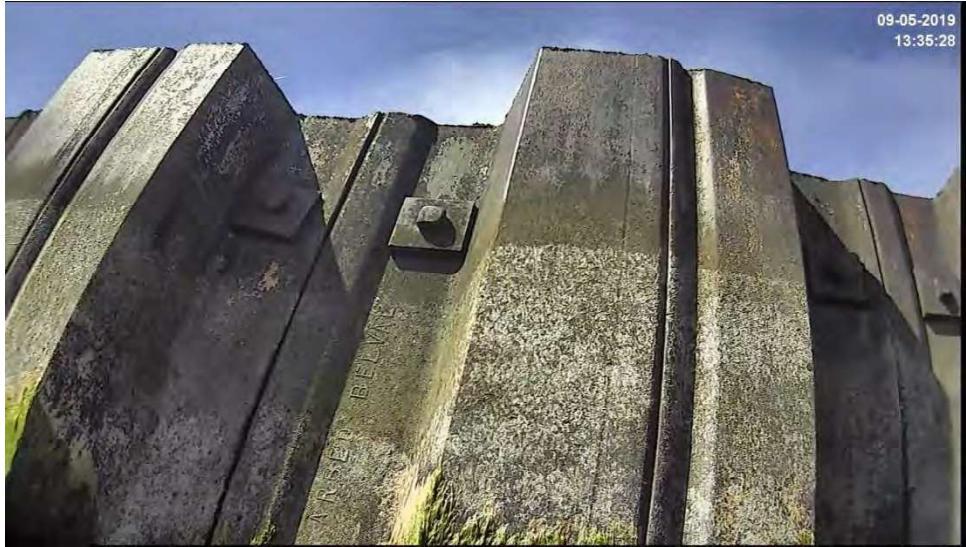
Photo 1 - East Breakwater, East Face

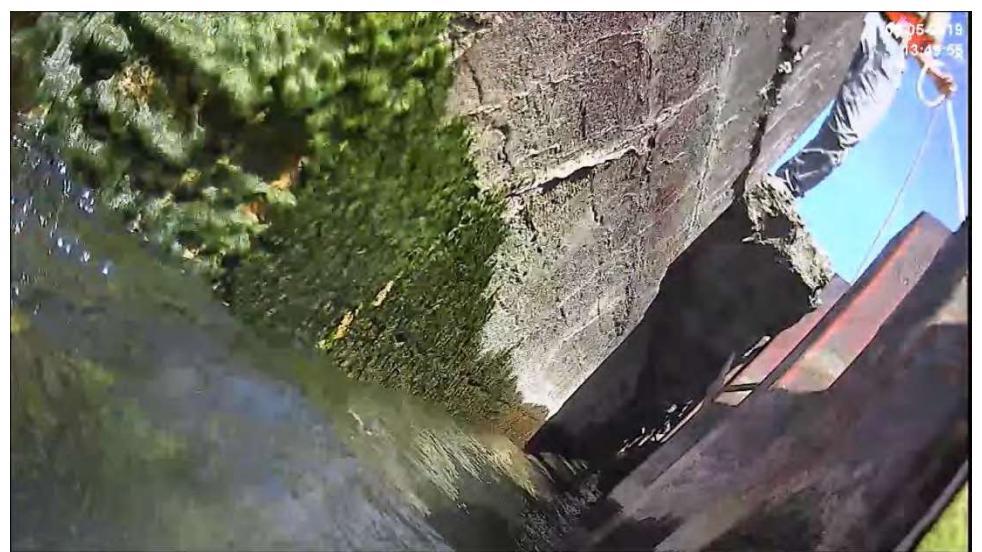
Photo 4 - East Breakwater, East Face Transition to Timber Cribs 0+075

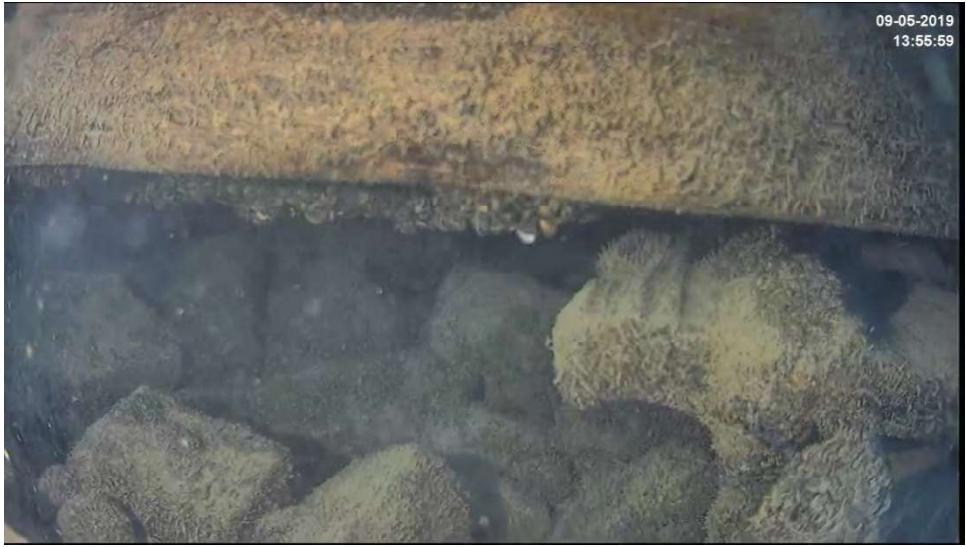
Photo 5 - East Breakwater, East Face Gap and Visible Fill Material

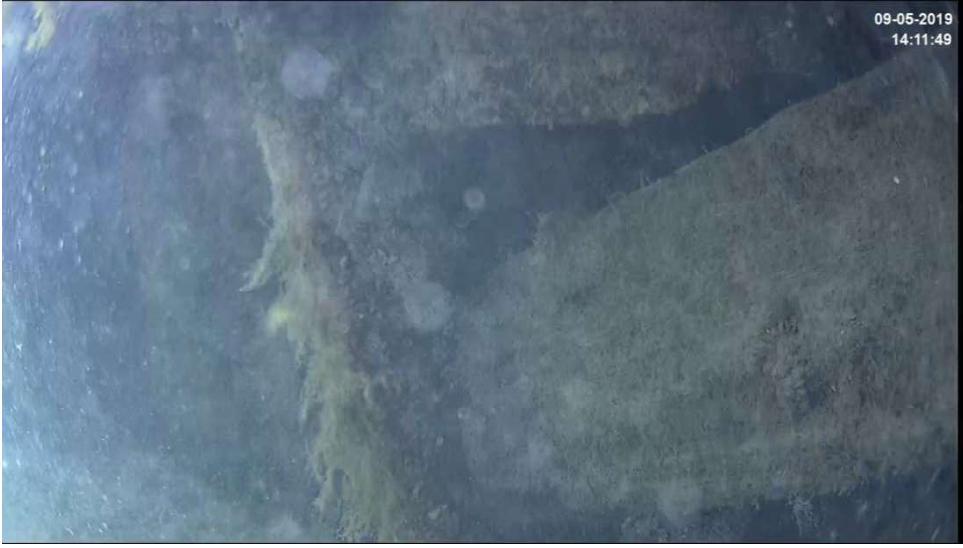
Photo 7 - East Breakwater, East Face Missing Top Two Timbers

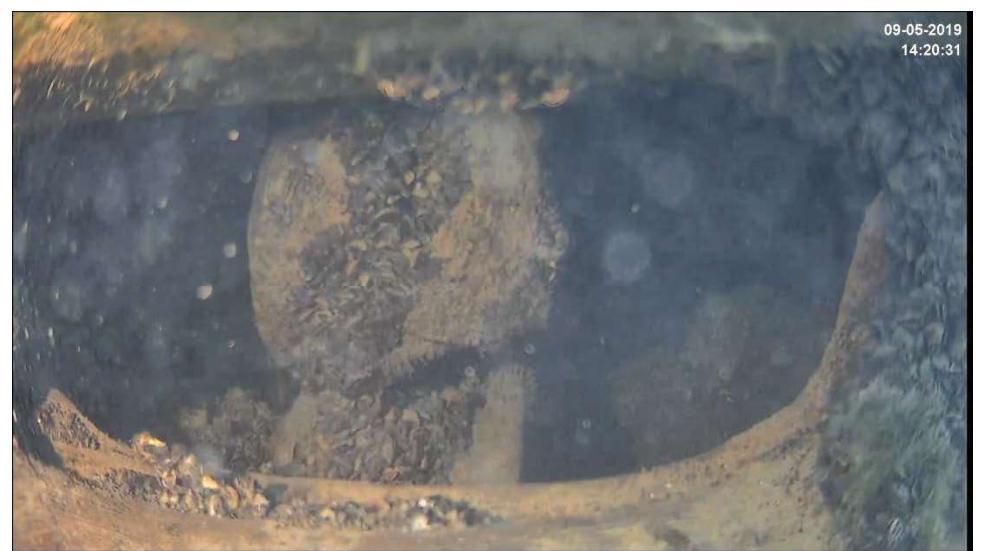
Photo 8 - East Breakwater, East Face Gap and Cross Members

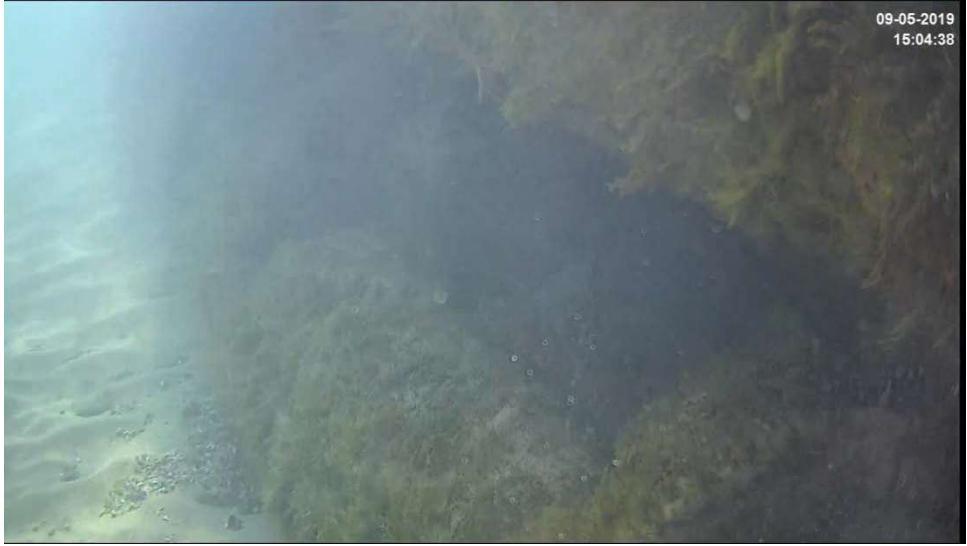
Photo 11 - East Breakwater East Face Top Two Timbers Missing 0+158

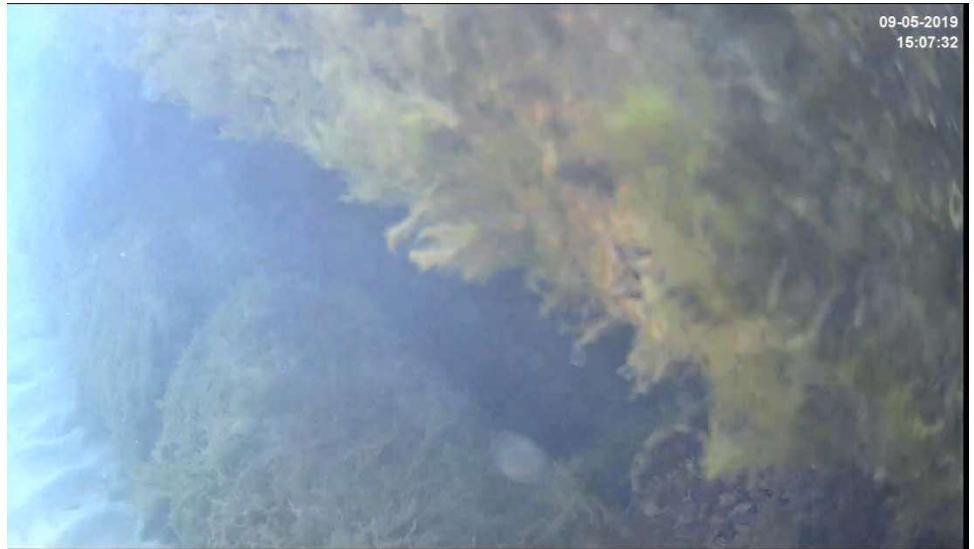
Photo 12 - East Breakwater East Face Top Two Timbers Missing 0+173

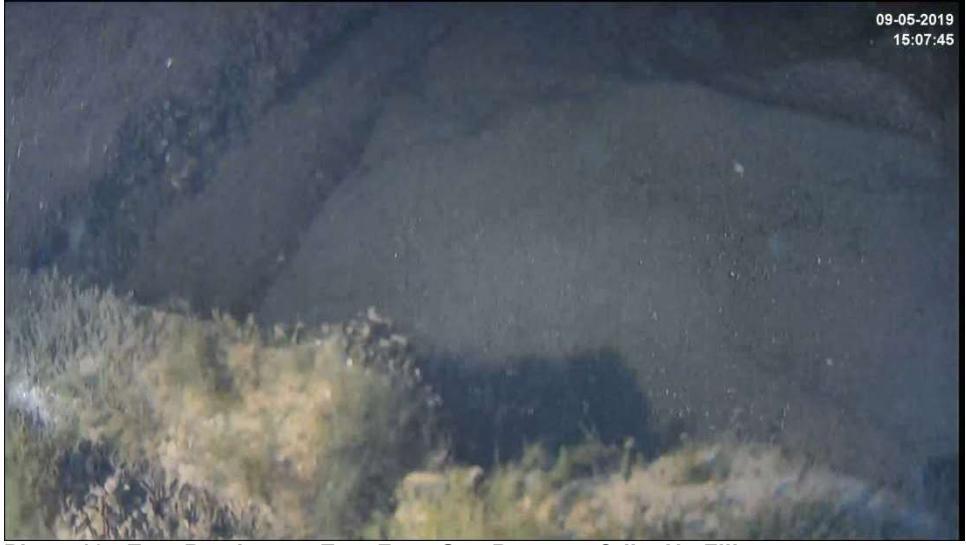
Photo 13 - East Breakwater East Face Gap Between Cribs No Fill

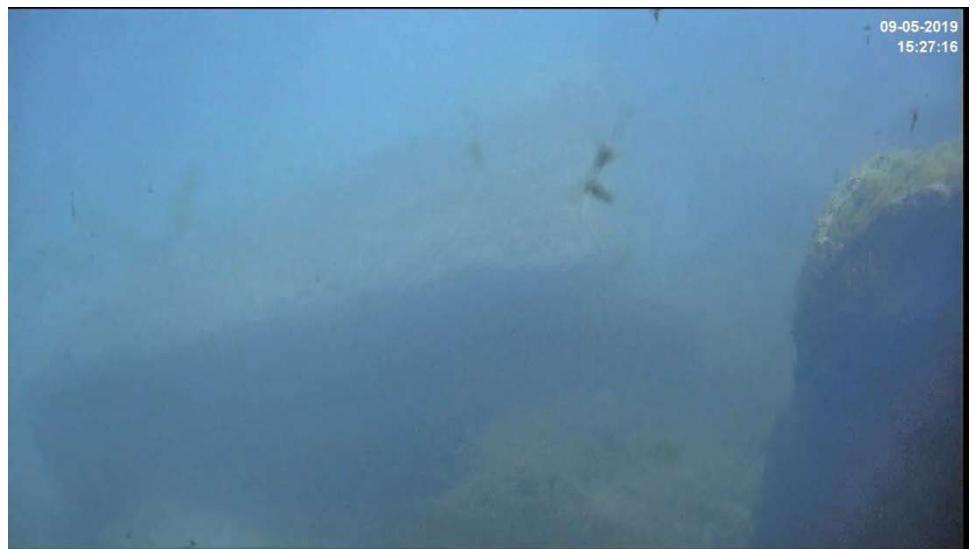
Photo 16 - Concrete Sections On Lakebed Adjacent to Lighthouse

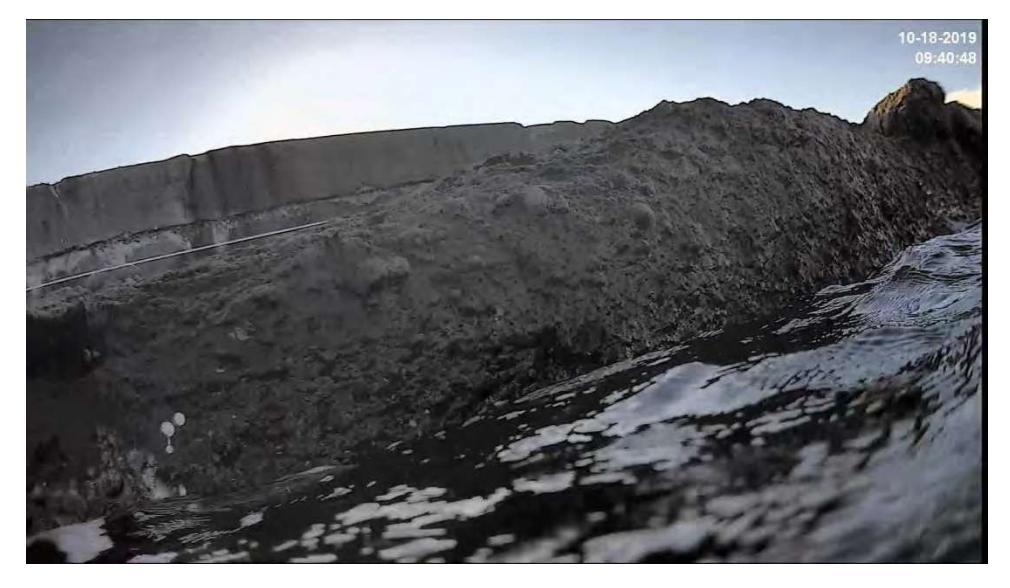
Photo 21 - East Breakwater West Face - Spawling in Cap 0+97 South

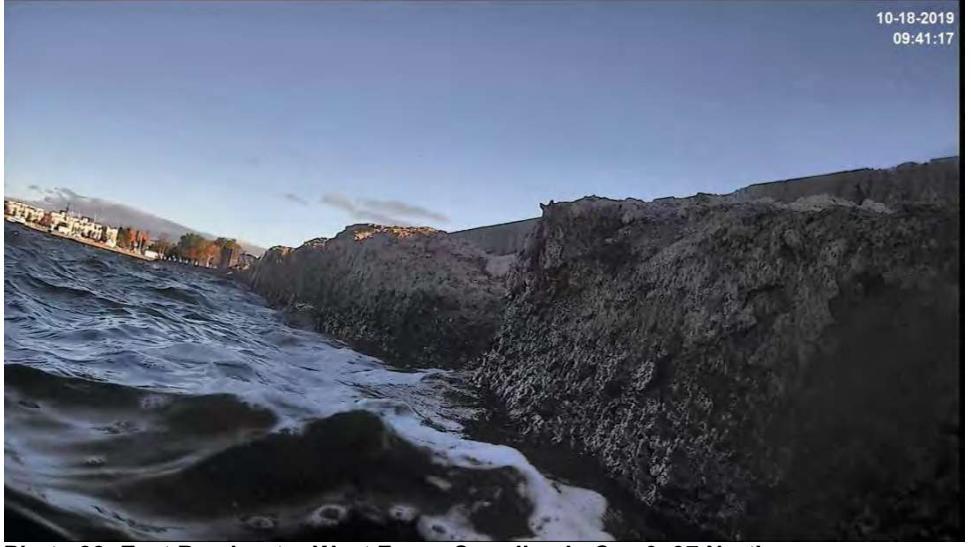
Photo 22- East Breakwater West Face - Spawling in Cap 0+97 North

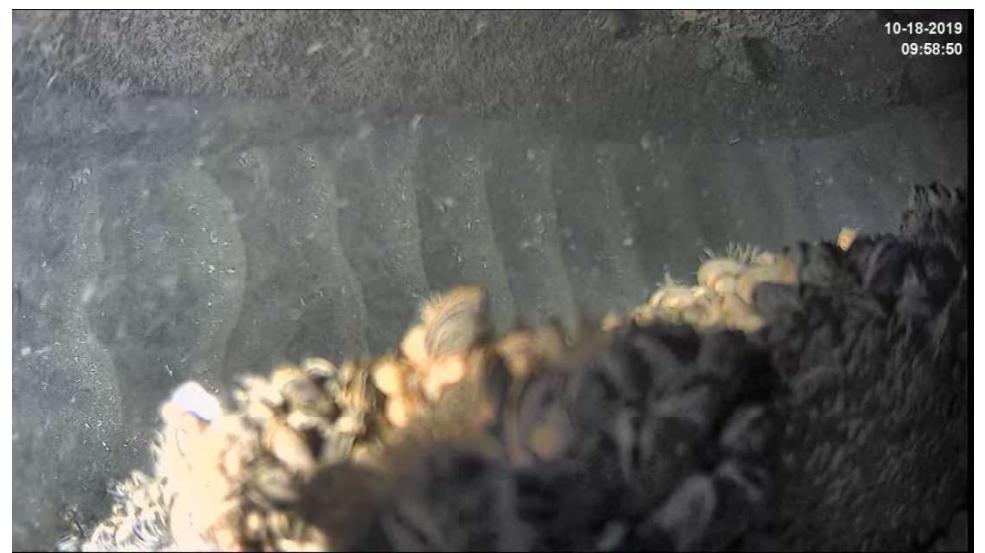
Photo 24 - East Breakwater West Face - Void between Cribs and SSP Flow E to W

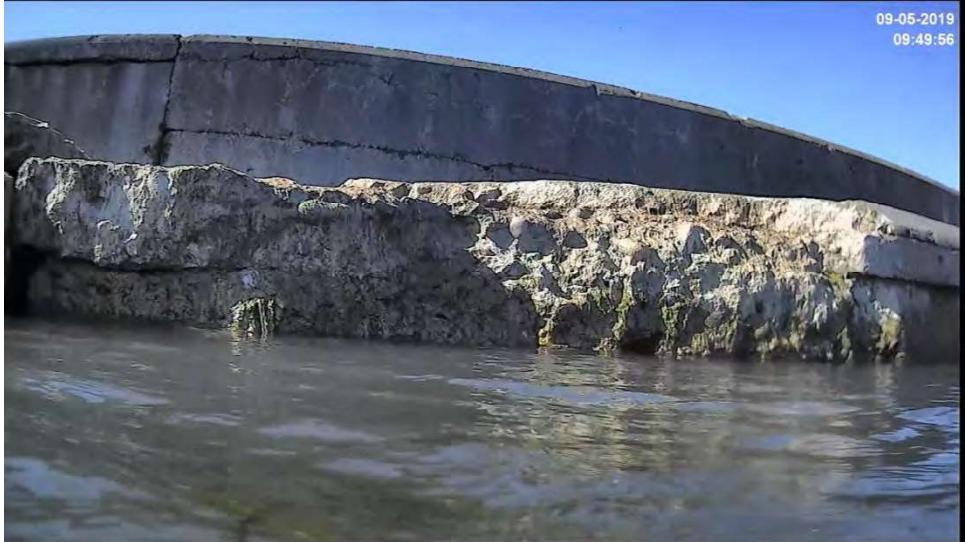
Photo 31 - West Breakwater North Side, Damage to Concrete Cap 0+20

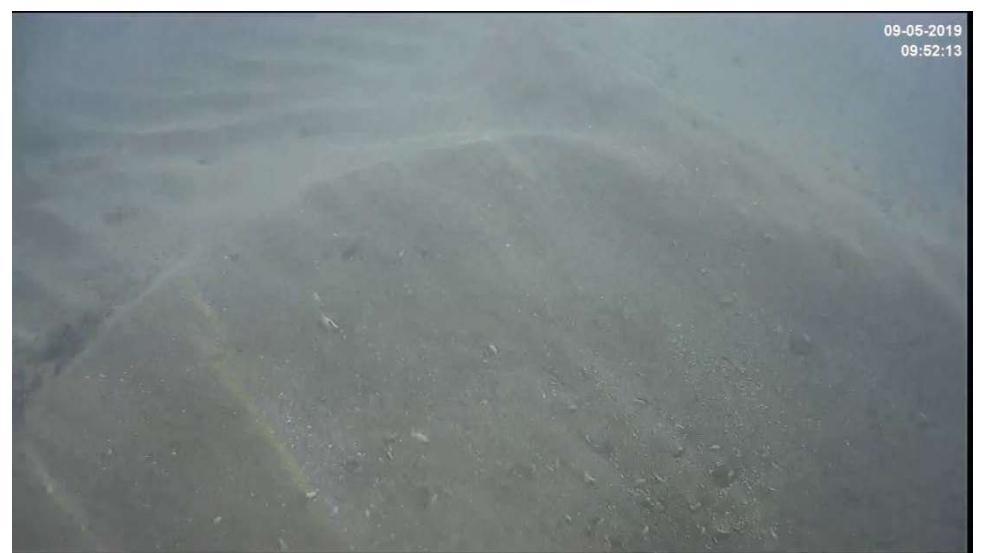
Photo 32 - West Breakwater North Side, Sand Pushed Away at Toe Void

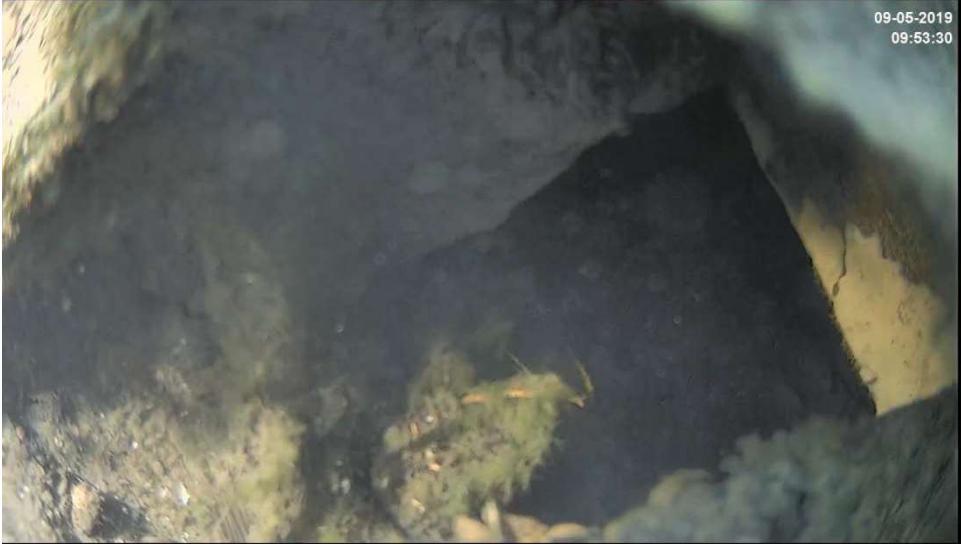
Photo 33 - West Breakwater North Side, Example Gap at Toe

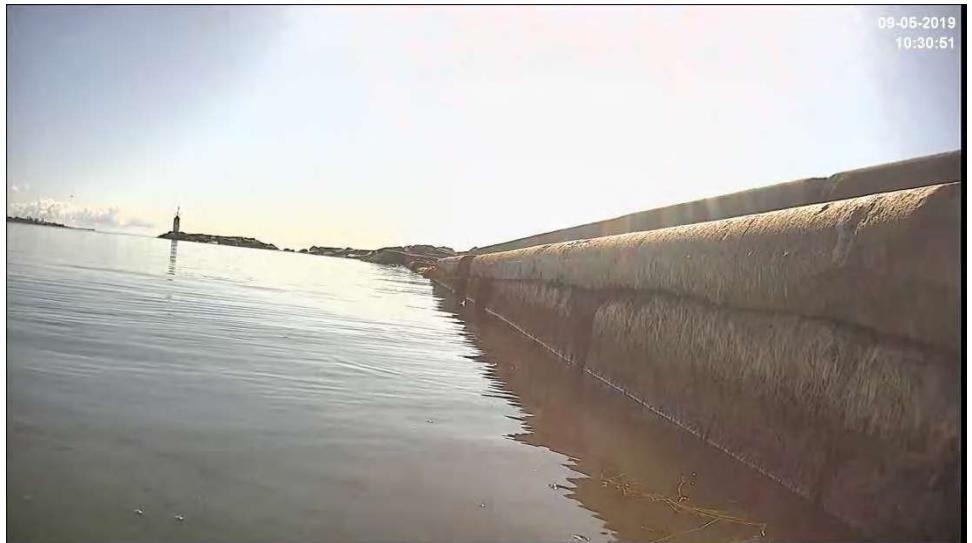
Photo 34 - West Breakwater North Side, Form Joints & Cracks in Cap

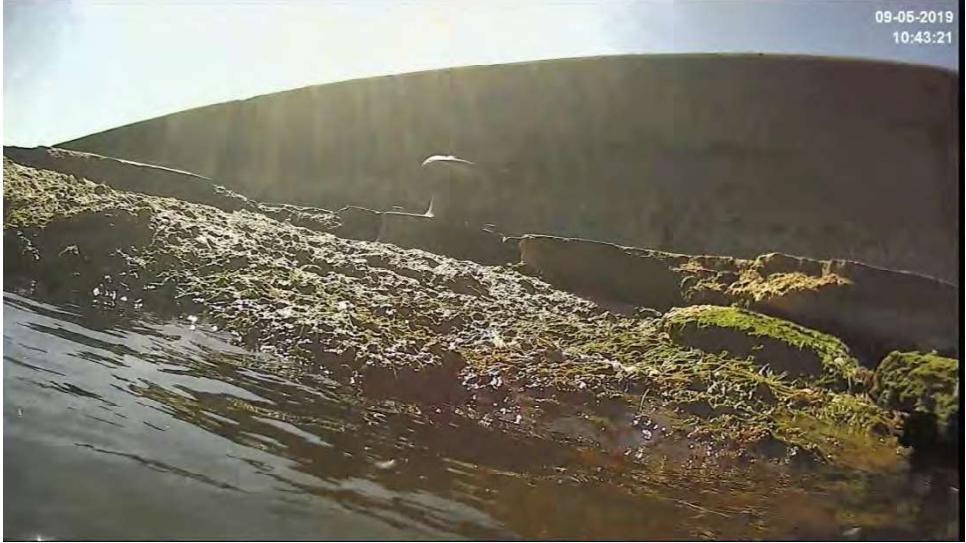
Photo 35- West Breakwater North Side, Large Section of Cap Damage 0+70

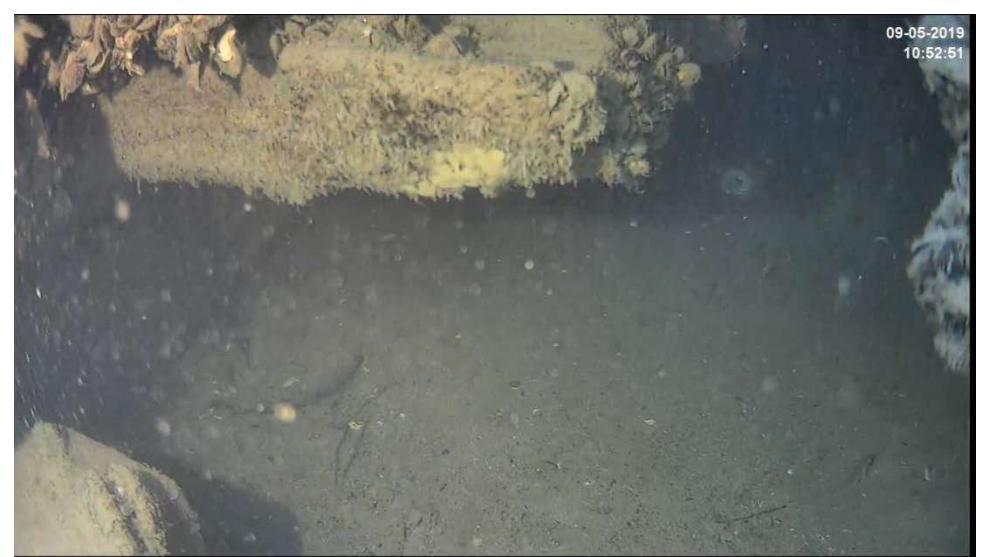
Photo 36 - West Breakwater North Side, Large Gap Between Cribs 0+84

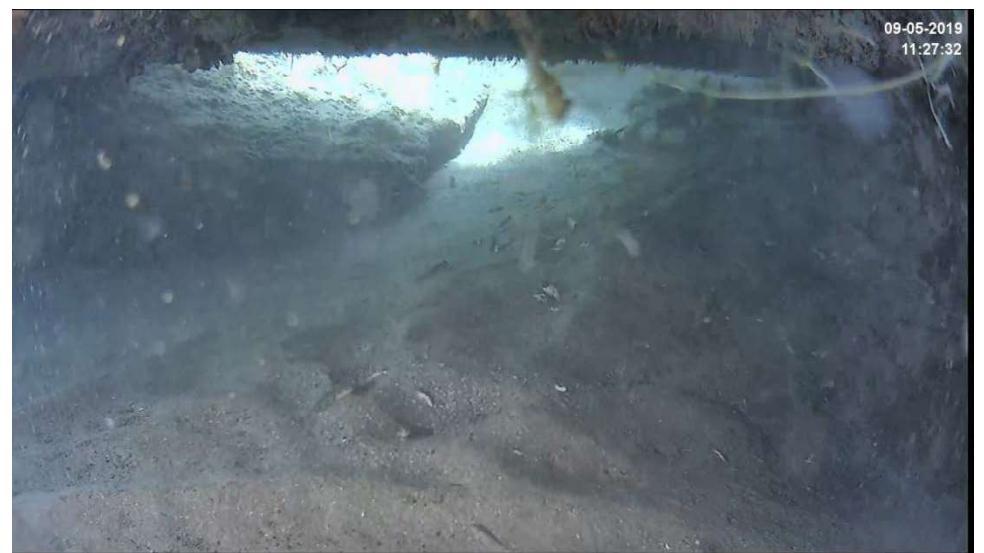
Photo 40 - West Breakwater North Side, Gap between Stones in Revetment Toe

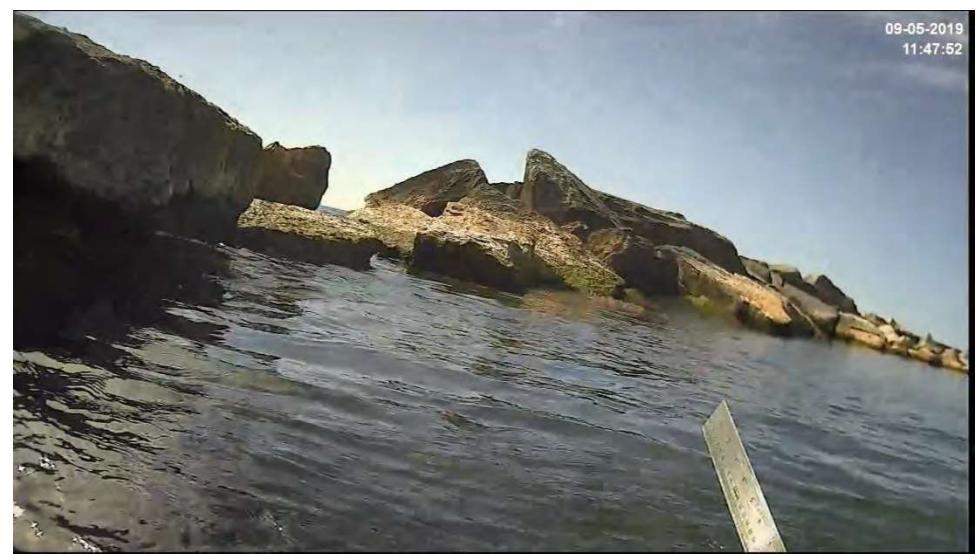
Photo 42 - West Breakwater North Side, Gap in Revetment

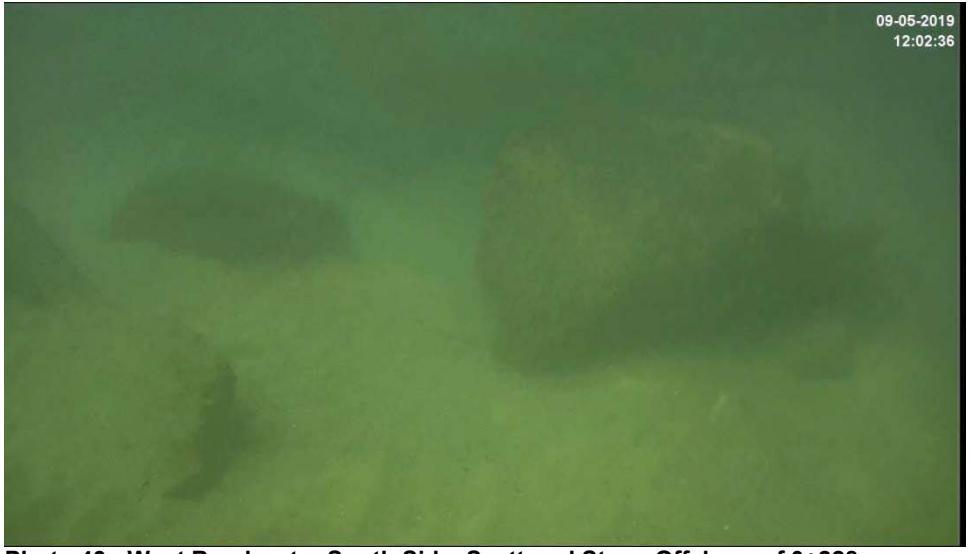
Photo 43 - West Breakwater South Side, Scattered Stone Offshore of 0+228

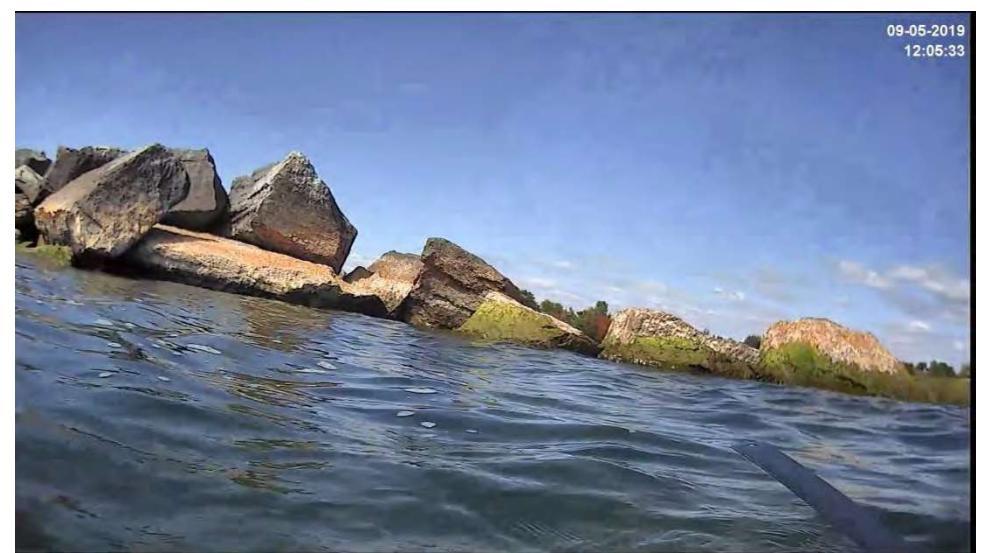
Photo 44 - West Breakwater South Side, Gap in Revetment

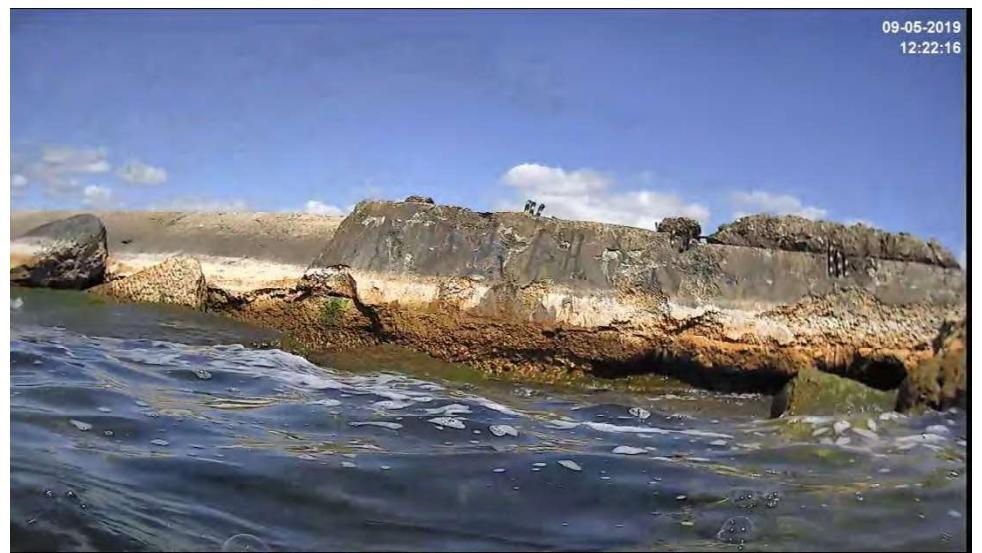
Photo 46 - West Breakwater South Side, Missing Stone at Concrete East End

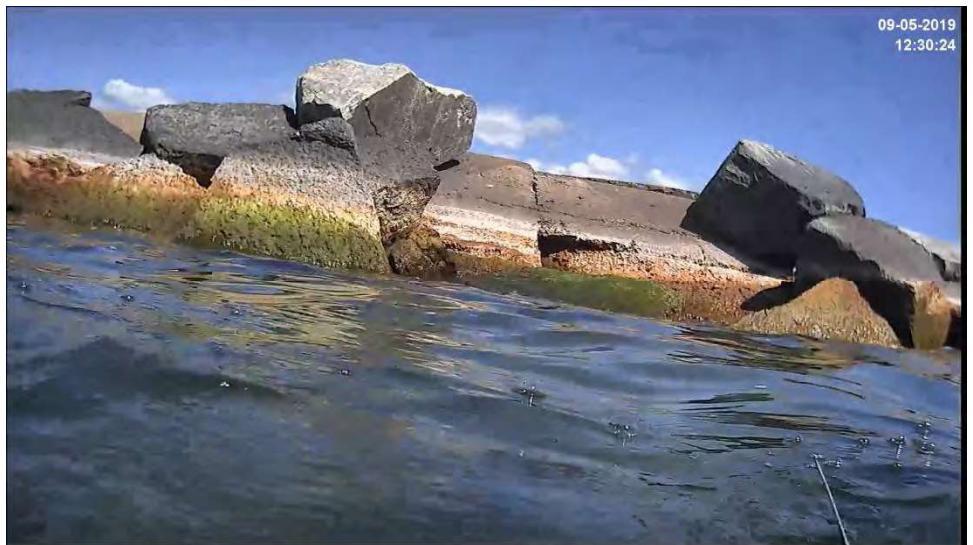
Photo 48 - West Breakwater South Side, Small Gap Onshore 0+30

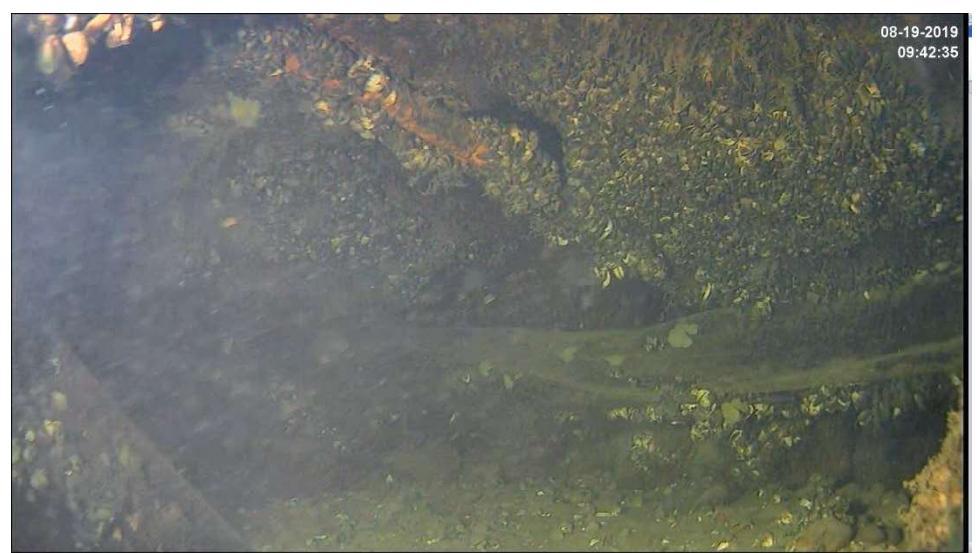
Photo 54 - North Wall Inside Large Void at 0+35

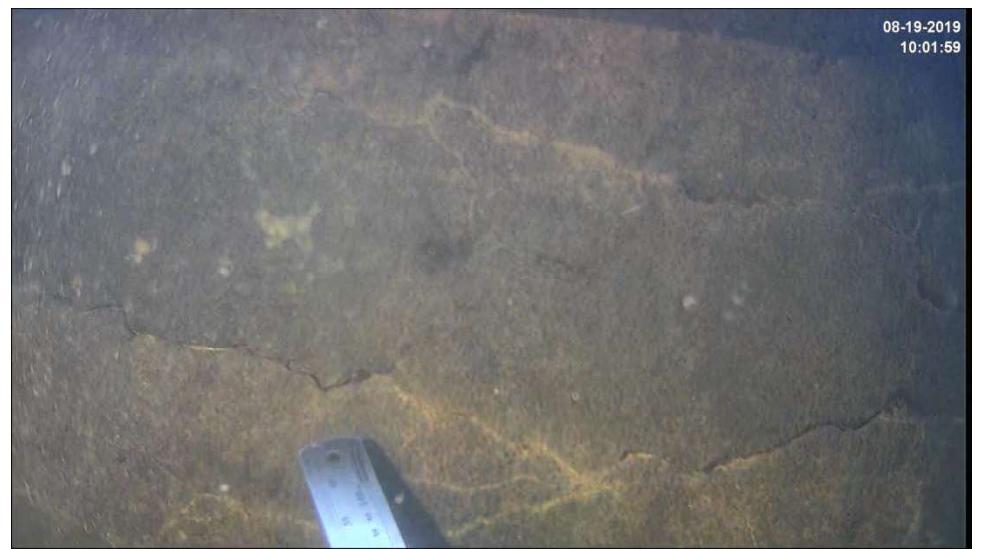
Photo 56 - North Wall Example of Cracking in Concrete Blocks

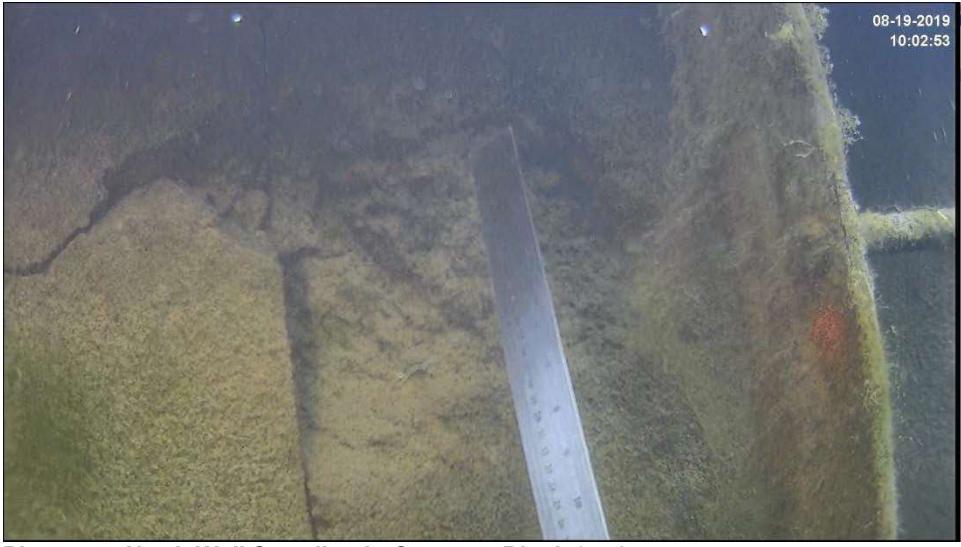
Photo 57 - North Wall Spawling in Concrete Block 0+42

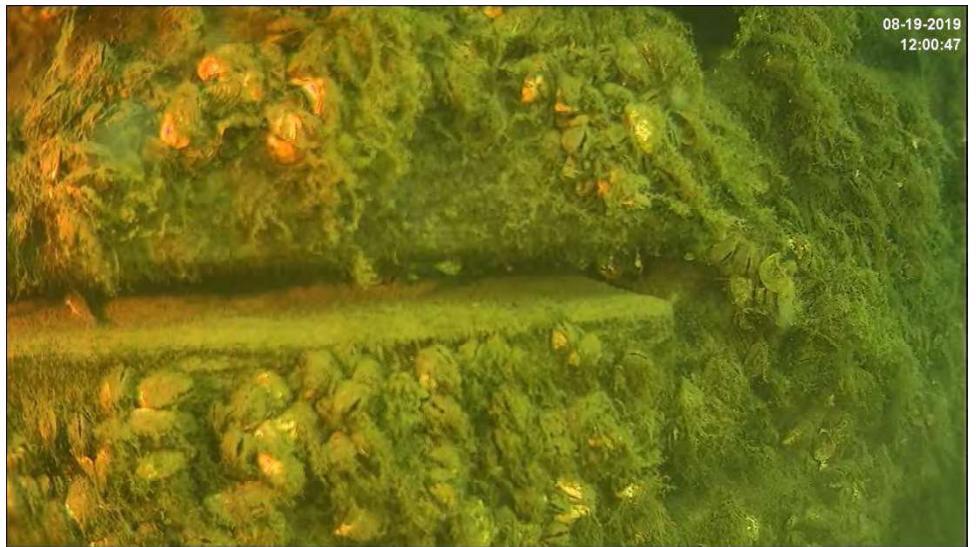
Photo 60 - North Wall Typical Gap Between Timbers 0+135

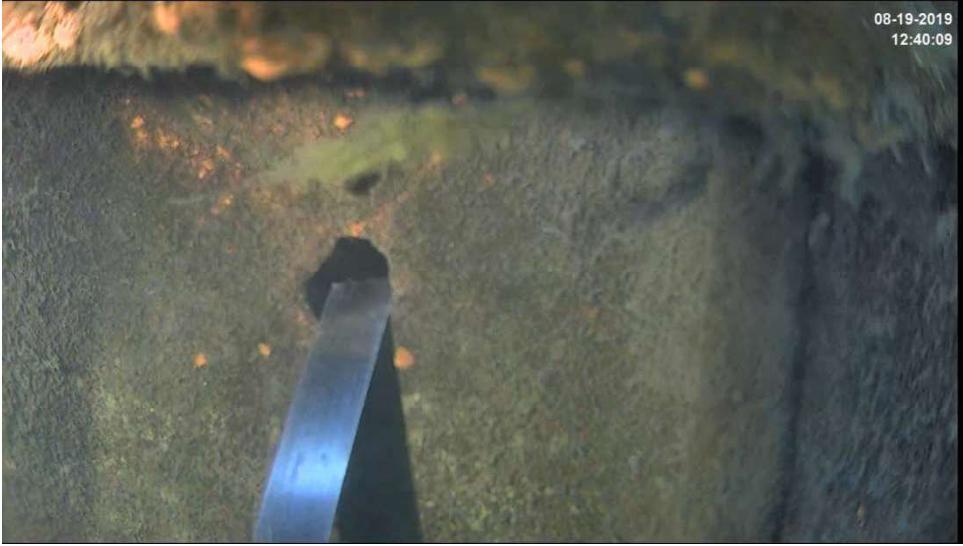
Photo 64 - East Wall Typical Hole

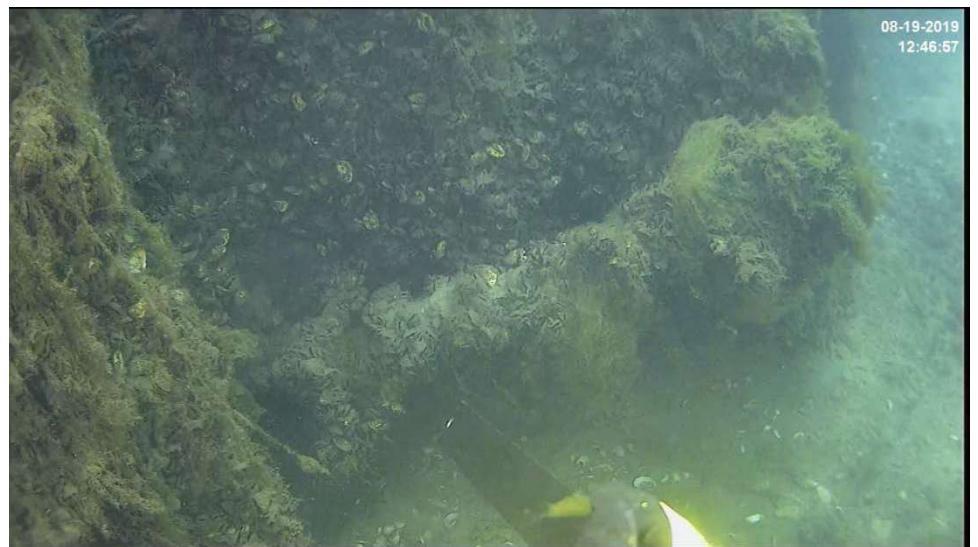
Photo 65 - East Wall Tie and Bolt Pulled Away From Wall at Lakebed

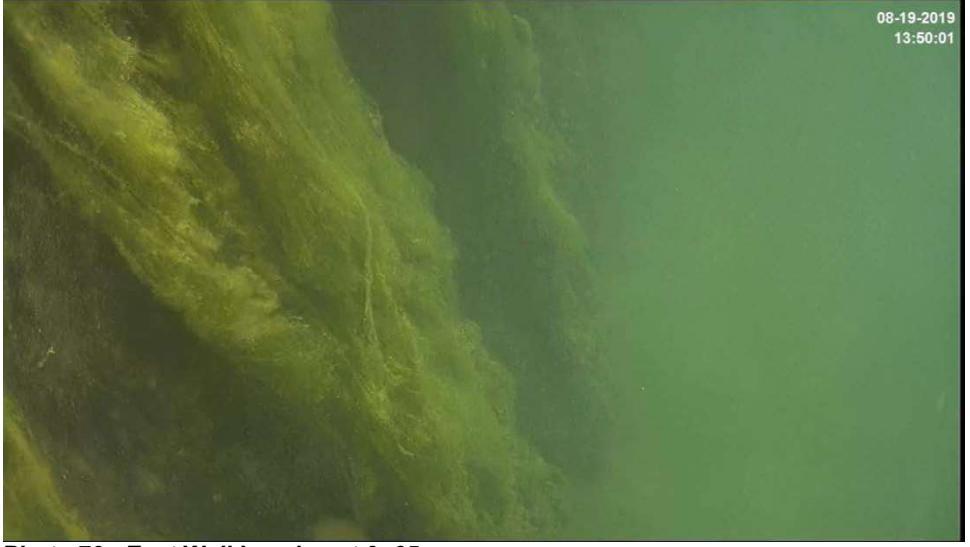
Photo 70 - East Wall Leaning at 0+65

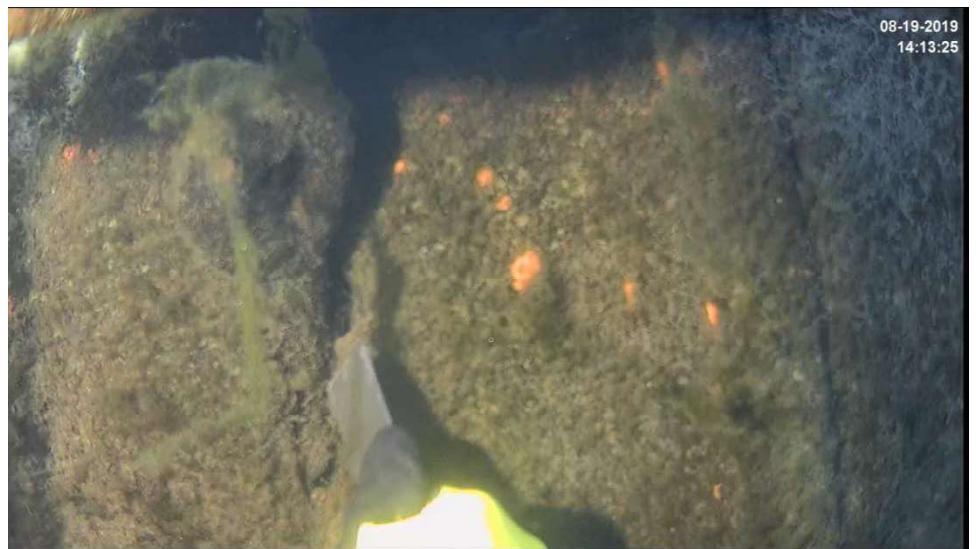
Photo 71 - East Wall Example of Eye Bolt in Wall with Small Gap Around

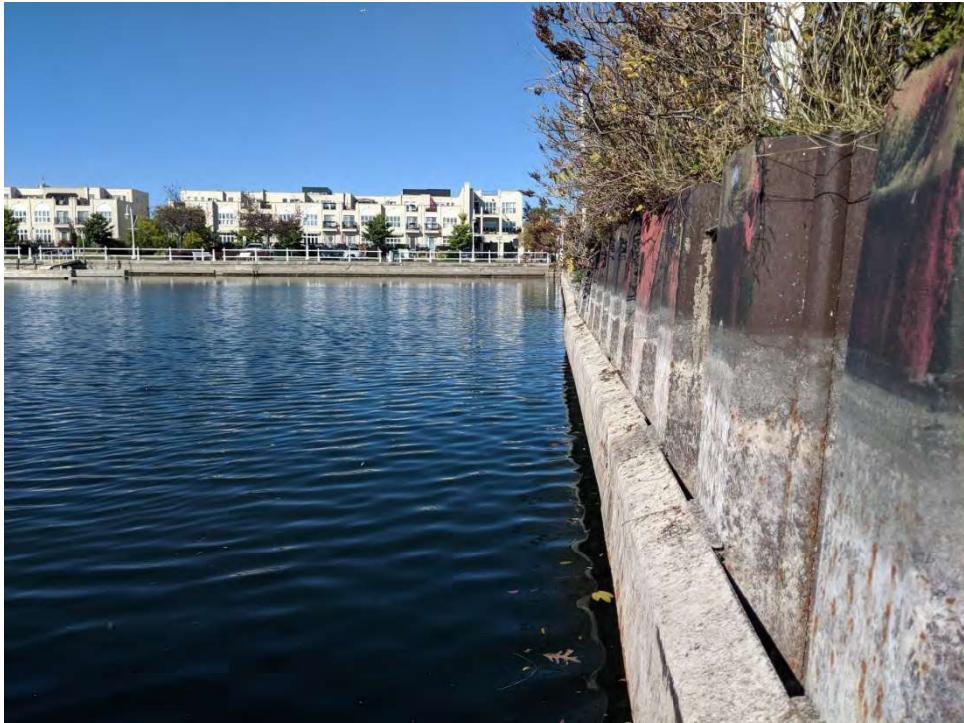
Photo 72 - East Wall Leaning Piles Above Water

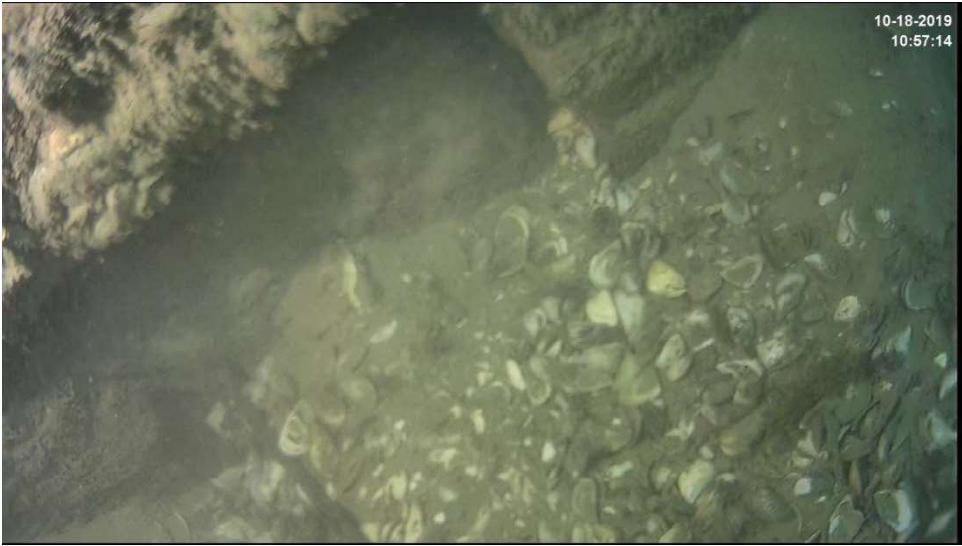
Photo 75 - Centre Pier West Face Gap at Toe With Flow 0+47

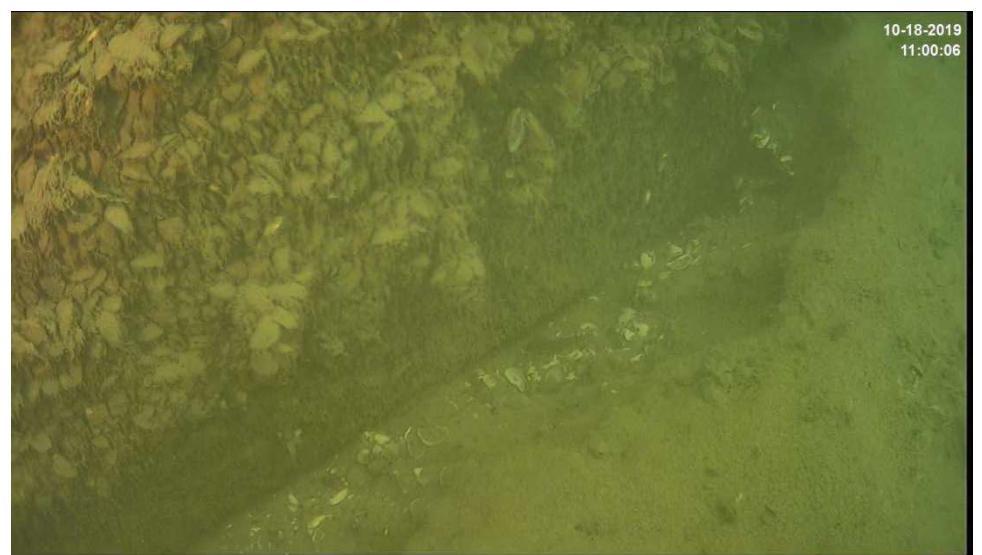
Photo 76 - Centre Pier West Face Scour from Flow Through Wall

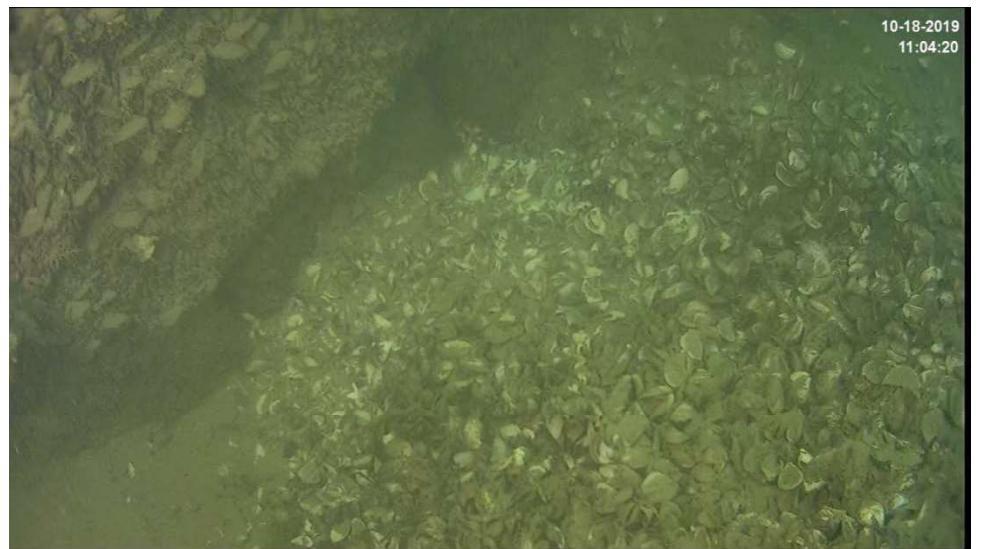
Photo 78 - Centre Pier West Face Typical Scour at Toe Due to Small Gaps

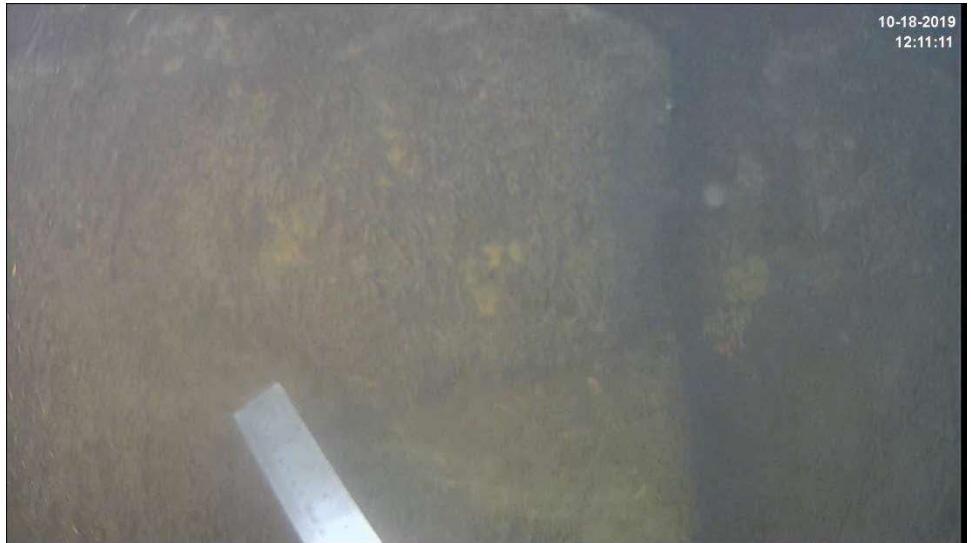
Photo 82 - Centre Pier Crack and Spawling in Cap
