STAFF REPORT

THE CORPORATION OF THE TOWN OF COBOURG

Subject/Title: **Roof Replacement – 212 King Street West – Marie Dressler House (Town of Cobourg)**

To review and provide a recommendation regarding Heritage Permit Application HP-2021-009 for a new roof at 212 King Street West in the West Heritage Conservation District.

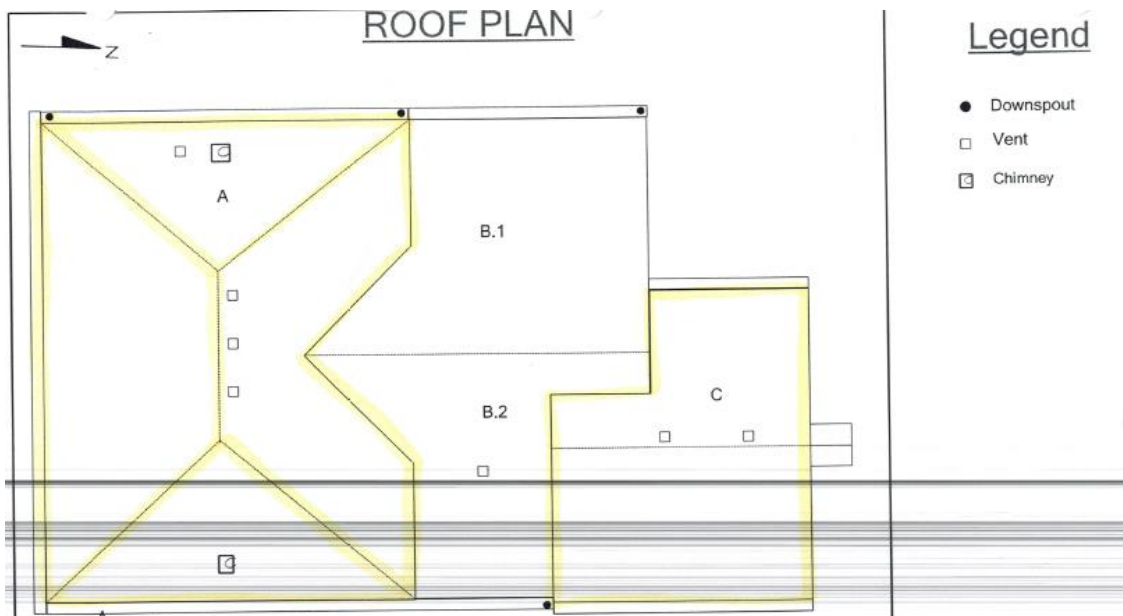
The Town of Cobourg is proposing to replace the current ageing cedar shake roofing system that exists on the front and rear sections of Dressler House as it leaking into the attic (see Figure 12- roof plan below and Figures 13-16). Presently, the Town is proposing a product called "Presidential Shake" which is a fiberglass shingle with the colour to be "weathered wood" (see Figure 17). The new fiberglass shingle is only to replace the existing deteriorated cedar shake shingles on the front primary building and the rear addition (Figure 12). The central portion of the building is currently sheathed with a composite polymer shake material design (see Figure 17). Over the years, it appears that the roofing material on the building has been altered a number of times, including what appears to have been slate, asphalt shingle and cedar wood shake.

Figure 12: 212 King St. W (Dressler House) roof plan – only highlighted areas are to be replaced. Areas B.1 and B.2 have already been replaced with a composite polymer shake style material (see Figure 17).

It should be noted that the composite polymer shake on the central portion of the existing Dressler House roof that was installed a number of years ago is no longer available. It is the recommendation of staff that a Davinci composite polymer shake product (or equivalent) be implemented in the colour "Chesapeake" as this appears to be the closest matching design and colour to the existing composite roofing material (see Figures 17-18). Additionally, the roofing contractor has indicated that

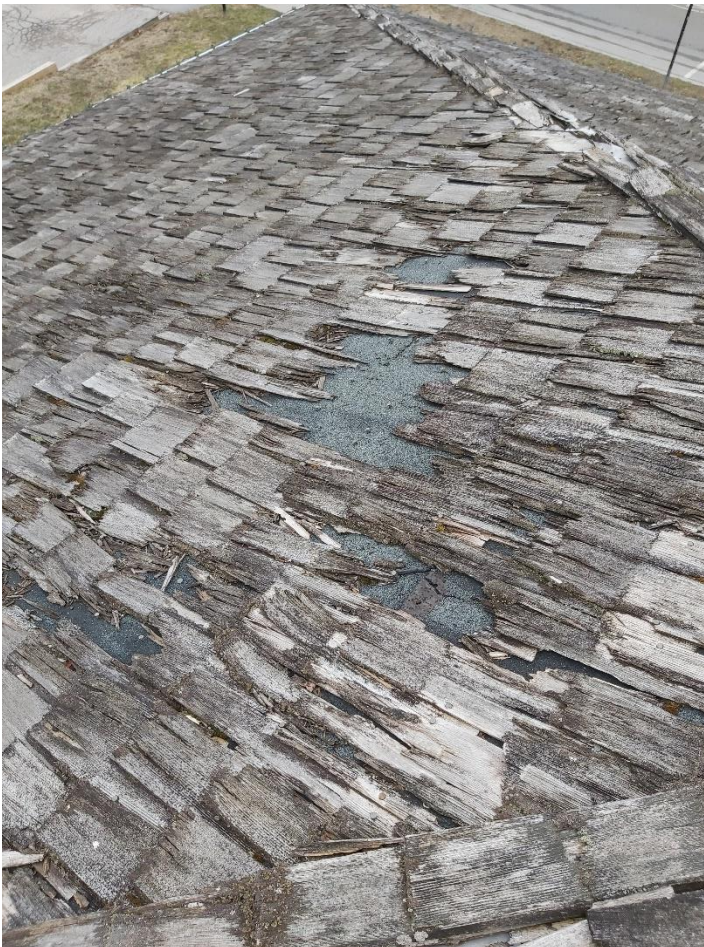
Figure 13: 212 King St. W (Dressler House) roof damage

In summary, Heritage and Planning staff does not recommend using the proposed fibreglass shingle product to replace the existing deteriorating cedar shakes on the front and rear sections of the building, but rather recommends using a composite polymer shake material by Davinci (or equivalent) in “Chesapeake” colour to more closely match the existing polymer shake currently in use on the central section of the building. Staff’s recommended approach for this polymer shake has been evaluated against the West HCD Plan, specifically the policy relating to roofs (4.2), and it is our opinion that the new roof on the front and rear sections of the building (change from cedar wood shake to a polymer shake) is an acceptable, complementary alteration and would be consistent with the central section that already exists today. The roofline and chimneys, and other defined heritage attributes, are not proposed to be changed as a result of this alteration. The applicant has retained Ontario Roofing as the contractor to undertake the proposed alteration.

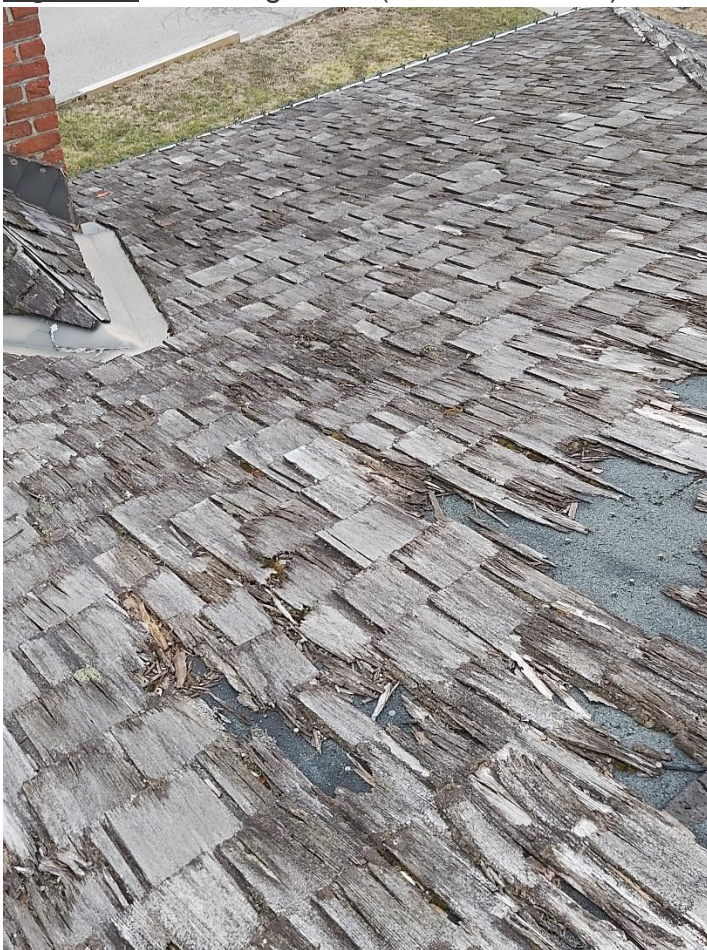
Figure 15: 212 King St. W (Dressler House) roof damage
