# CULTURAL HERITAGE IMPACT ASSESSMENT (REVISED)

## 93 ALBERT STREET

Cobourg, Ontario

July 15, 2021

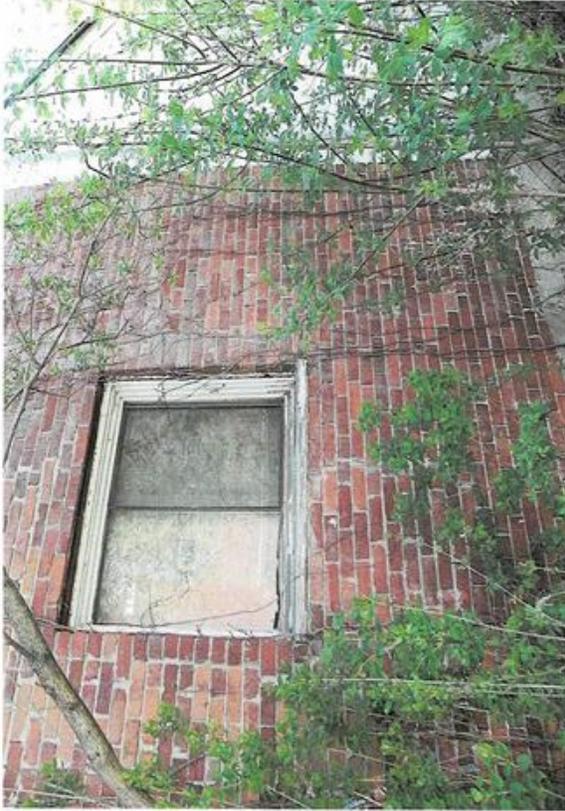
Top left – Exterior west wall.  
See old window with deteriorating frame, and cracked brick under the window. Brick repairs have been made in the past.

Bottom left – Exterior east wall.  
It appears that some brick repairs have been made in the past. See difference in the colour of the brick at the corner, and the difference in mortar joints.

Bottom right – North window on east wall of upper floor.  
See spalding brick, difference in brick colours and difference in mortar joints.

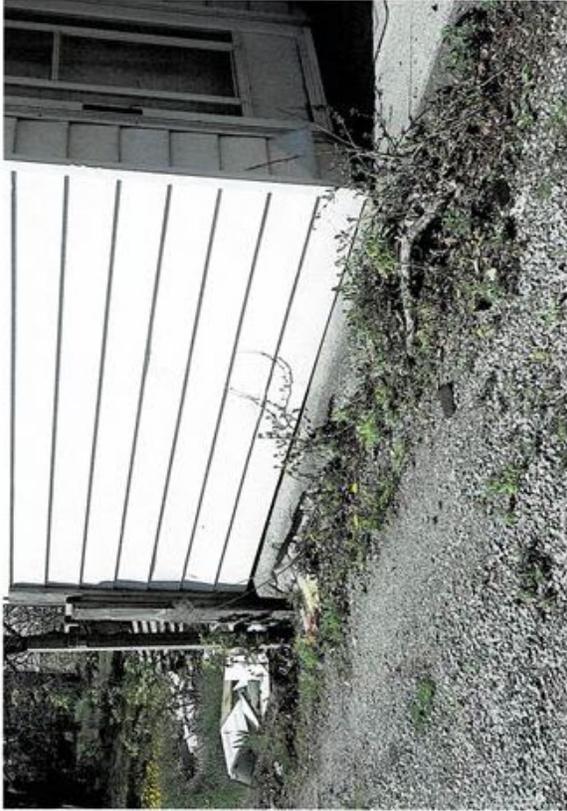
Top left – East side of rear addition  
See deteriorating foundation wall.

Bottom left – South window on east wall of upper floor  
See spalding brick.

Bottom right – Southeast side of rear addition  
See deteriorating and partially parged foundation wall.

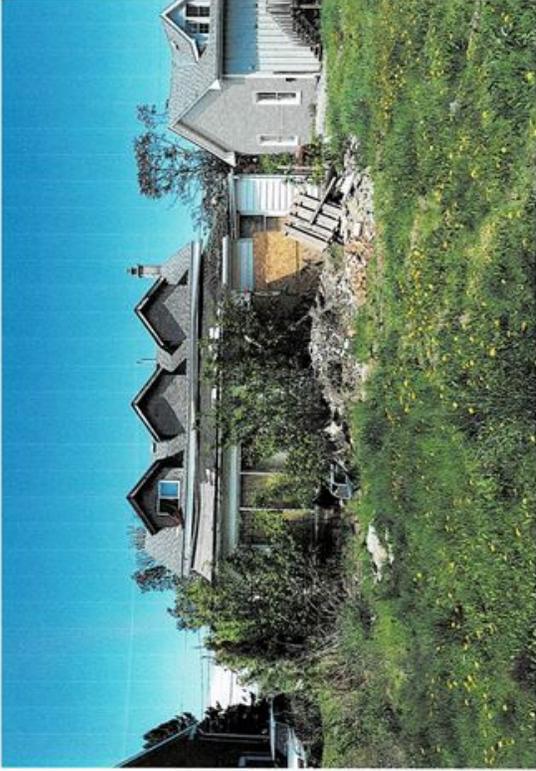
Top left – Building addition at rear of residence  
See new dormers (3) on original building and partial roof  
collapse on the corner of the addition.

Bottom left – Wood joist for second floor  
See split and deteriorated wood joist and 'sistered' joist and  
hanger.

Bottom right – Southeast corner of building addition  
See deteriorated corner at roof.

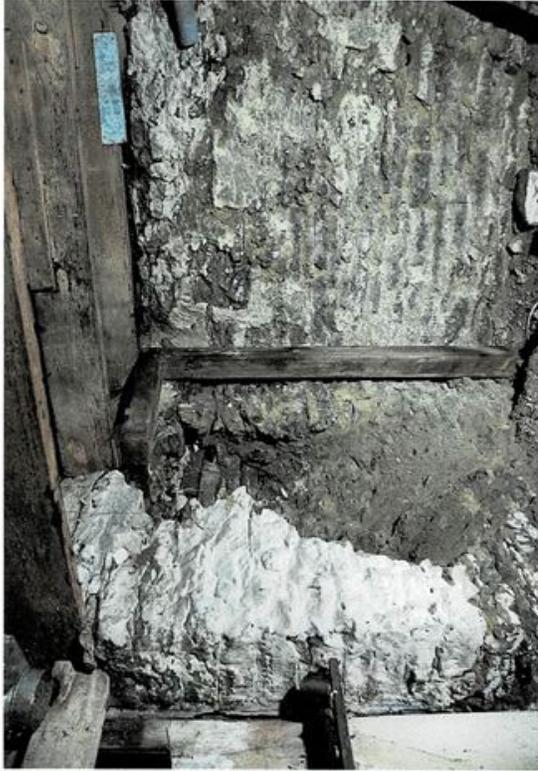
Top left – Foundation corner  
See deteriorating rubble wall.

Bottom left – Interior rubble foundation wall  
See wood posts added adjacent the foundation wall, damp floor at the bottom of the wall, water damage to added posts and deterioration of floor joists.

Bottom right – West wall foundation  
See fallen parging on rubble foundation.

- The limestone rubble wall is deteriorating and water is seeping into the basement. Foundation repairs are necessary.
- The first floor structure is in poor condition. The main wood floor beams, wood columns, floor joists and perimeter beams are all deteriorating. The entire structure would need replacement, including new footings for any proposed interior columns.
- The second floor joists are also deteriorated, and a number are split. The past owner has repaired a section of the floor. There is also visible water damage throughout the roof boards on the entire building and overtop the top wall plates of the original building.

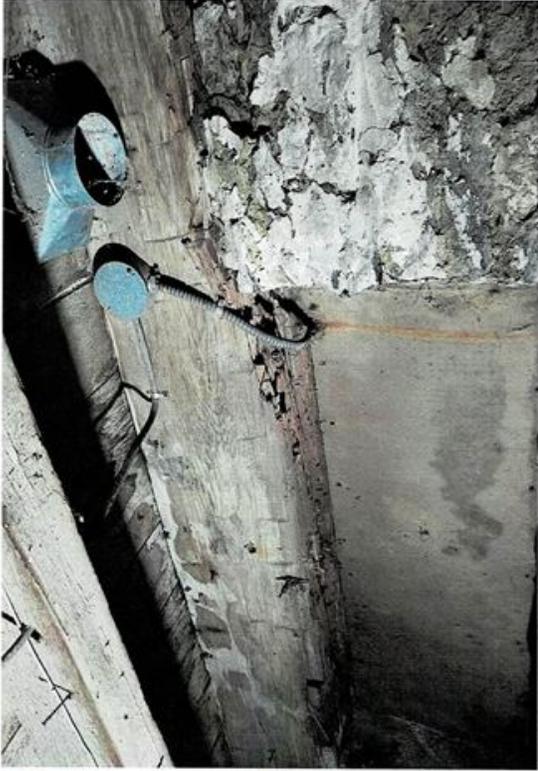
Top left – Perimeter wood beam  
See deteriorated beam over foundation wall and water damage of floor boards.

Bottom left – Foundation wall  
See deteriorated wood perimeter beam.

Bottom right – Foundation wall, beam and joists  
See added supports under joists/beam and deteriorated joists and beams.

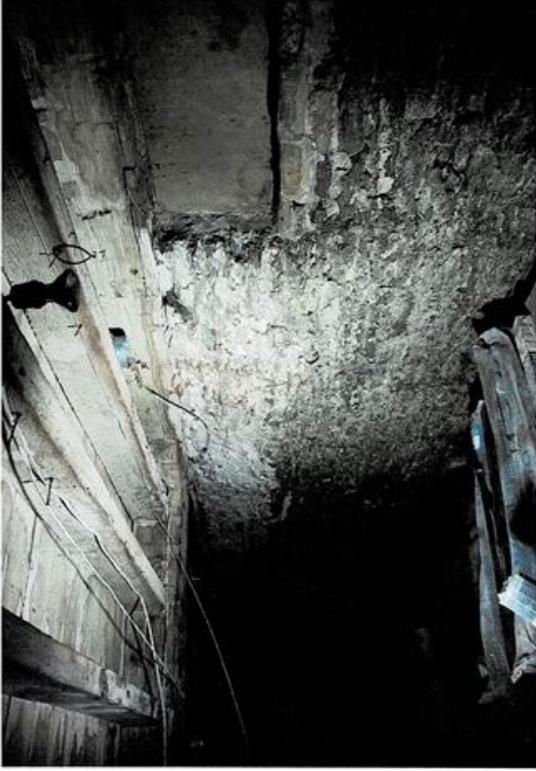
Top left – Foundation wall and joists  
See deteriorated wood perimeter beam and joists.

Bottom left – Wood beam  
See deteriorated wood beam and joists, and added supports  
for the floor.

Floor joists over foundation wall  
See deteriorated wood joists.

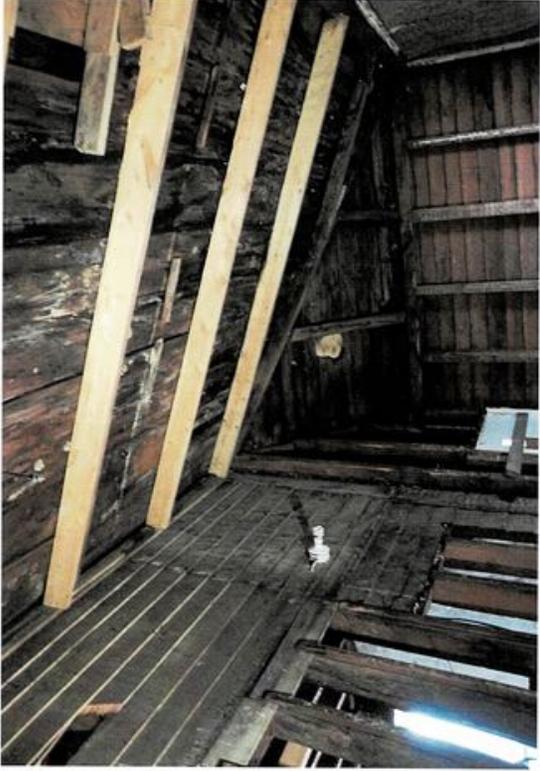
Top left – Roof over addition  
See new 2x4 rafters supporting roof in rear addition and water damage to roof boards.

Bottom left – Wood beam  
See deteriorated wood beam over foundation wall.

Bottom right – Top of building wall and roof rafters  
See wall top plates and water damage.  
See roof rafters and recently added dormer.

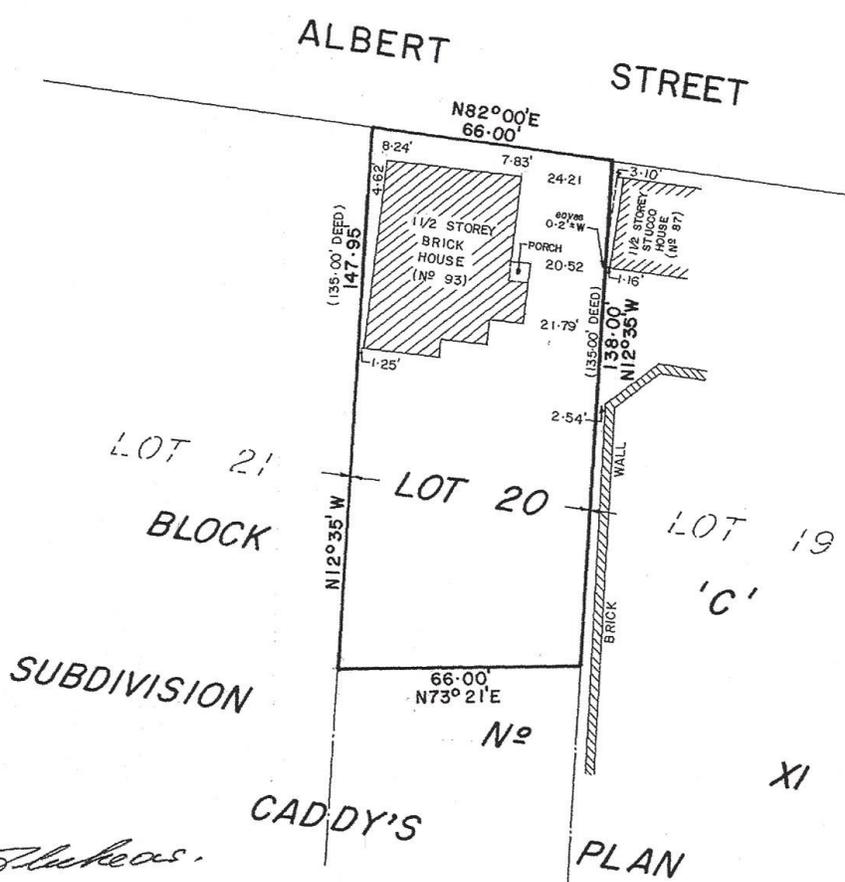
PLAN OF SURVEY  
 OF LOCATION OF BUILDING  
 ON PART OF LOT 20, BLOCK 'C',  
 SUBDIVISION N<sup>o</sup> XI, CADDY'S PLAN  
 (BEING PART OF LOT 17, BROKEN FRONT CONCESSION 'B')  
 TOWN OF COBOURG  
 COUNTY OF NORTHUMBERLAND  
 SCALE - 1" = 40'

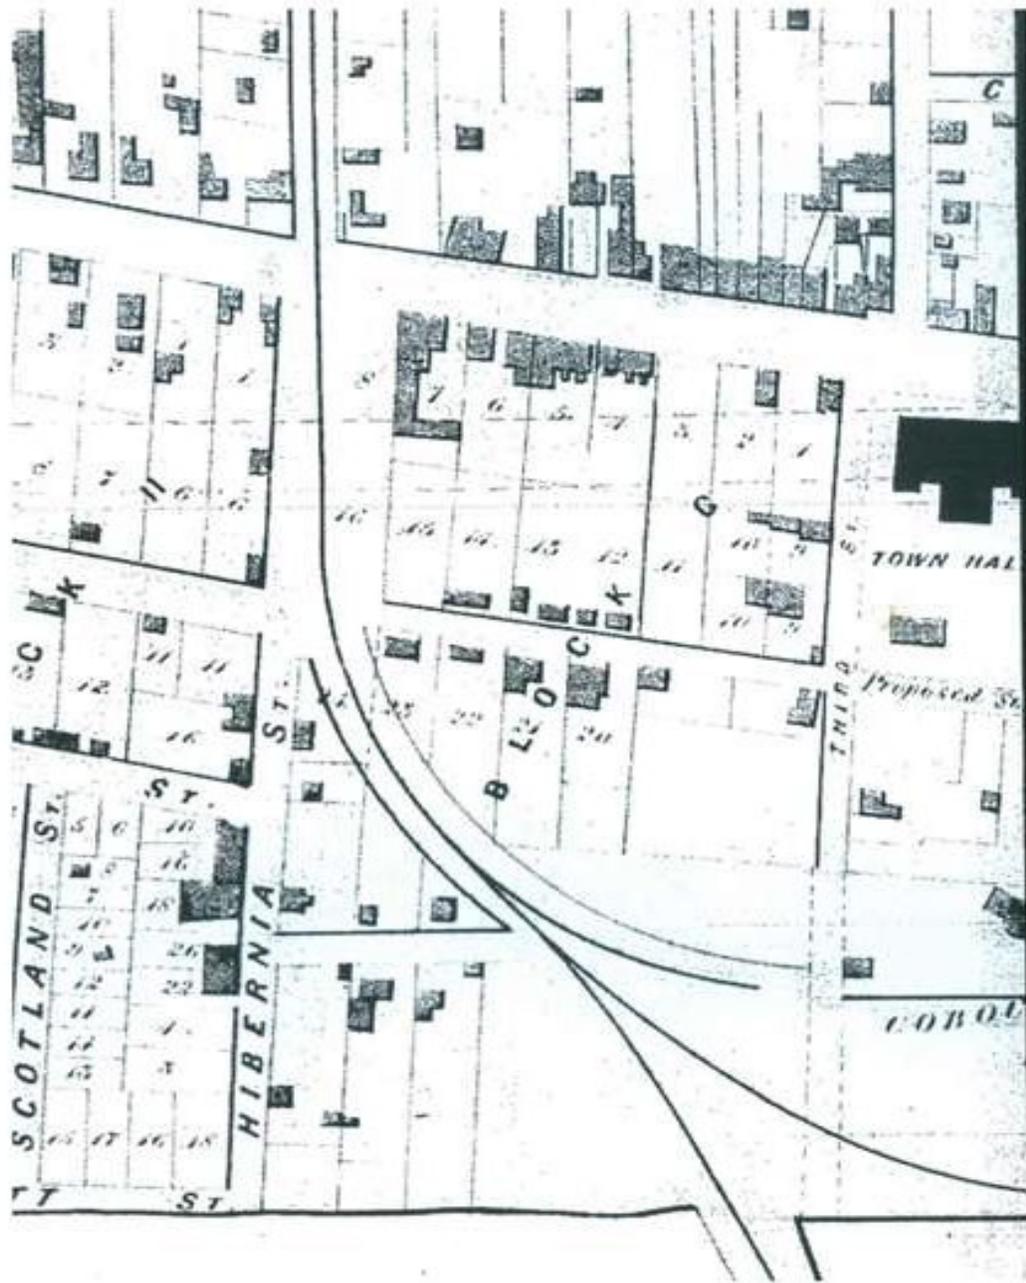
Detail of the Hannaford and Lloyd 1858 plan of Cobourg, showing a structure on lot 20.

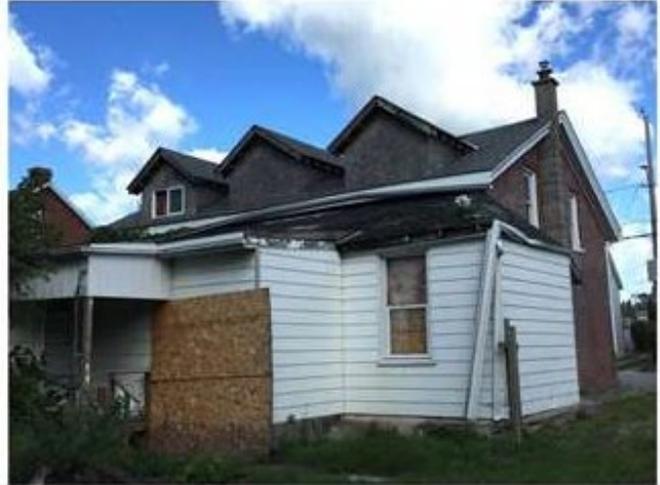
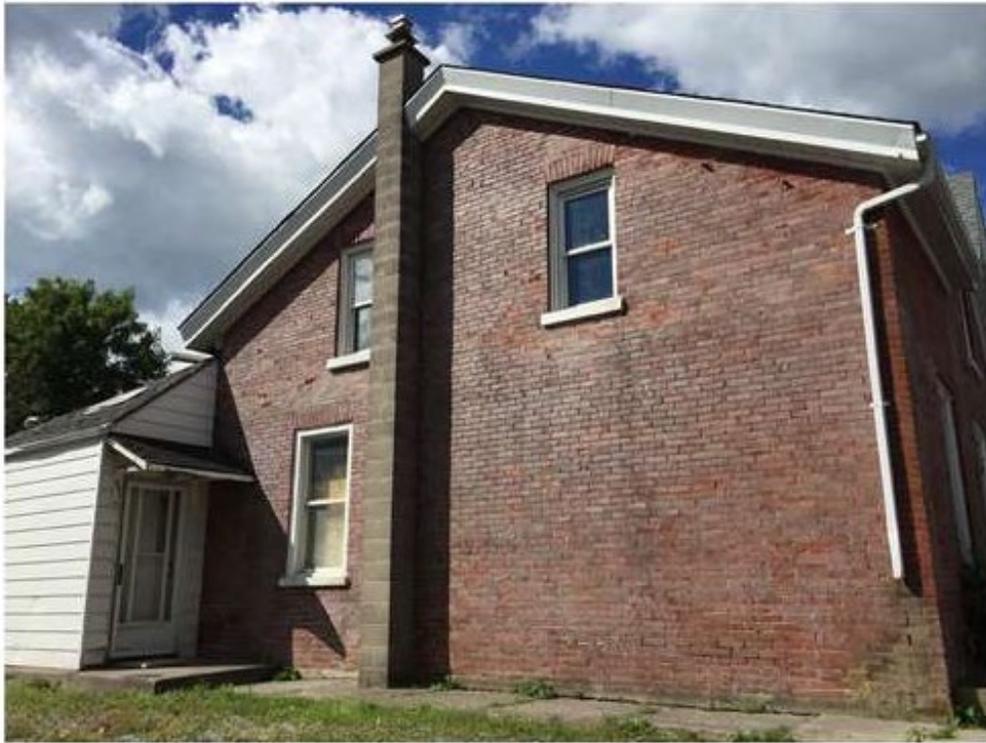
93 Albert St. Top left: Detail of round-headed window in peak; top right: rear (south) elevation showing unfinished new dormer additions; bottom: east elevation.

The existing building at 93 Albert Street, Cobourg has a two-storey brick exterior with multiple wood frame additions at the back. The front (north side) of the building is brick veneer with wood windows. Mortar is missing from some bricks, and joints are not consistent. The front entrance wood sill is damaged and the concrete front porch surface is rough and not level. The east elevation brick face is cracked and spalling due to the freeze/thaw cycle. The west side of the building is not accessible due to overgrowth of plants and trees. The overall roof ridge line is sagging in the middle from east to west.
