# STAFF REPORT

THE CORPORATION OF THE TOWN OF COBOURG

| <b>Report No.:</b> | HP-2021-009 | | |

**Subject/Title:**      **Roof Replacement – 212 King Street West – Marie Dressler House (Town of Cobourg)**

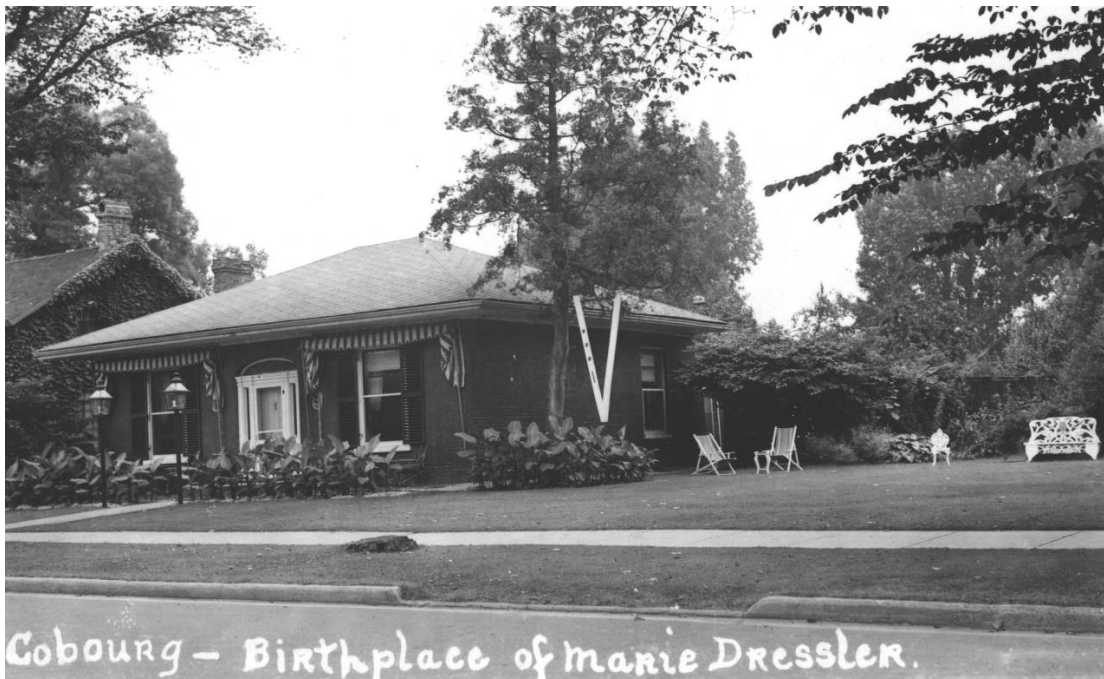
Figure 3: 212 King St. West (Dressler) seen in this un-dated photo – notice the roof does not appear to be cedar shake, but some other unconfirmed material composition (slate or shingle) -- Photo Credit: County Archives.

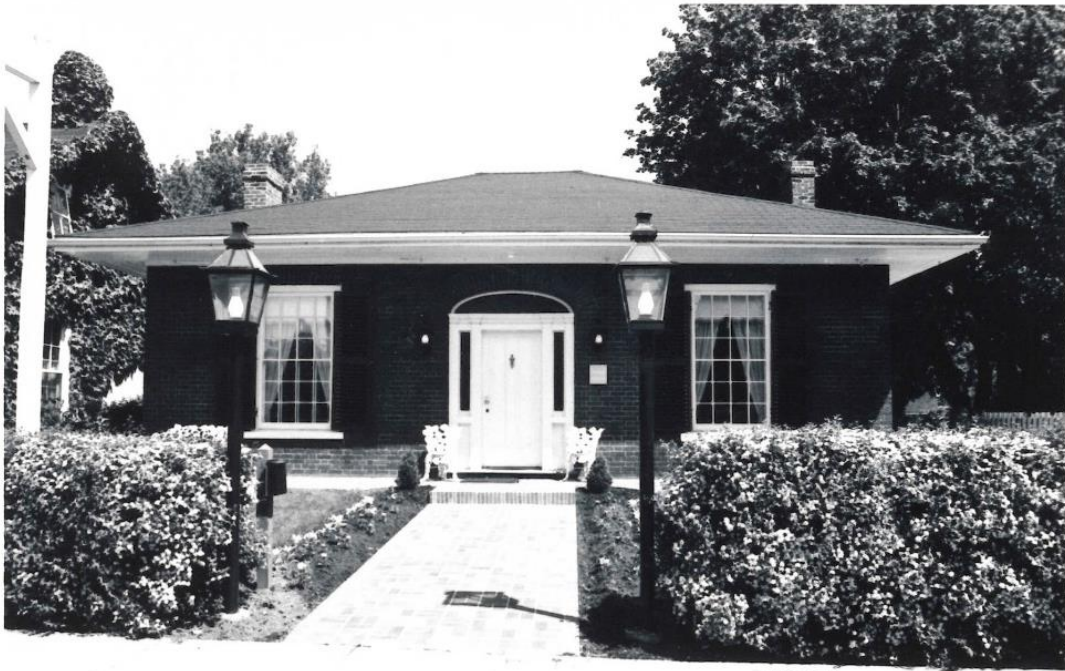
Figure 4: 212 King St. W (Dressler) seen in this photo from the 1980s property file. Notice the roof again appears to be a different material than cedar shake (unconfirmed) – Photo Credit: County Archives

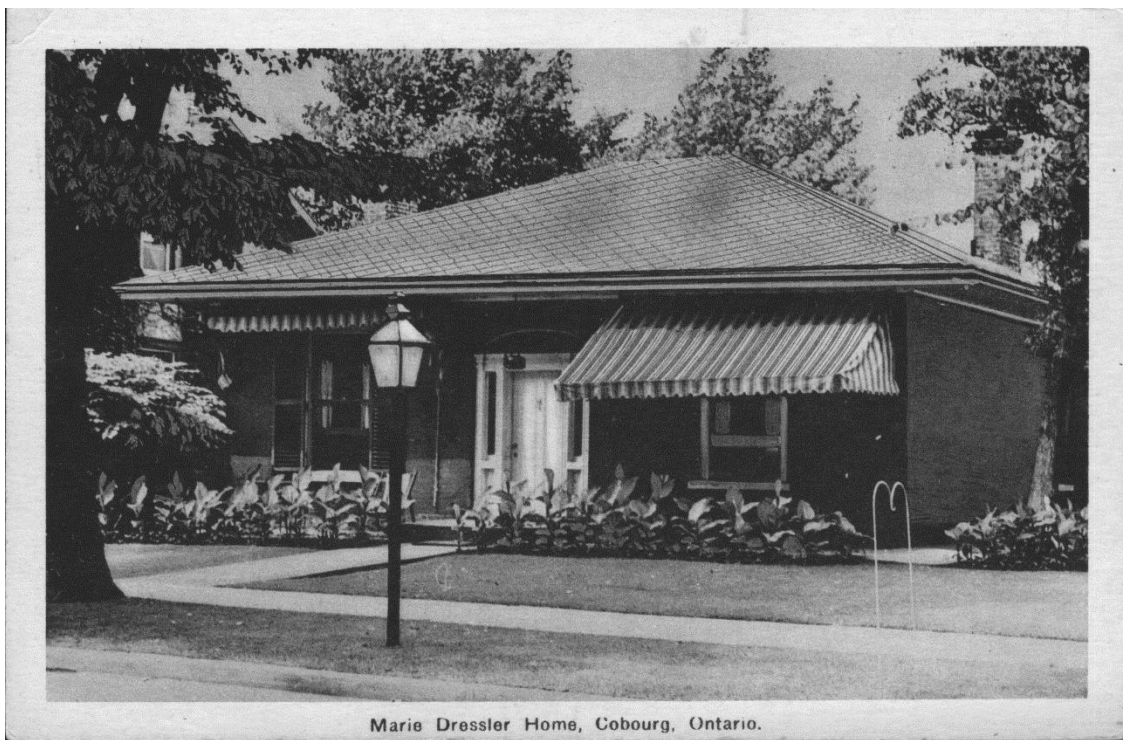
Figure 5: 212 King St. W (Dressler) – seen in an undated photo – roof looks to be slate but unconfirmed – Photo Credit: County Archives

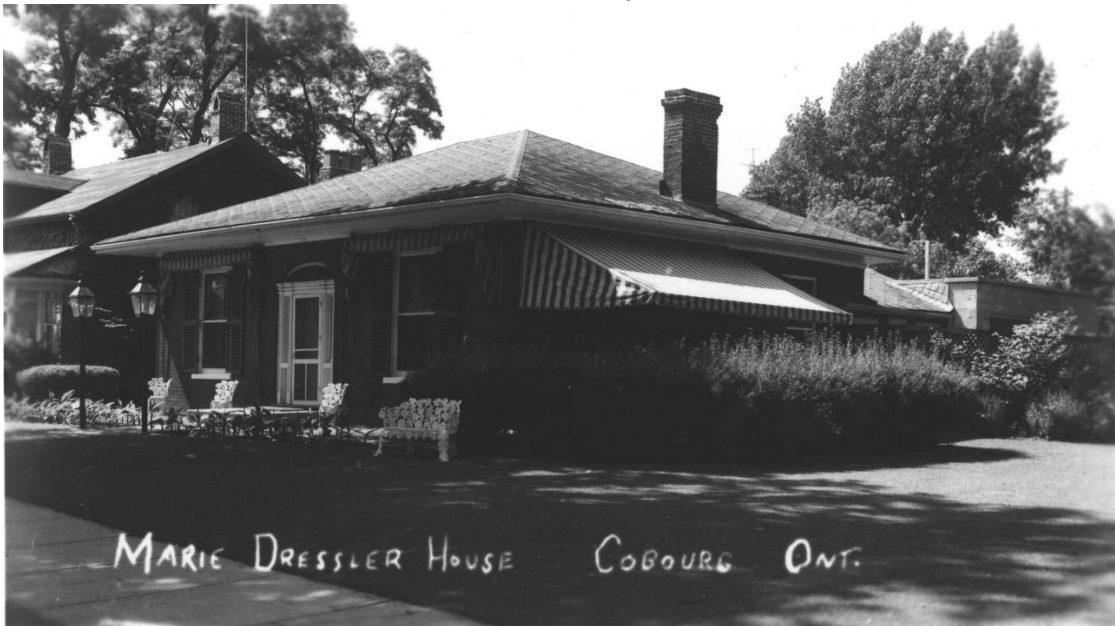
Figure 6: 212 King St. W (Dressler) – seen in an un-dated photo – appears to be during the days when the property was a restaurant – roof material unclear – Photo Credit: County Archives.

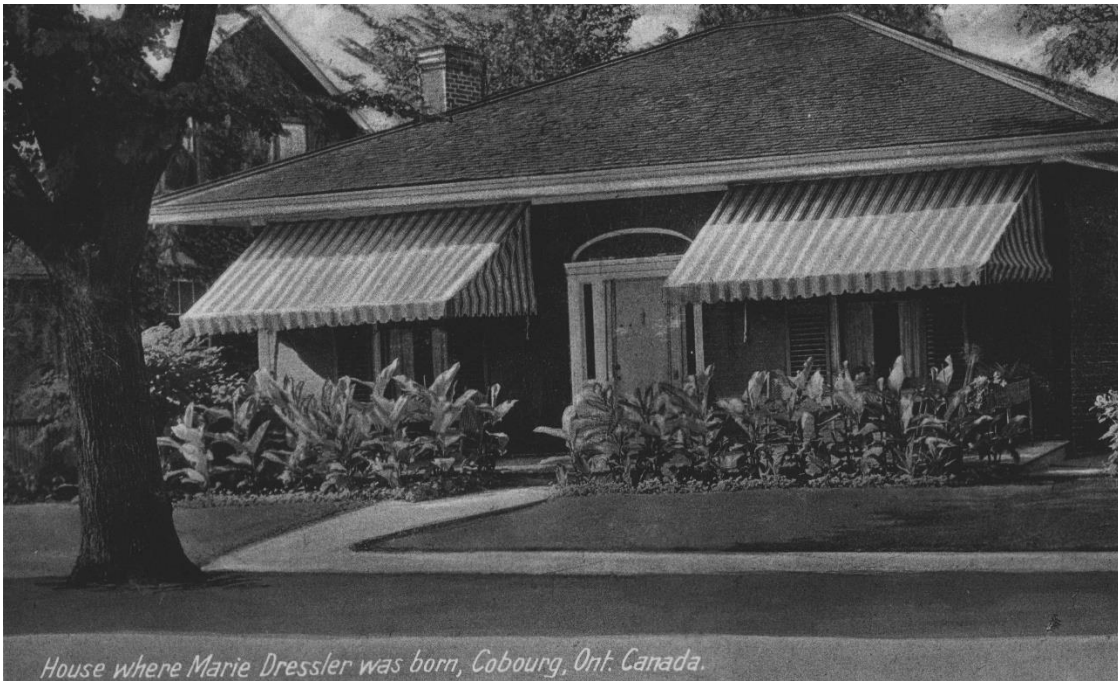
Figure 7: 212 King St. W (Dressler) – seen in an un-dated photo – roof looks to have changed to cedar shake, but unconfirmed – Photo Credit: County Archives

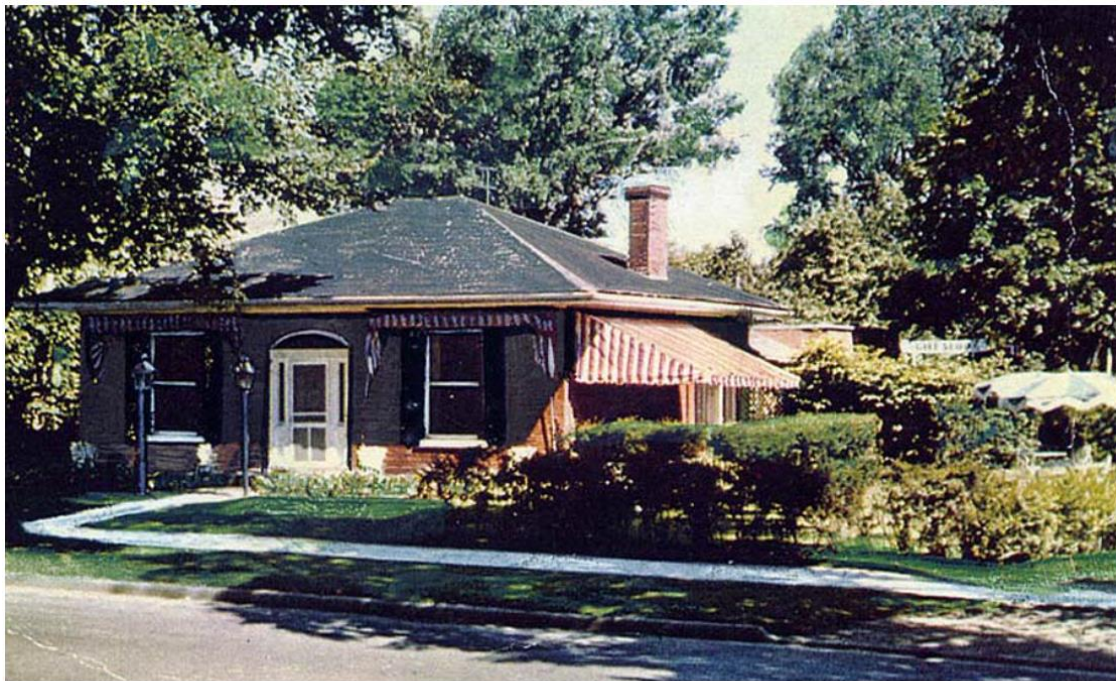
Figure 8: 212 King St. W. (Dressler) – use as a restaurant in the 1950's – roof material unknown – Photo Credit: Marie Dressler Foundation

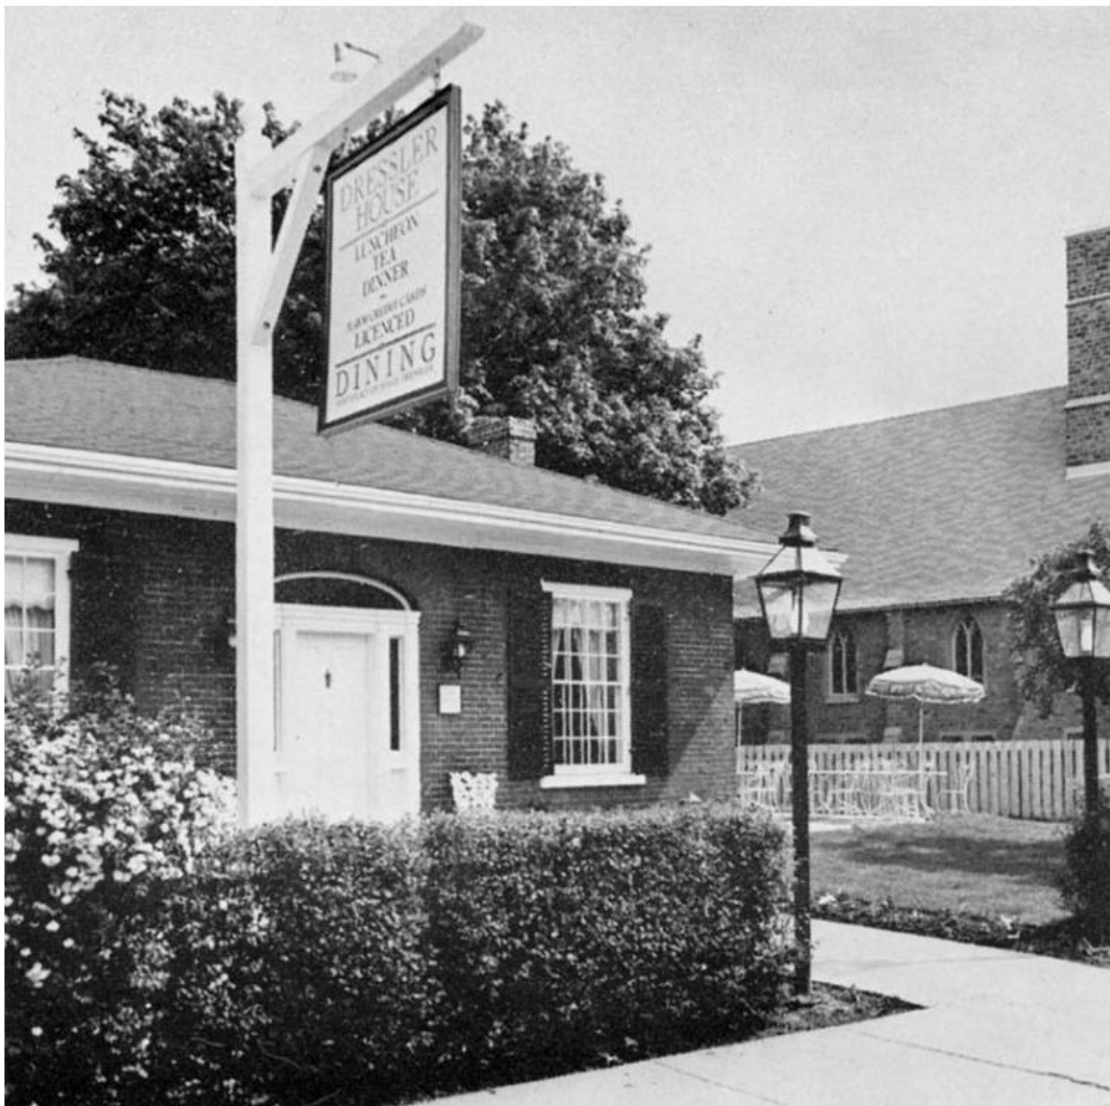
Figure 9: 212 King St. W. (Dressler) – seen in an undated photo as a restaurant – roof material unknown, but appears to possibly be shingle – Photo Credit: Marie Dressler Foundation

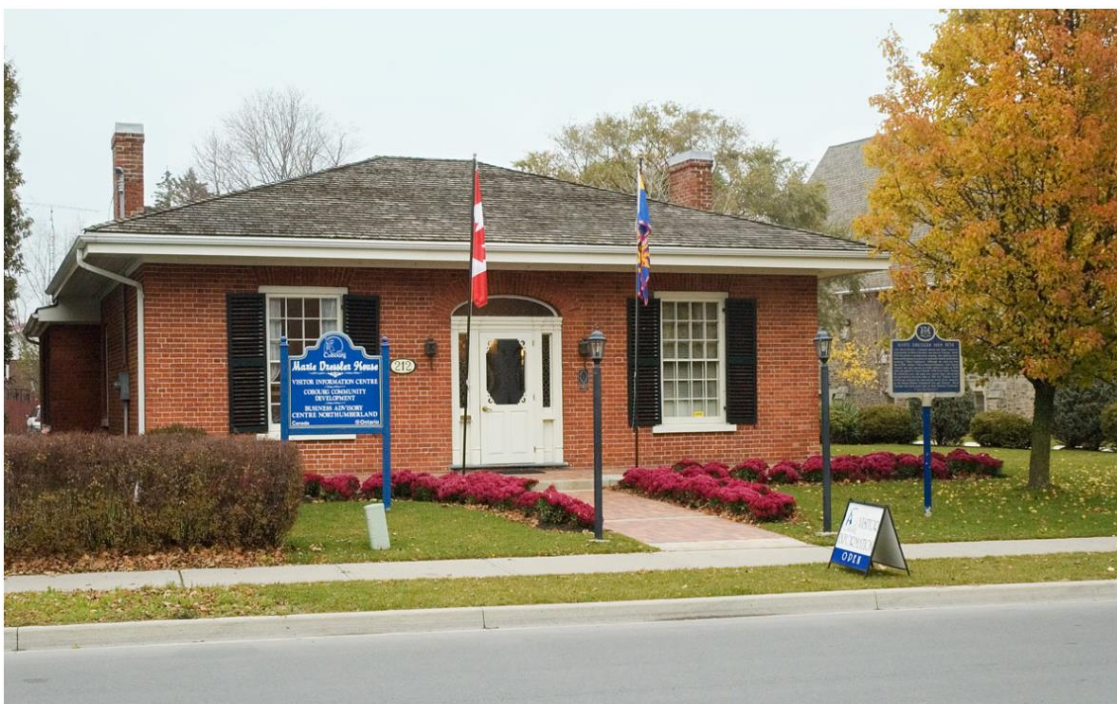
Figure 11: 212 King St. W. (Dressler) – seen in 2007 – cedar shake roof -- Photo Credit: Marie Dressler Foundation
