The Corporation of The Town of Cobourg SPECIAL COUNCIL MEETING AGENDA

Cobourg Harbour

Breakwaters and Basin Walls Condition Assessment

Shoreplan Engineering Limited

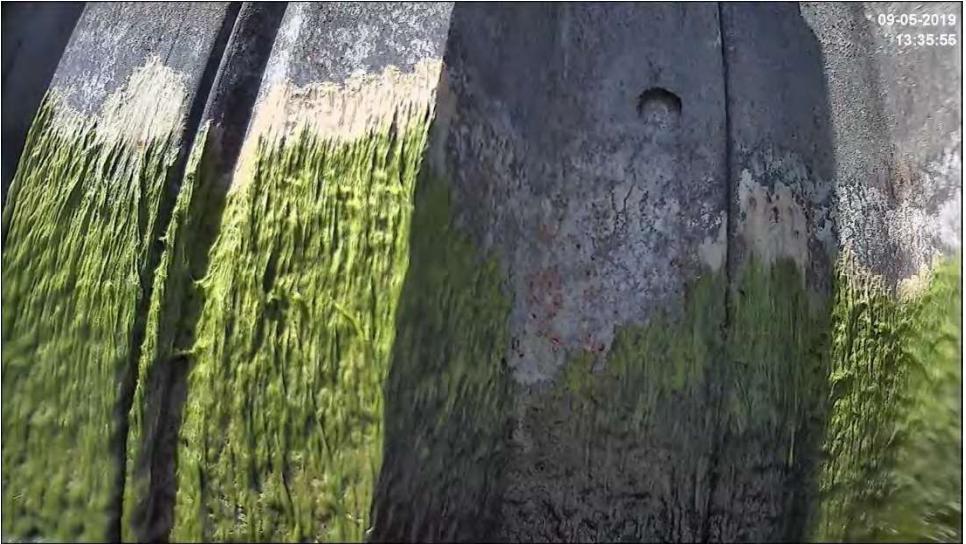
Photo 1 - East Breakwater, East Face

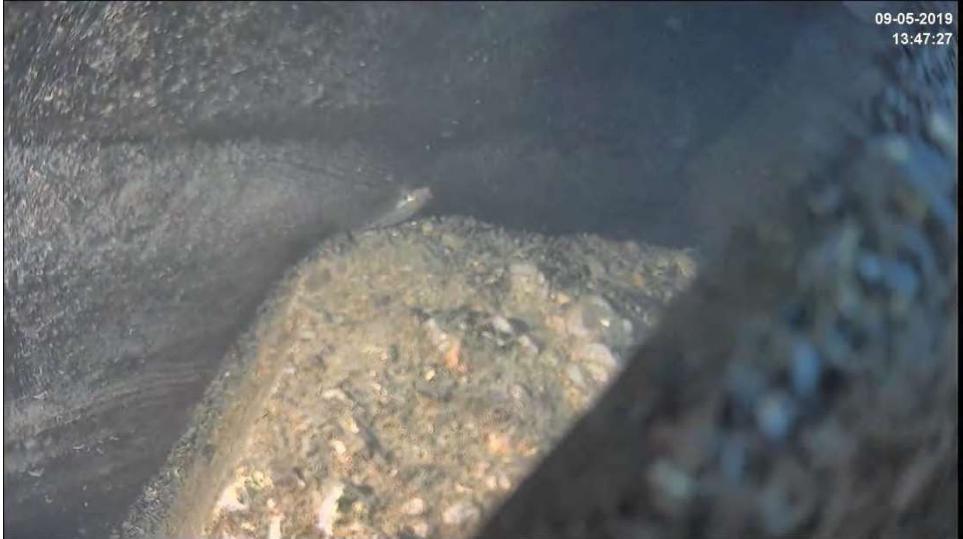
Photo 2 - East Breakwater, East Face Small Hole

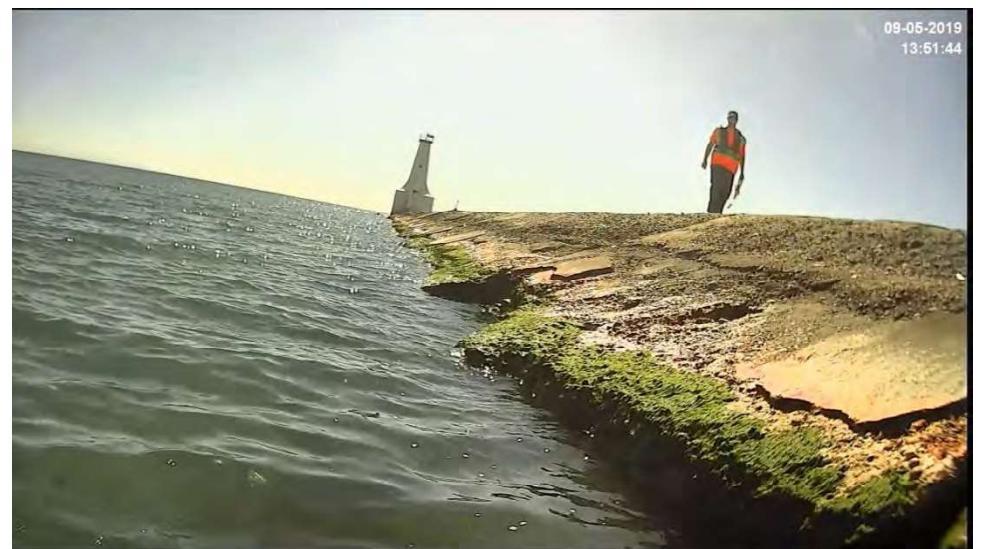
Photo 5 - East Breakwater, East Face Gap and Visible Fill Material

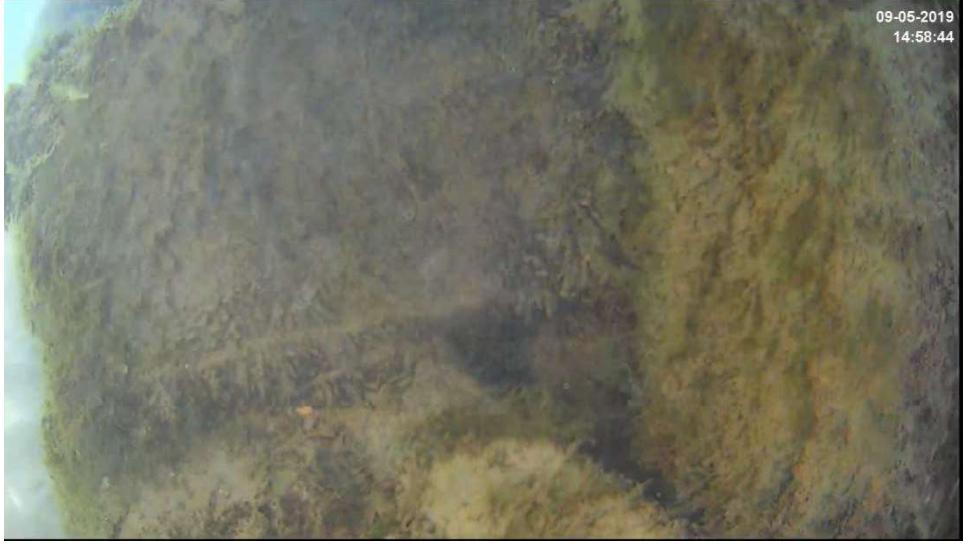
Photo 8 - East Breakwater, East Face Gap and Cross Members

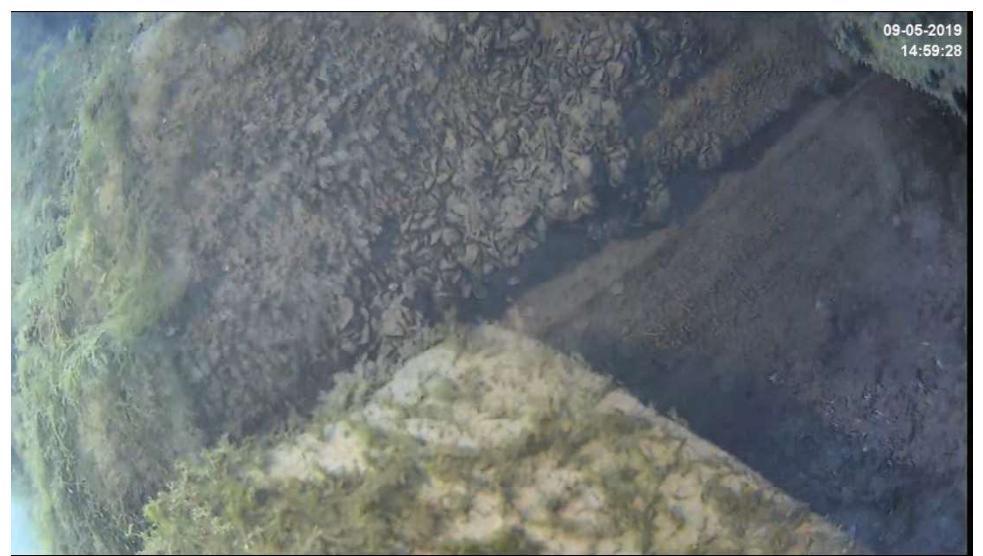
Photo 9 - East Breakwater, East Face Cross Member Coming Through

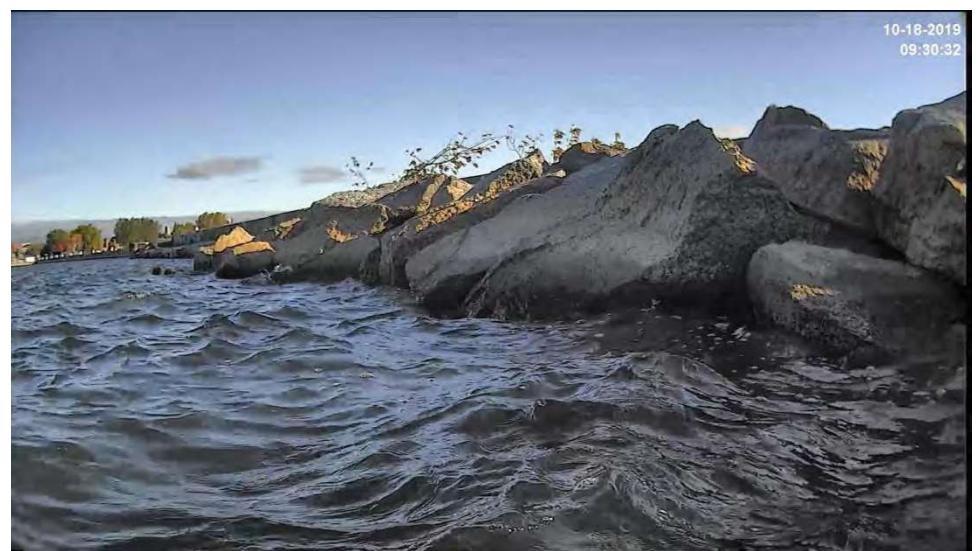
Photo 17 - East Breakwater West Face Revetment - South End

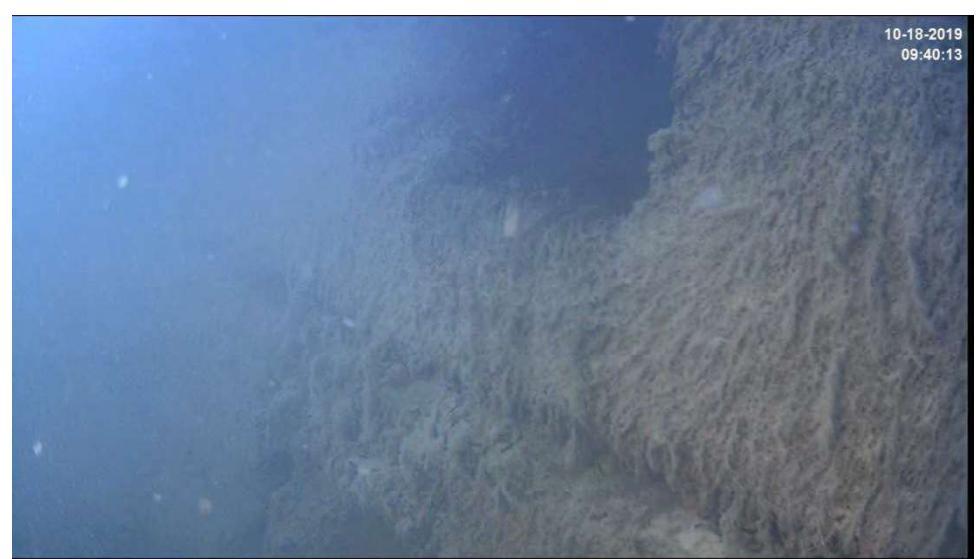
Photo 19 - East Breakwater West Face Revetment - North End Connection with Cribs

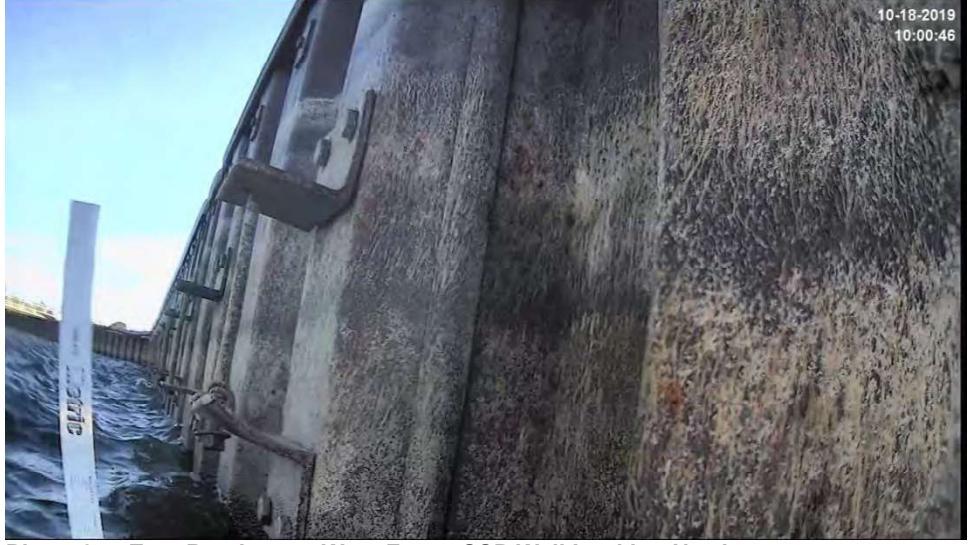
Photo 24 - East Breakwater West Face - Void between Cribs and SSP Flow E to W

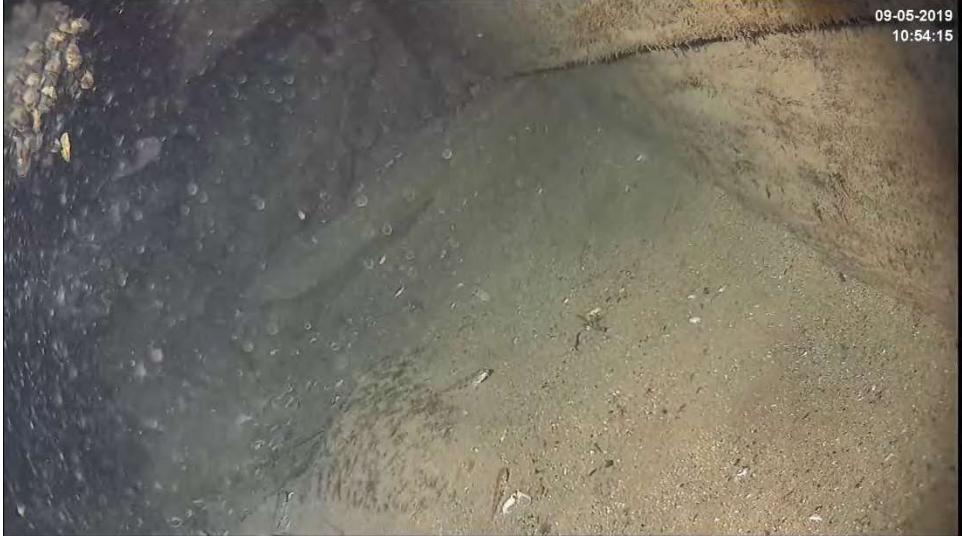
Photo 36 - West Breakwater North Side, Large Gap Between Cribs 0+84

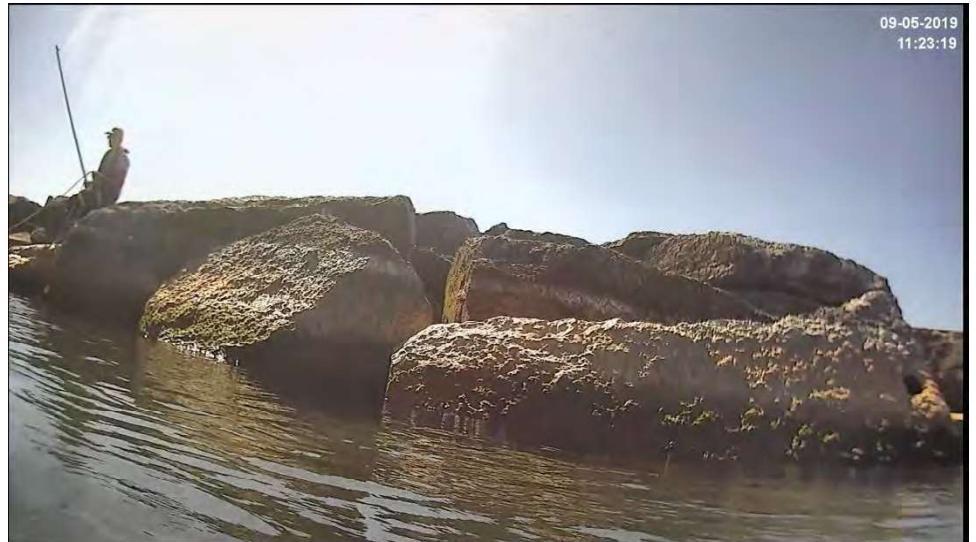
Photo 37 - West Breakwater North Side, Space Inside Large Gap 0+84

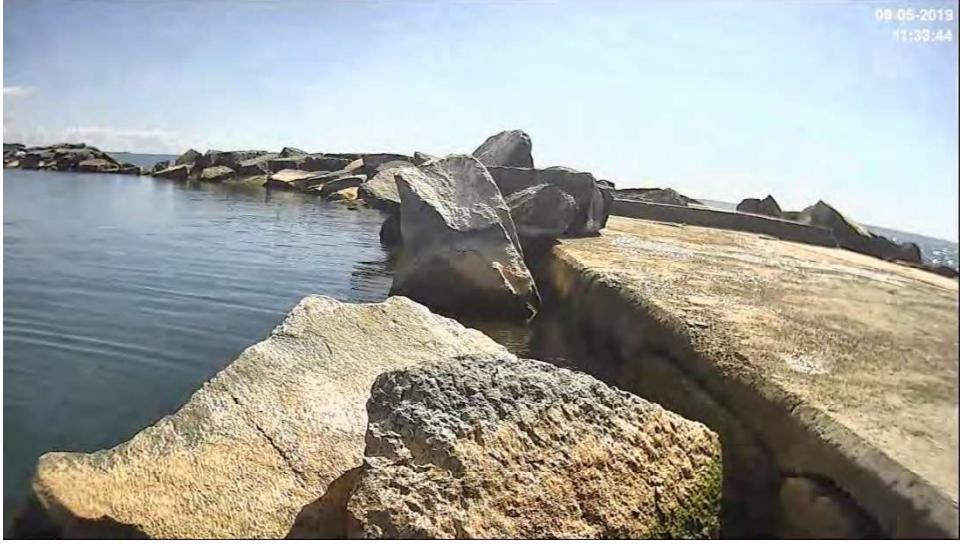
Photo 40 - West Breakwater North Side, Gap between Stones in Revetment Toe

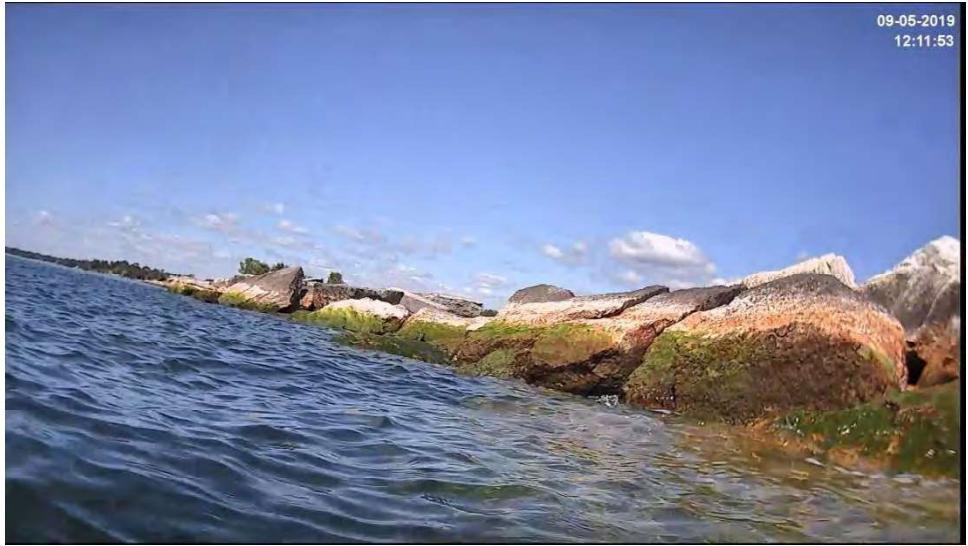
Photo 44 - West Breakwater South Side, Gap in Revetment

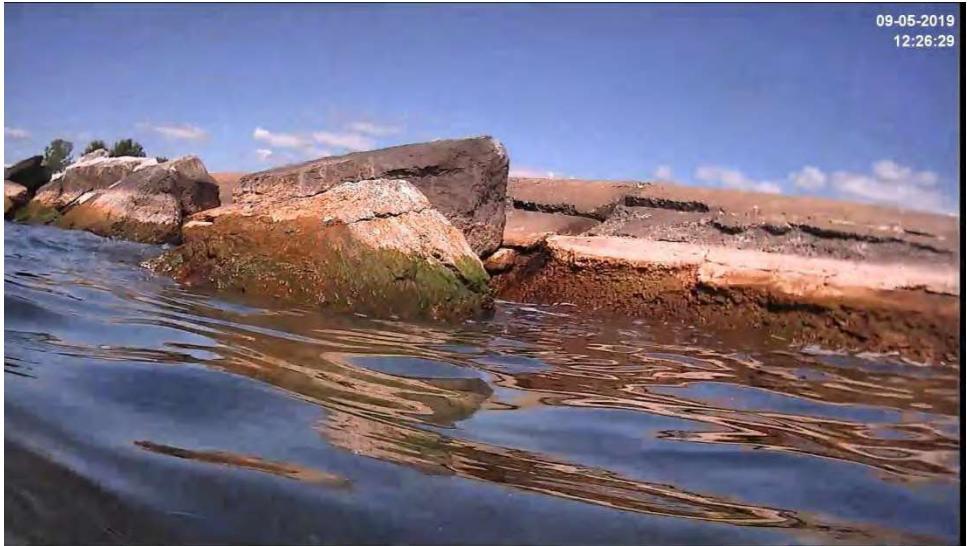
Photo 46 - West Breakwater South Side, Missing Stone at Concrete East End

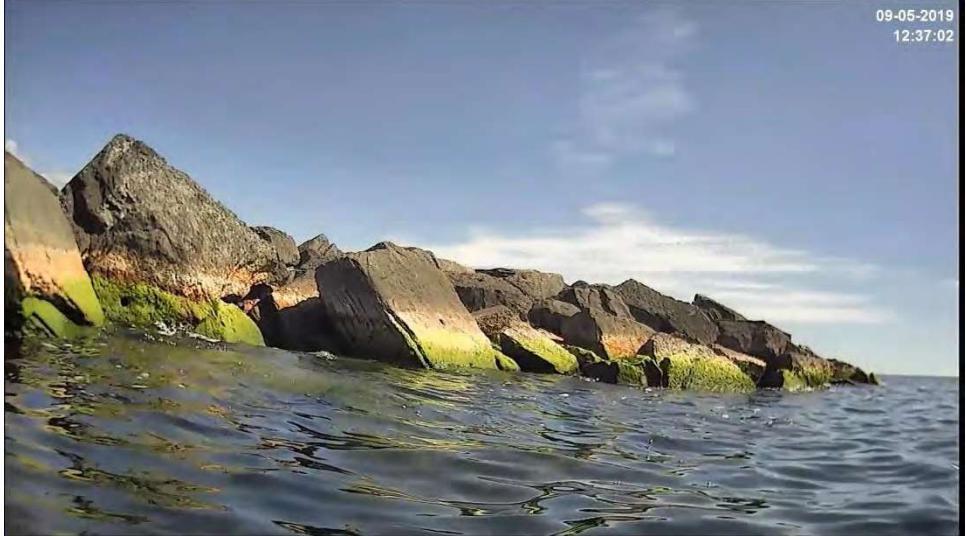
Photo 48 - West Breakwater South Side, Small Gap Onshore 0+30

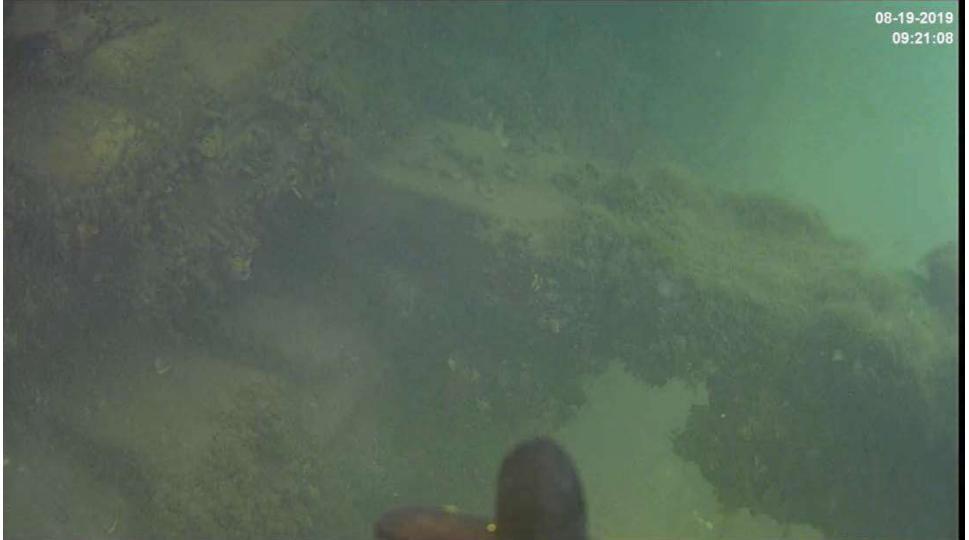
Photo 50 – North Wall - Timber Pulled Out From Wall 0+06

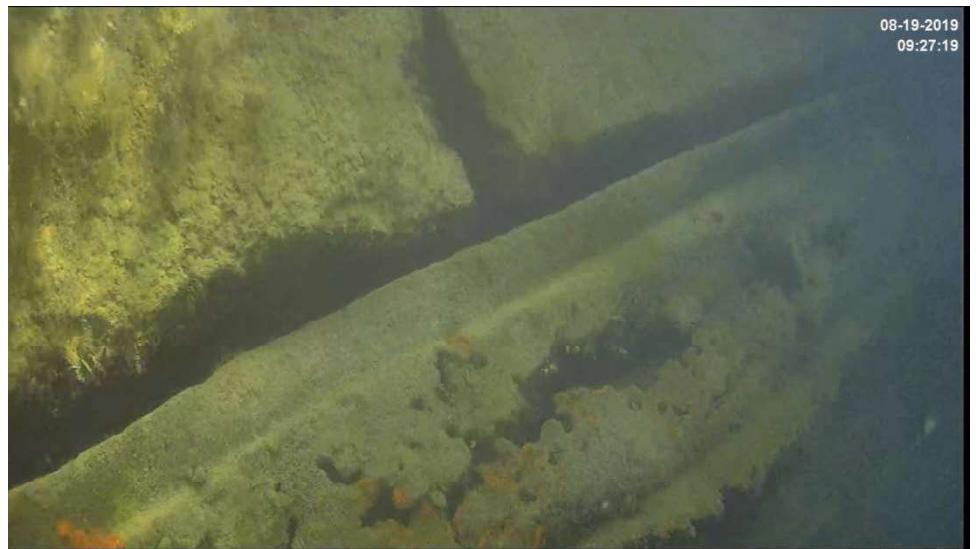
Photo 52 - North Wall Steel Belting Below Cap

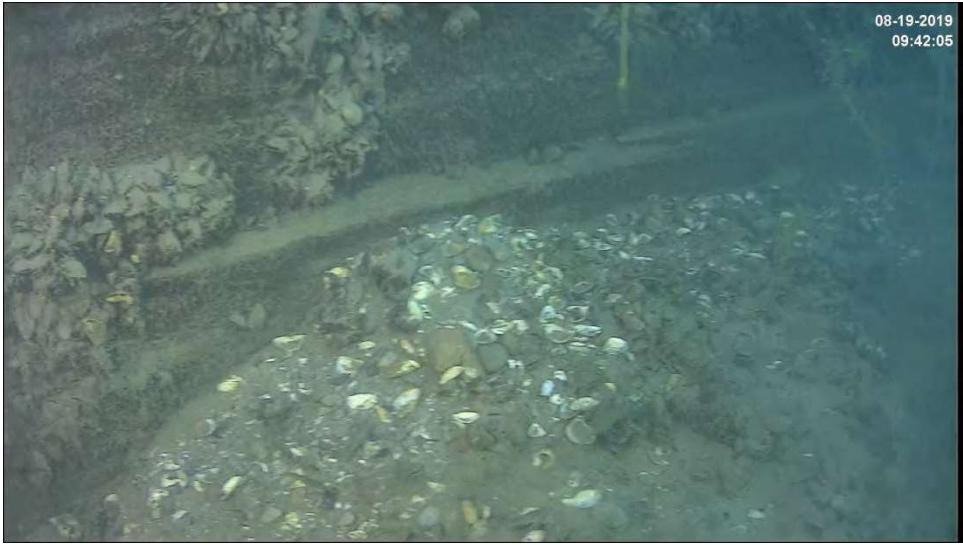
Photo 53 - North Wall Build Up of Material at Toe

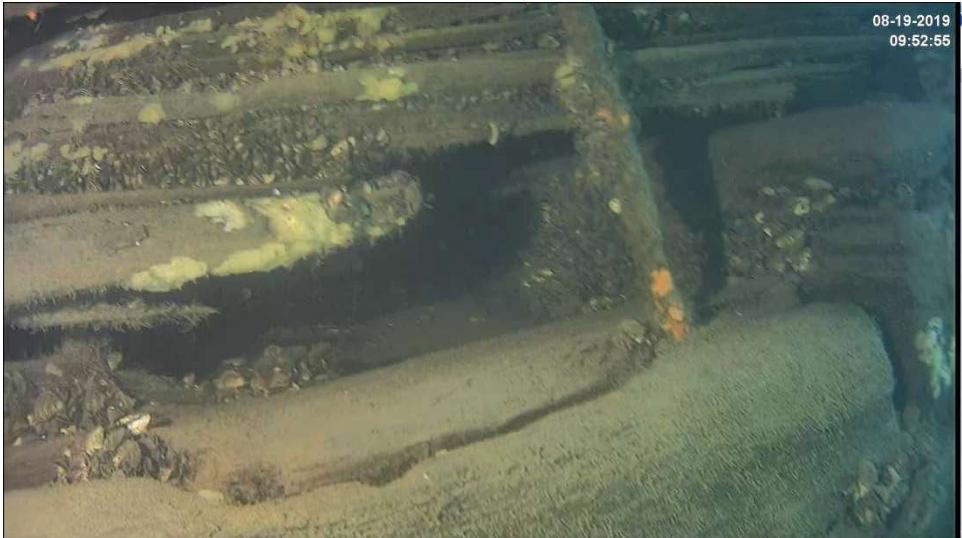
Photo 55 - North Wall Void at 0+41

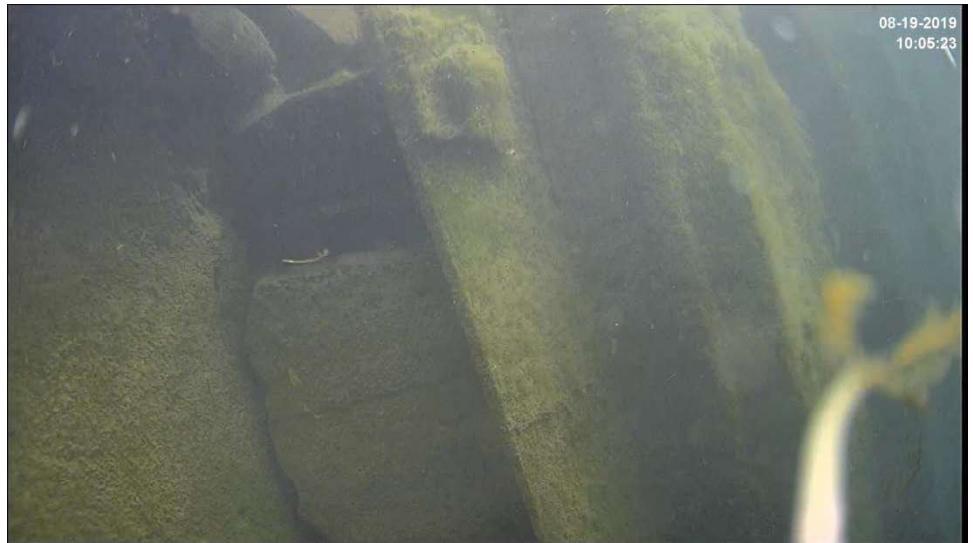
Photo 58 - North Wall Transition to Steel Sheet Pile 0+51

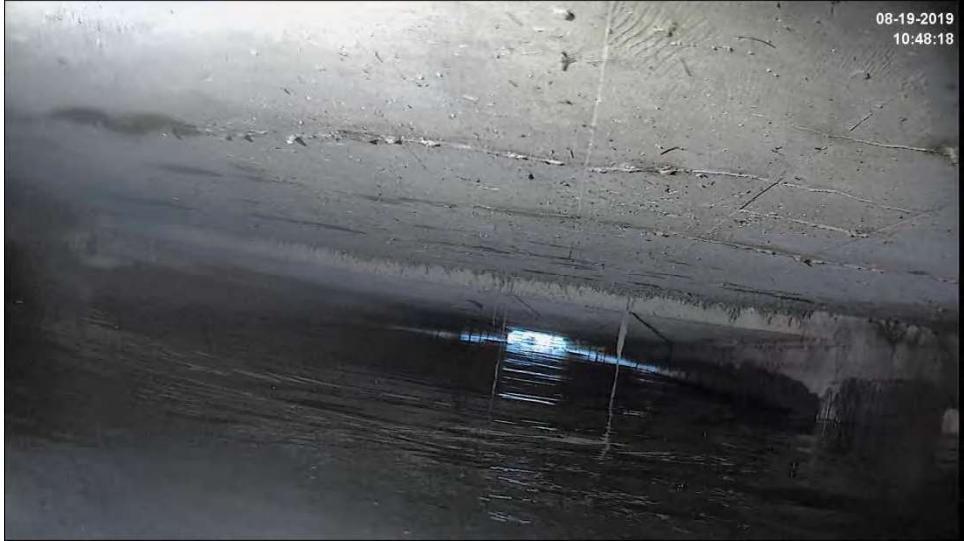
Photo 59 - North Wall Inside Culvert at 0+90

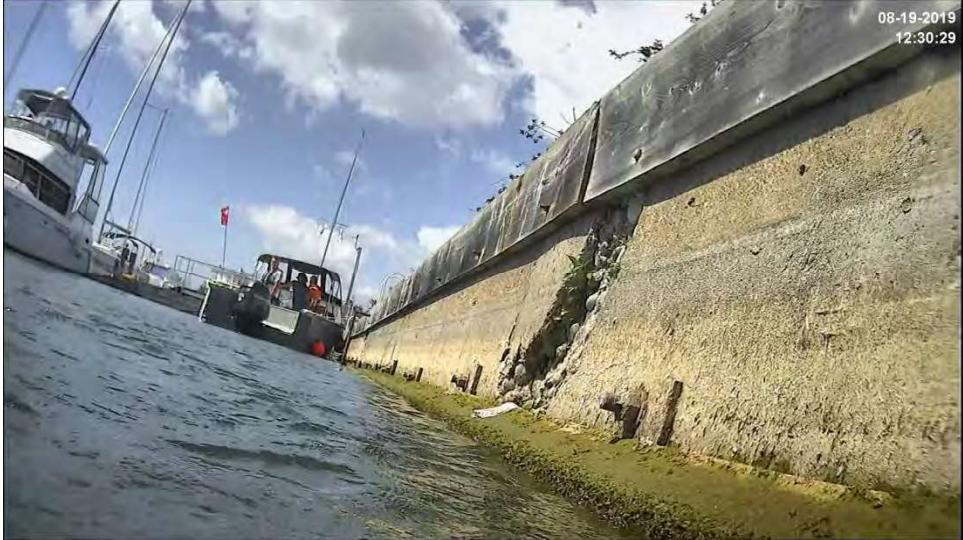
Photo 61 - North Wall View Above Water Line 0+190

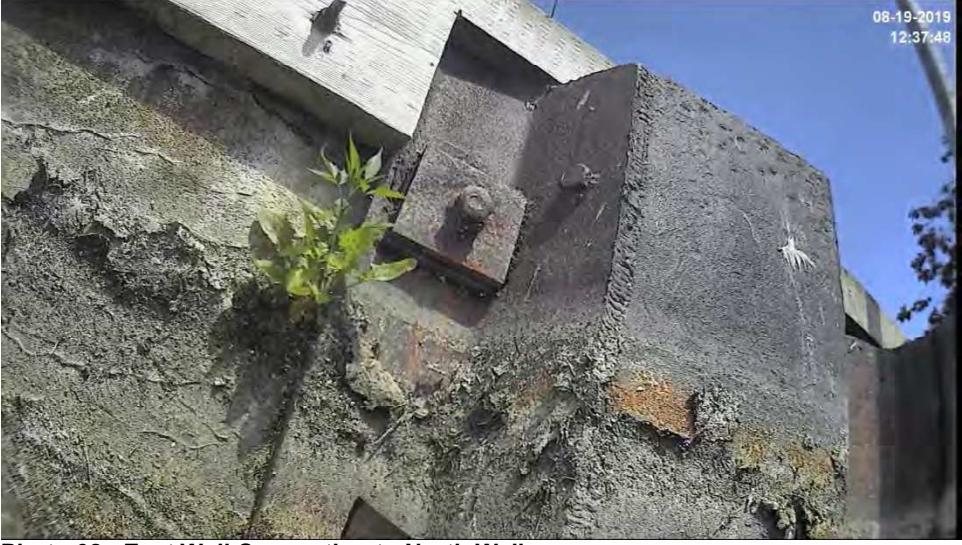
Photo 62 - East Wall Connection to North Wall

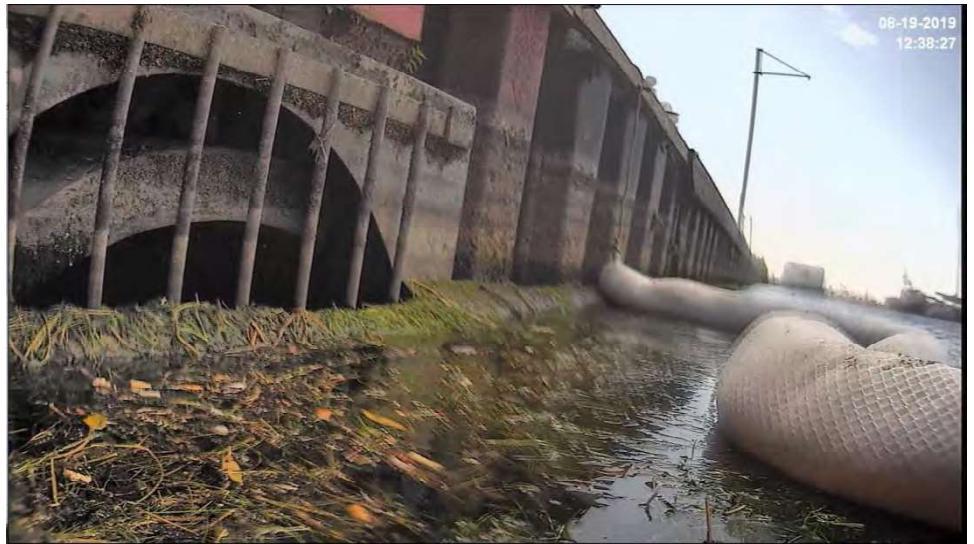
Photo 63 - East Wall Looking South from North End

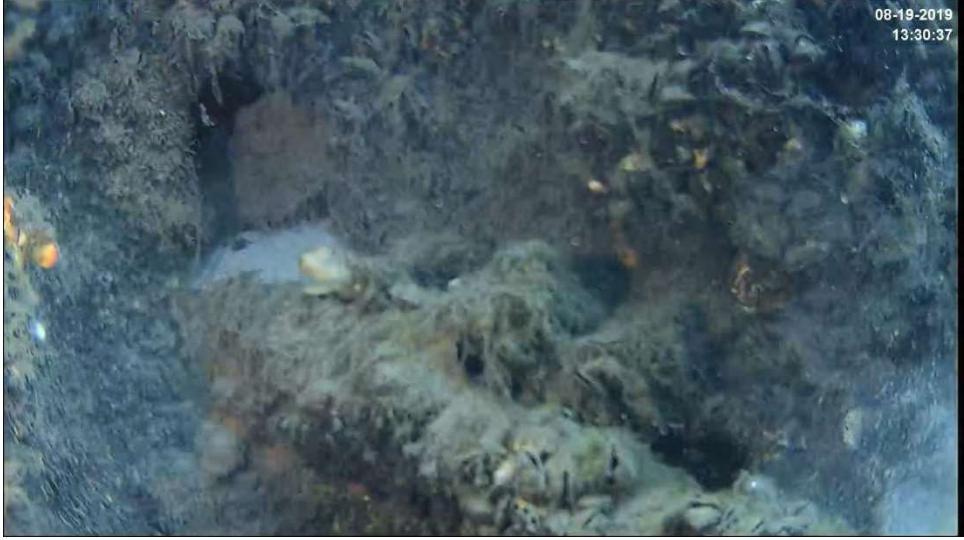
Photo 66 - East Wall Example of Hole Above Tie Back

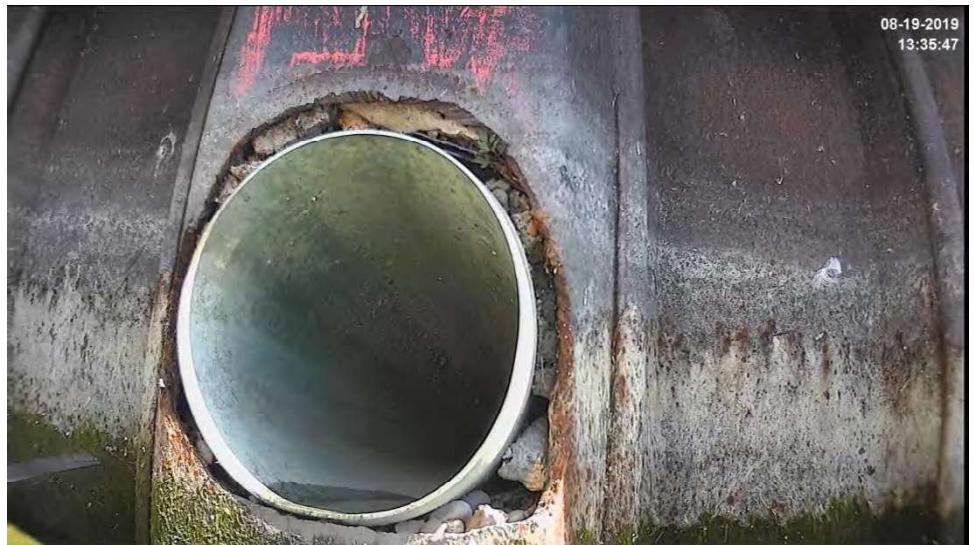
Photo 67 - East Wall Pipe Above Waterline at 0+50

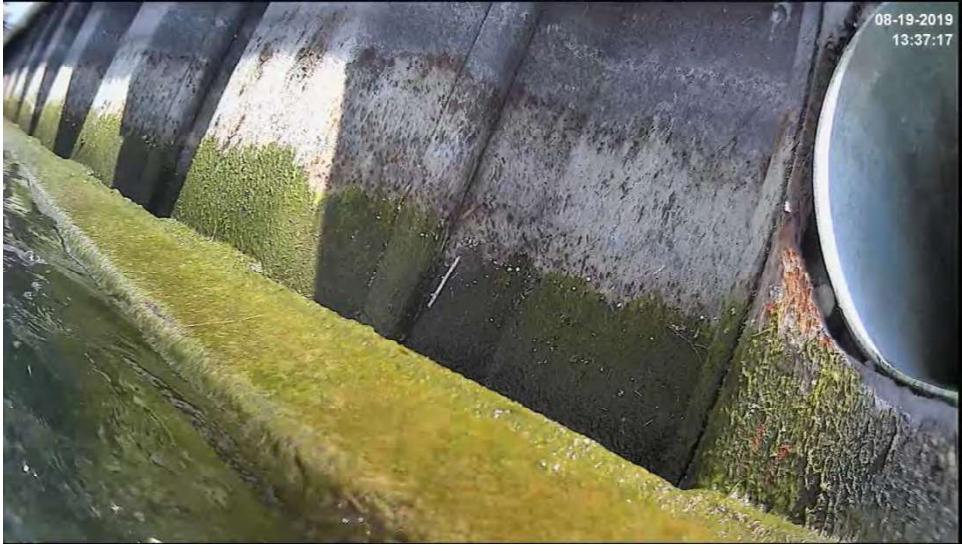
Photo 68 - "Bumper" at Waterline

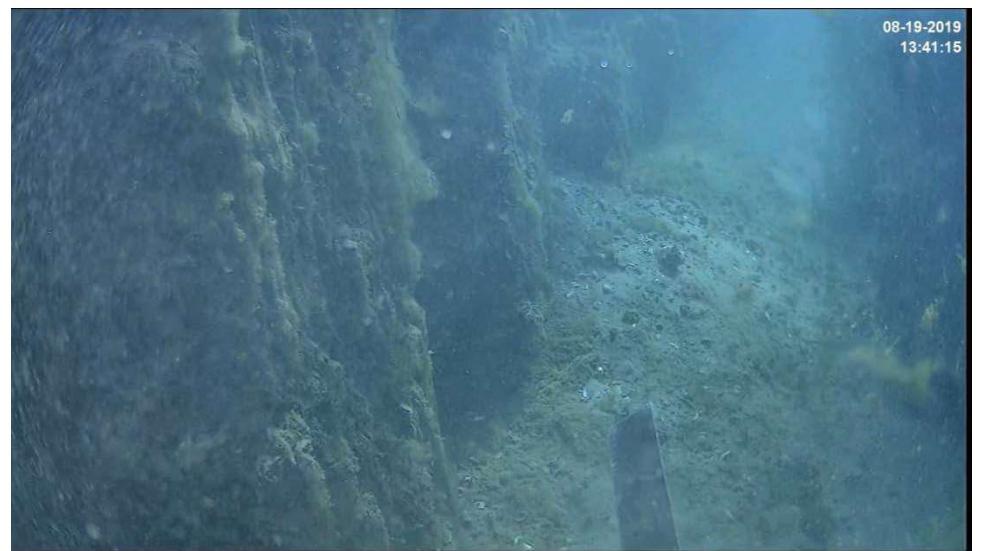
Photo 69 - Buildup of Material in Front of Wall

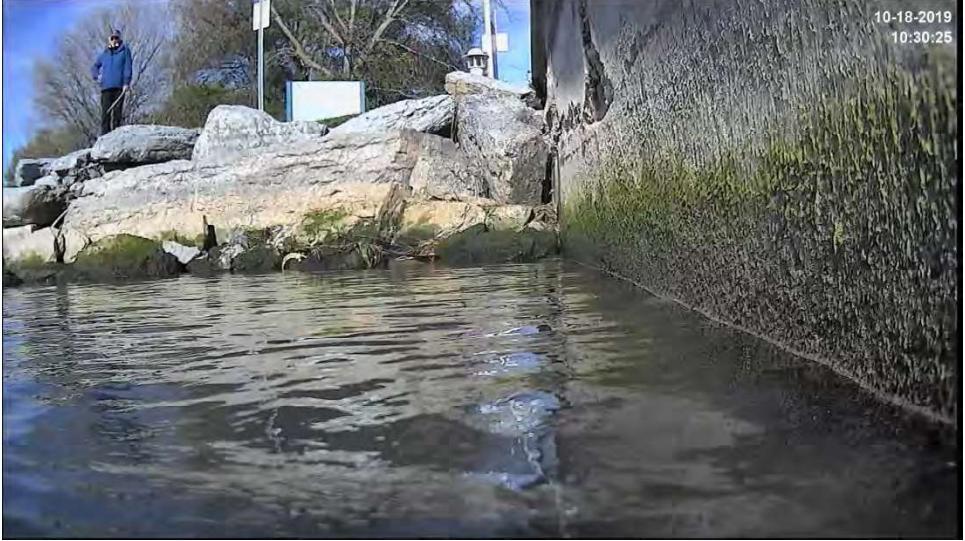
Photo 73 - Centre Pier West Face North End

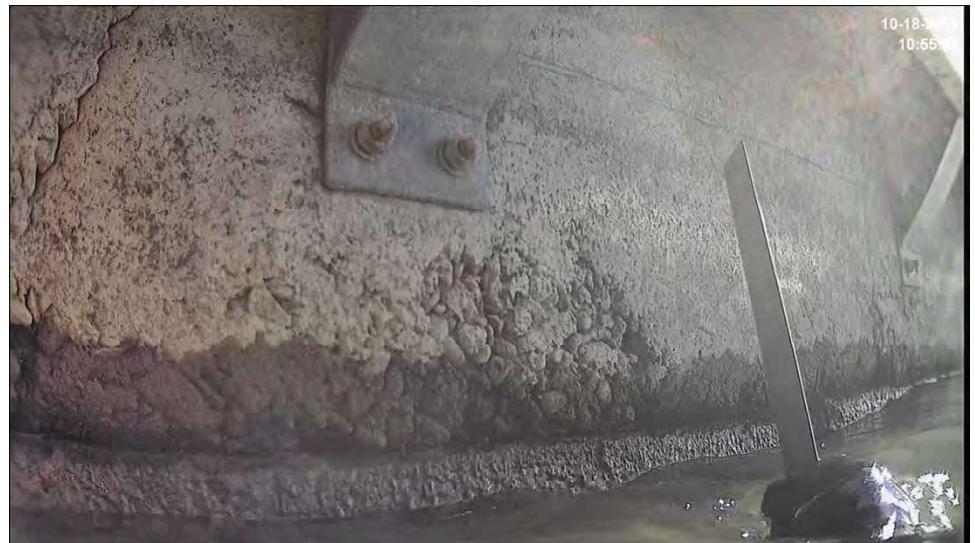
Photo 74 - Centre Pier Cap Condition

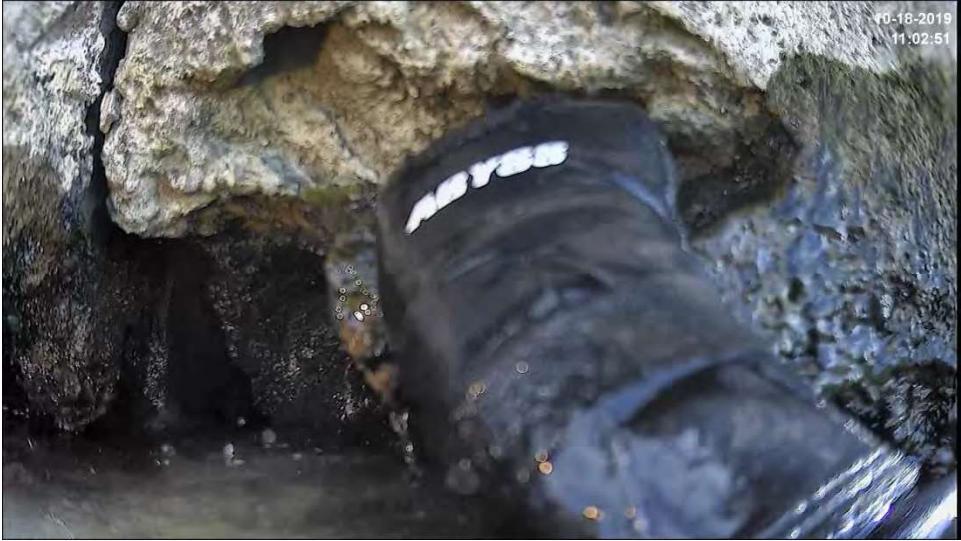
Photo 77 - Centre Pier West Face Spawling 0+61

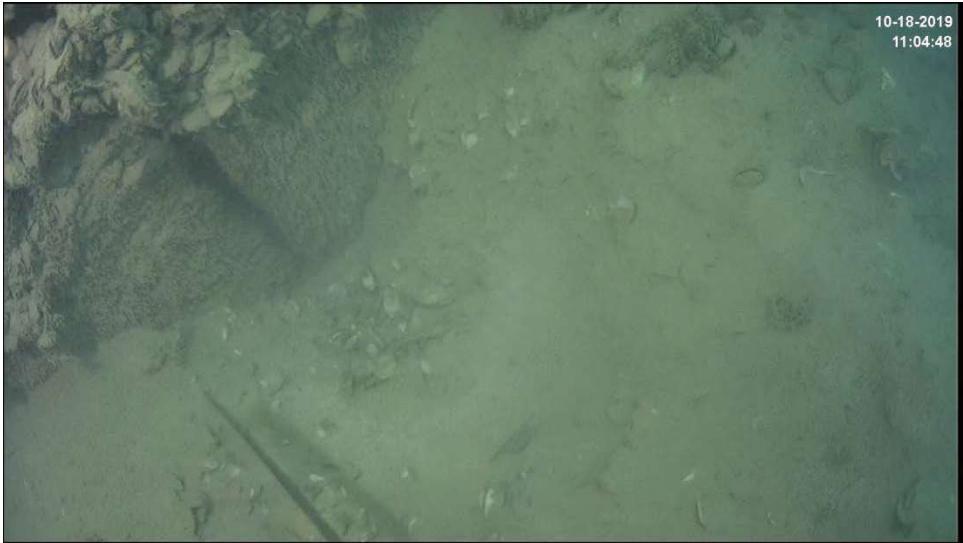
Photo 79 - Centre Pier West Face Typical Scour at Toe Due to Small Gaps

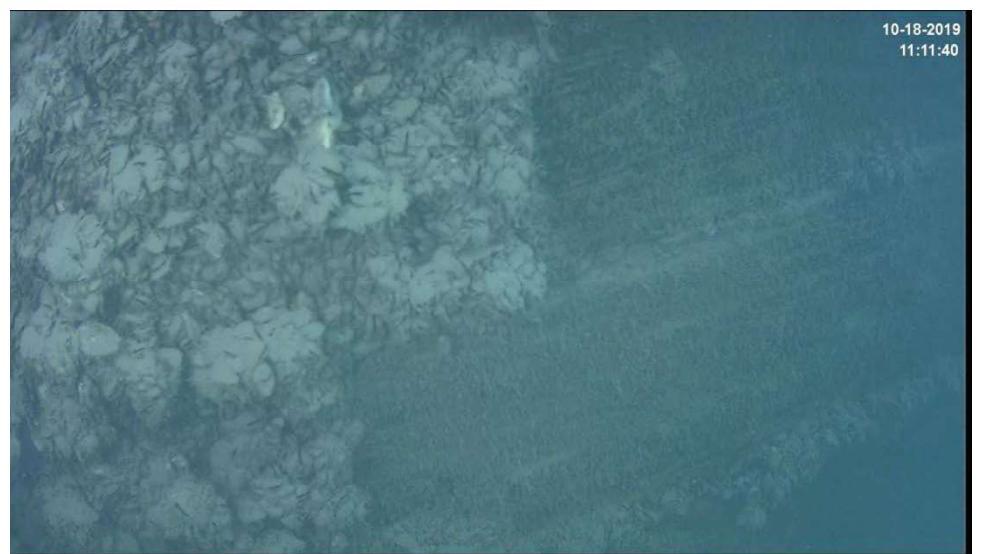
Photo 80 - Centre Pier West Face Sudden Stop of Zebra Mussel Growth 0+105

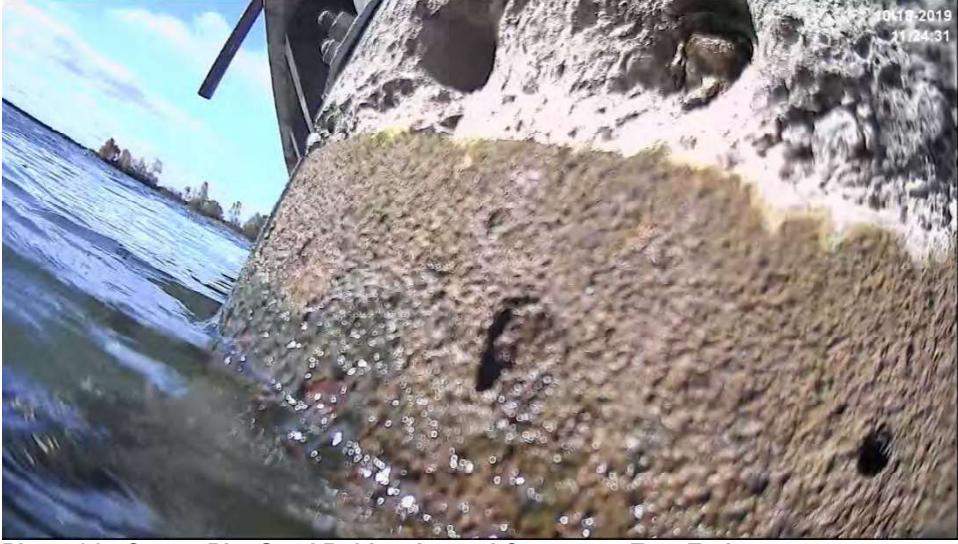
Photo 81 - Centre Pier Steel Belting Around Corners at East End

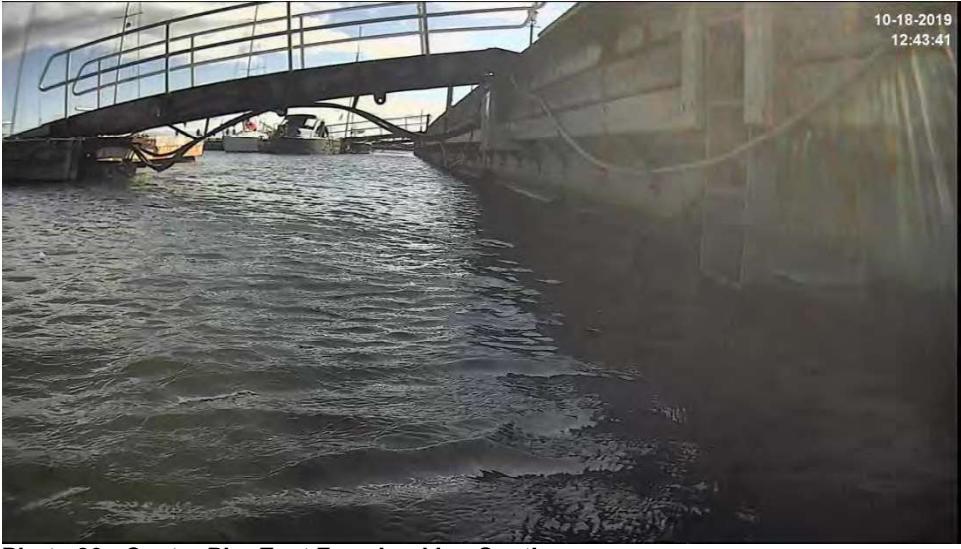
Photo 83 - Centre Pier East Face Looking South

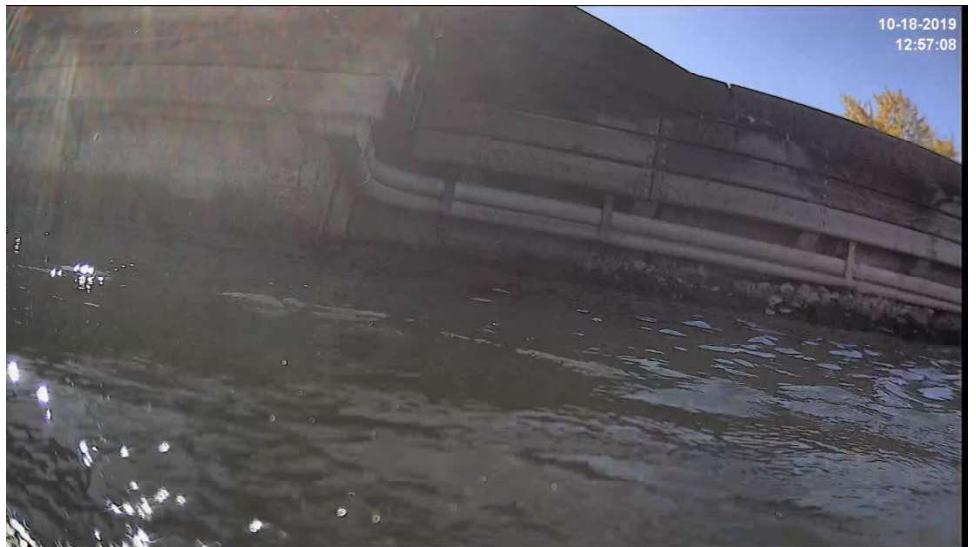
Photo 84 - Centre Pier East Side to Sloped Embankment 0+100
