Cobourg Harbour

Breakwaters and Basin Walls Condition Assessment

November 2020

**Cobourg Harbour
Breakwaters and Basin Walls Condition Assessment
2019**

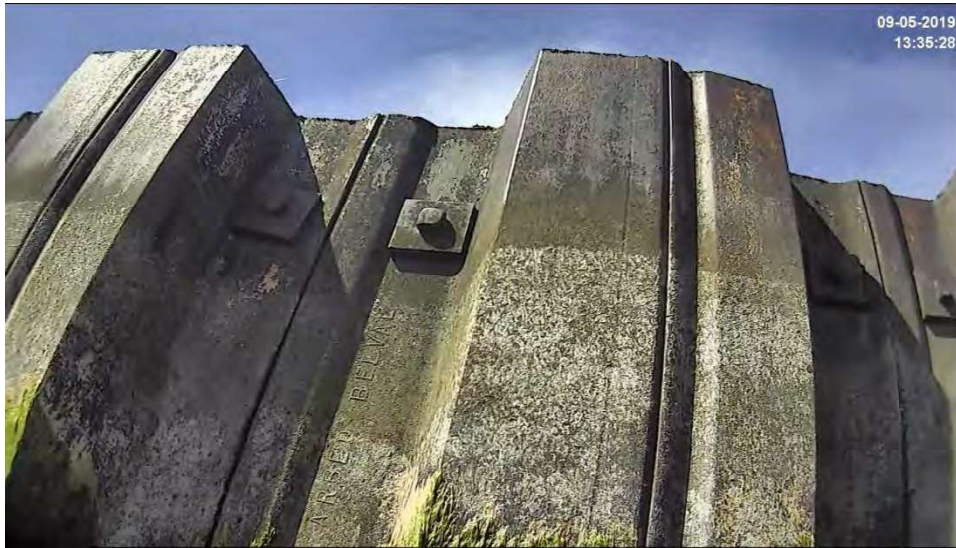
Photo 1 - East Breakwater, East Face

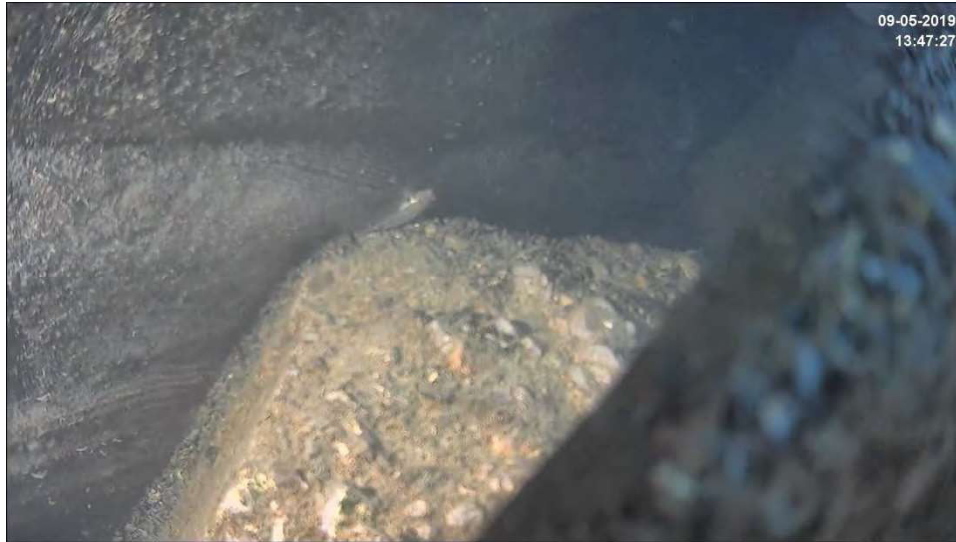
Photo 3 - East Breakwater, East Face Transition to Timber Cribs 0+075

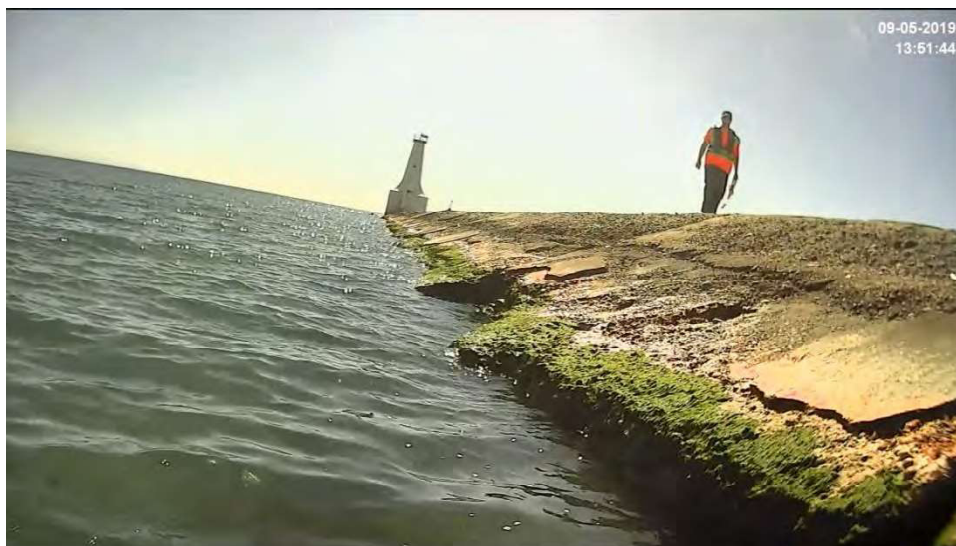
Photo 6 - East Breakwater Cap Looking South

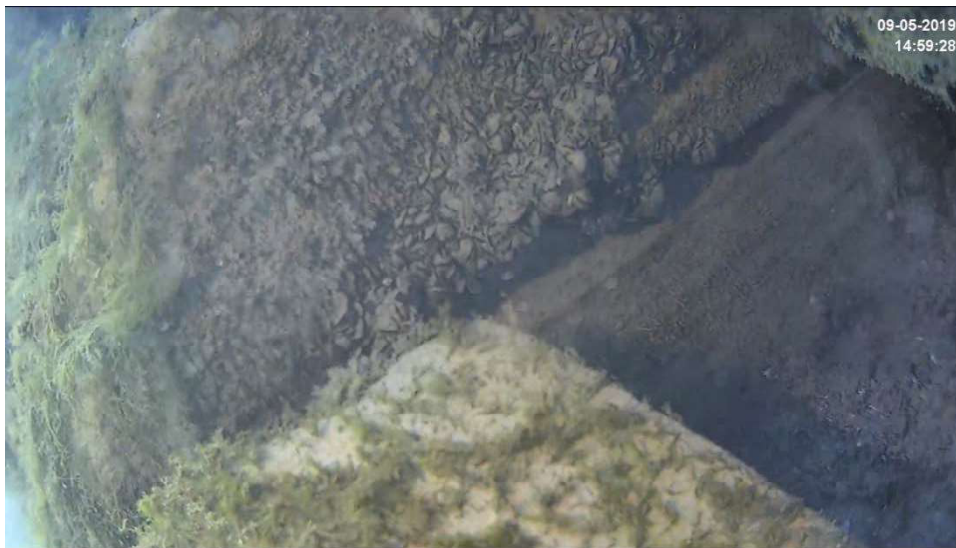
Photo 10 - East Breakwater Bottom Cross Members

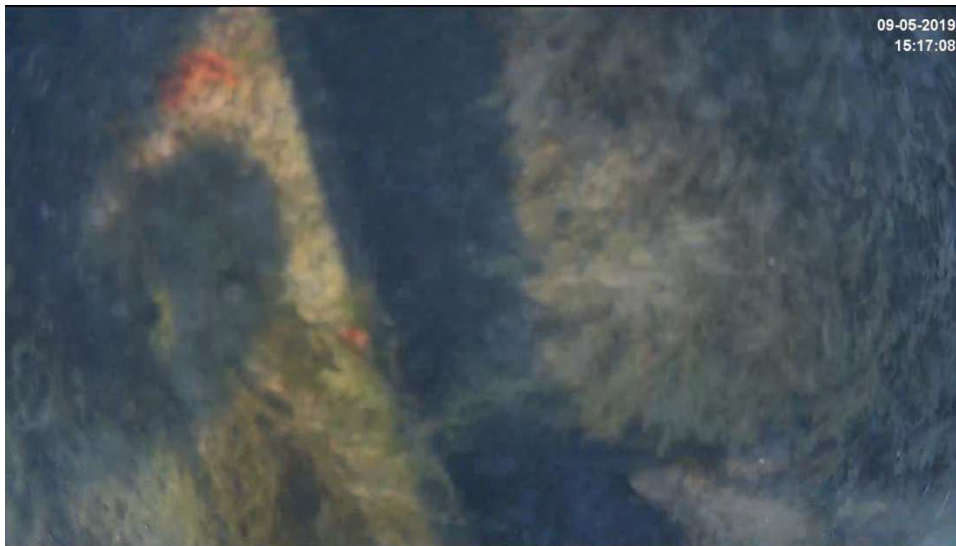
Photo 14- East Breakwater East Face Plate Secured to Timbers

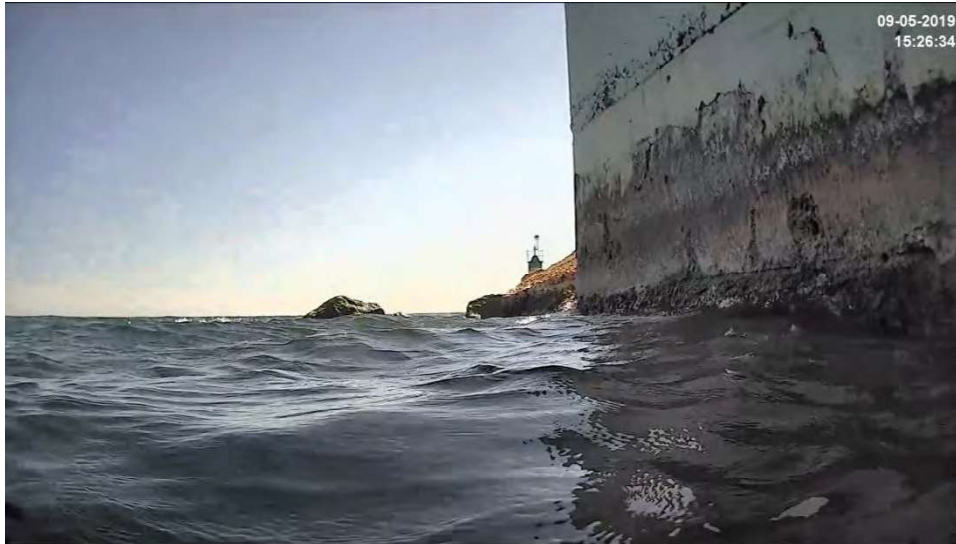
Photo 15 - East Breakwater East Side of Lighthouse

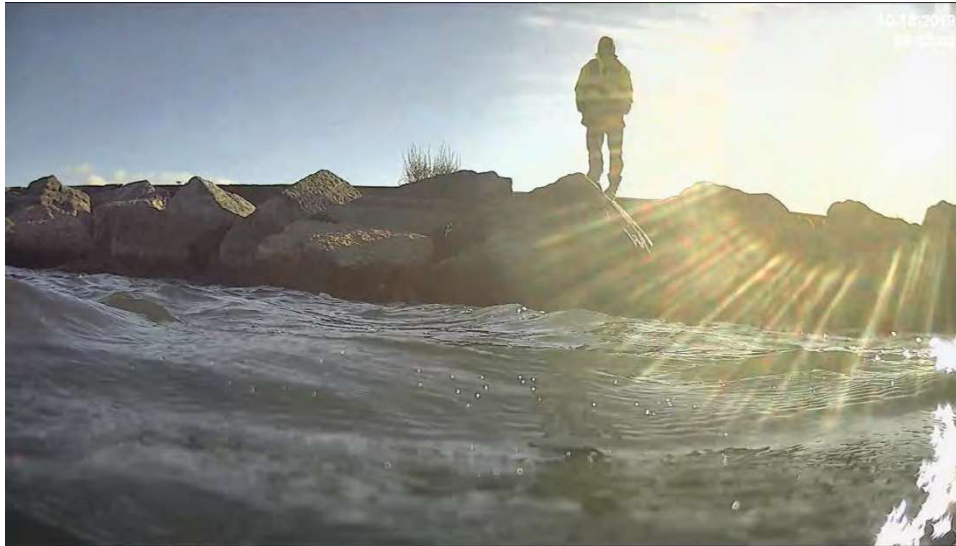
Photo 17 - East Breakwater West Face Revetment – South End

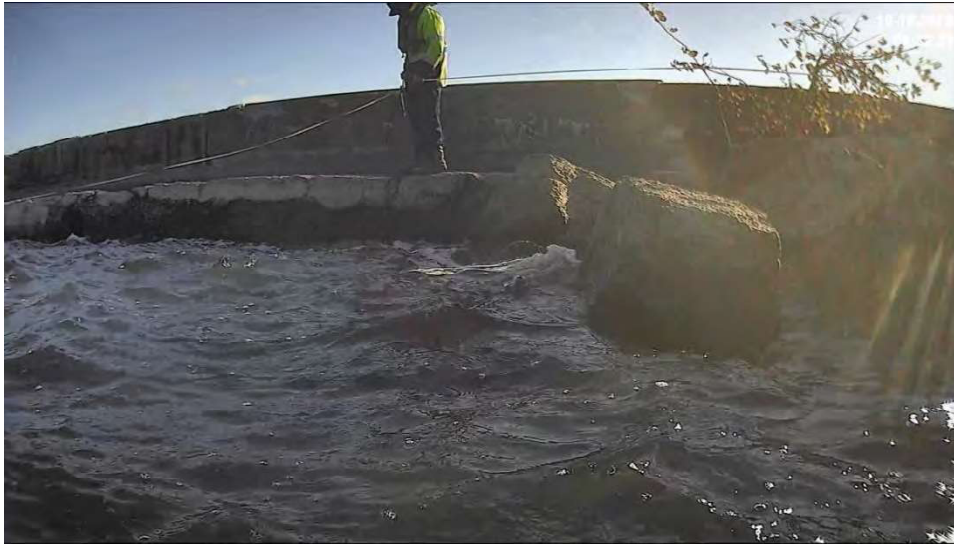
Photo 19 - East Breakwater West Face Revetment – North End Connection with Cribs

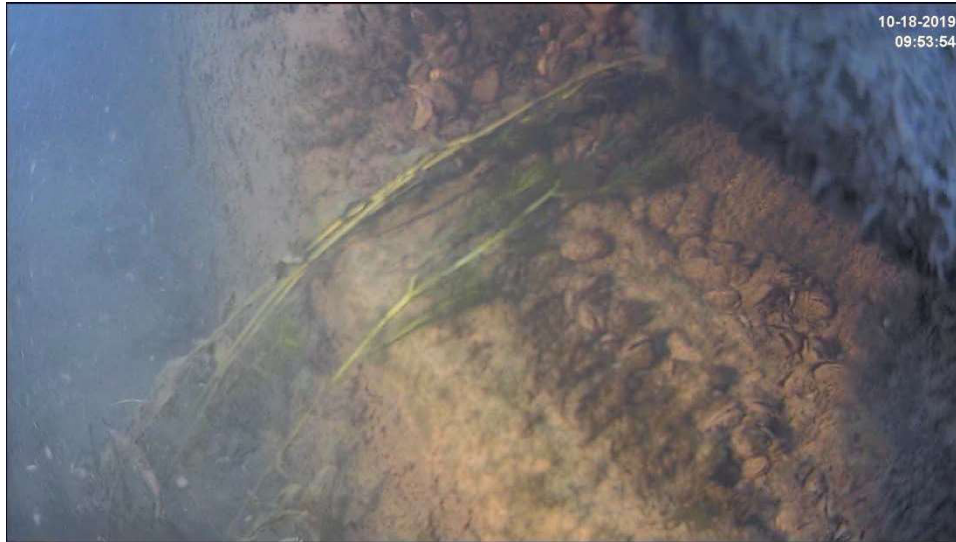
Photo 23 - East Breakwater West Face - Weeds Getting Pulled into Void in Wall

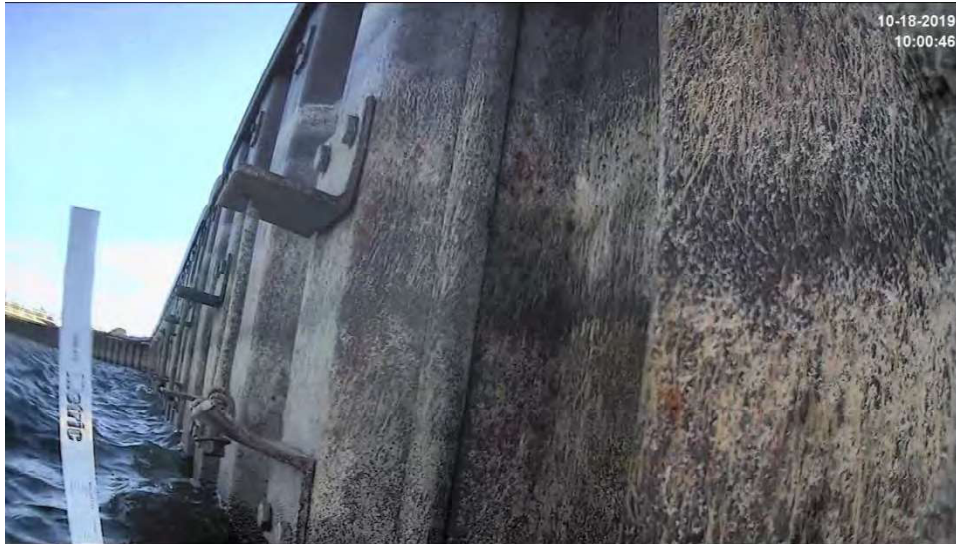
Photo 25 - East Breakwater West Face - SSP Wall Looking North

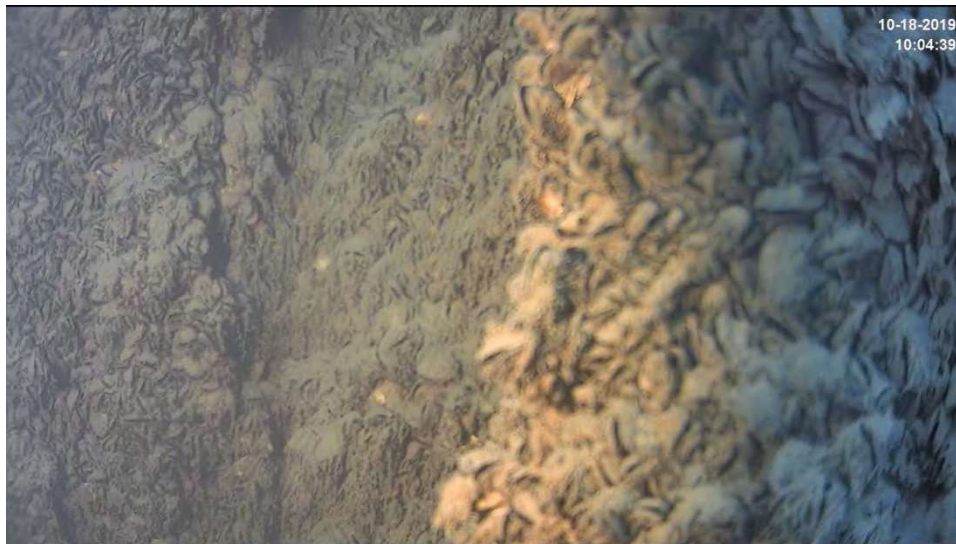
Photo 26- East Breakwater West Face - SSP Wall 100% Coverage

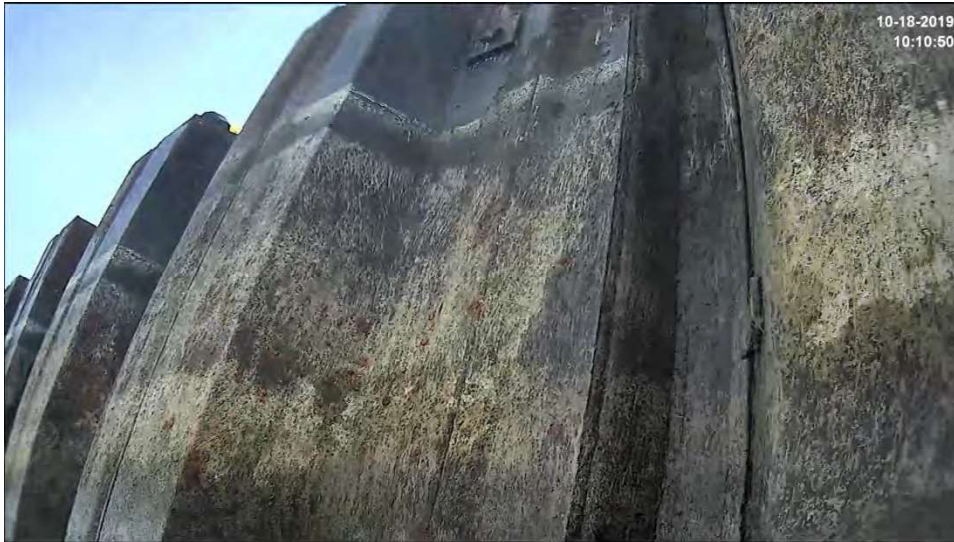
Photo 27- East Breakwater West Face Change to Z-Pile

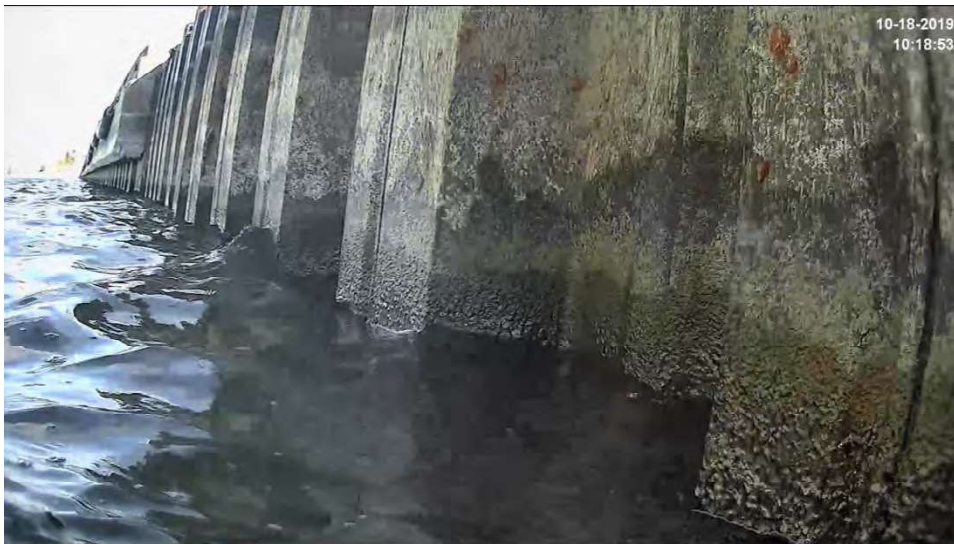
Photo 28 - East Breakwater West Face - North End of Breakwater Start of Pier

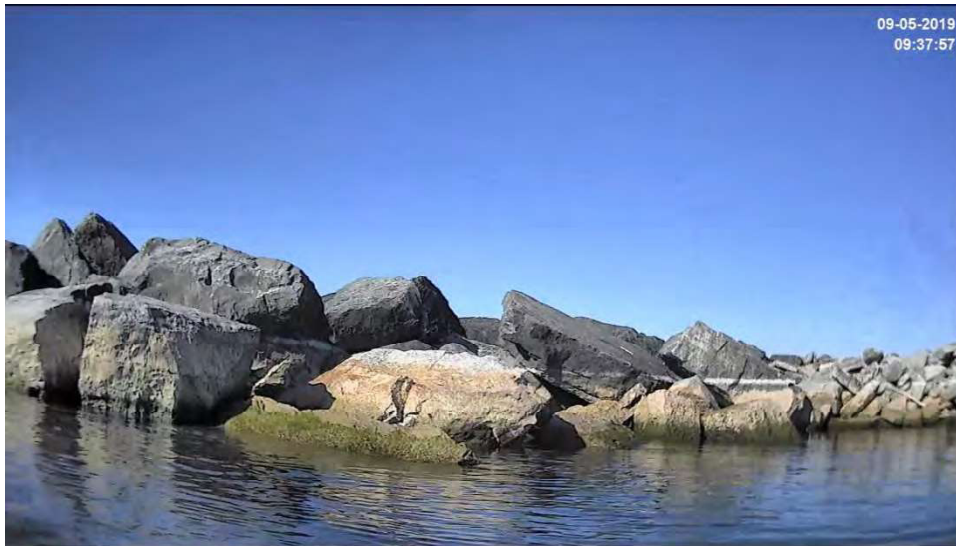
Photo 29 - West Breakwater North Side, West End Revetment

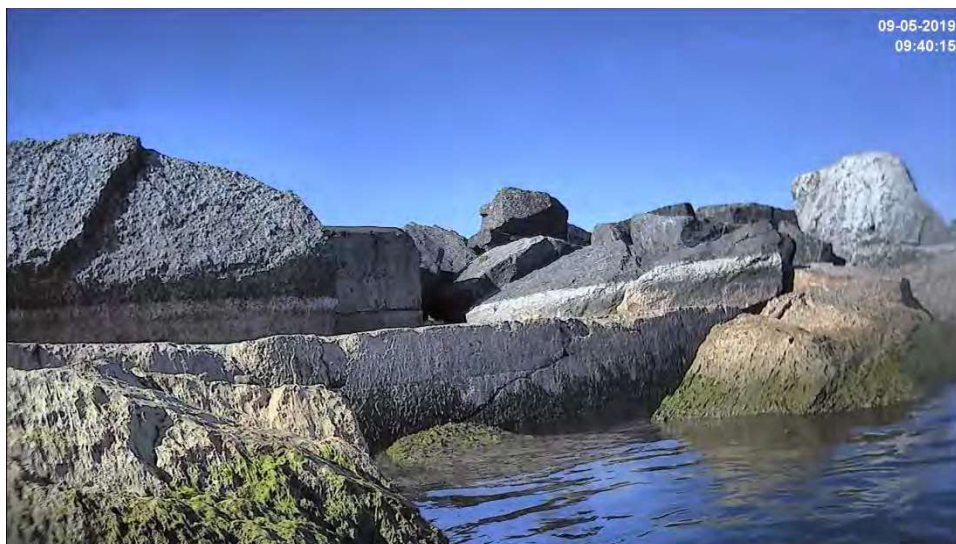
Photo 30 - West Breakwater North Side, End of Revetment

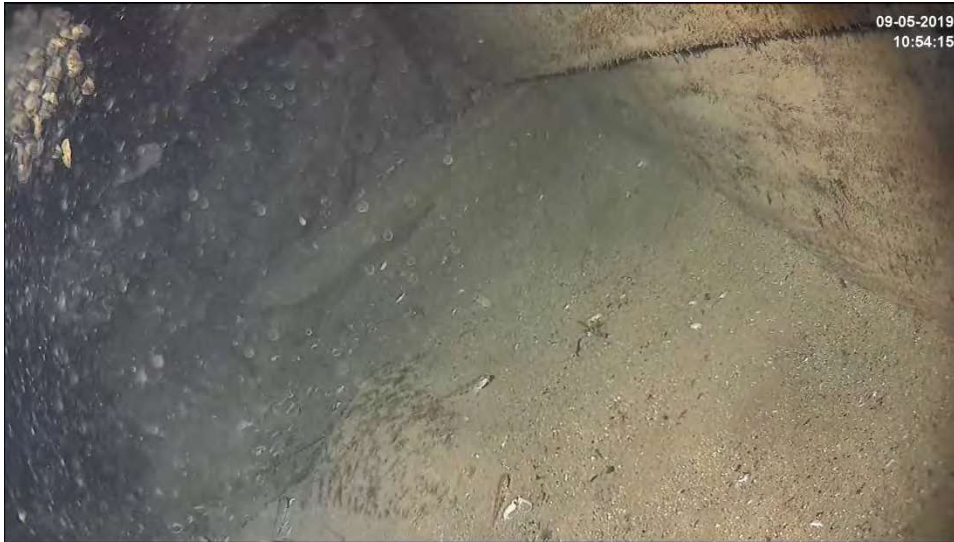
Photo 37 - West Breakwater North Side, Space Inside Large Gap 0+84

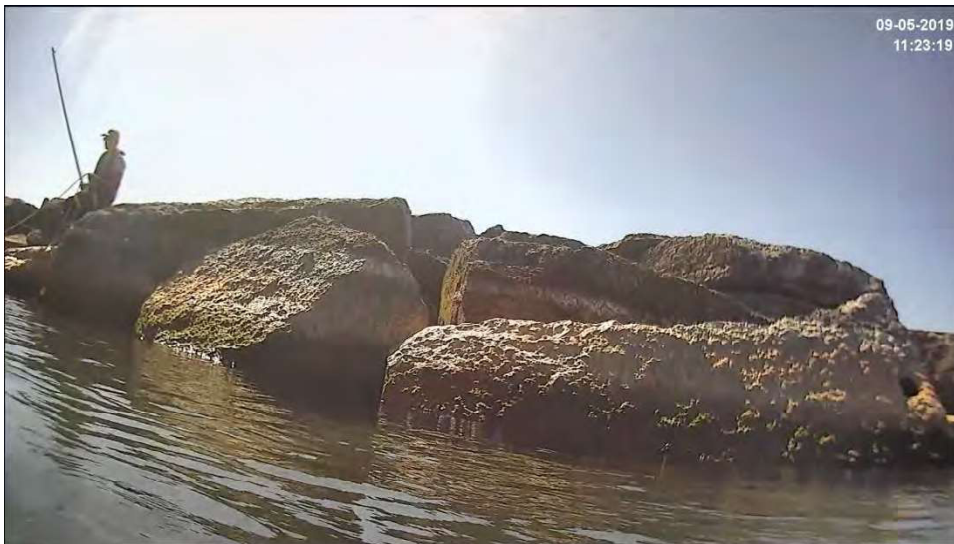
Photo 38 - West Breakwater North Side, Start of Stone Material 0+110

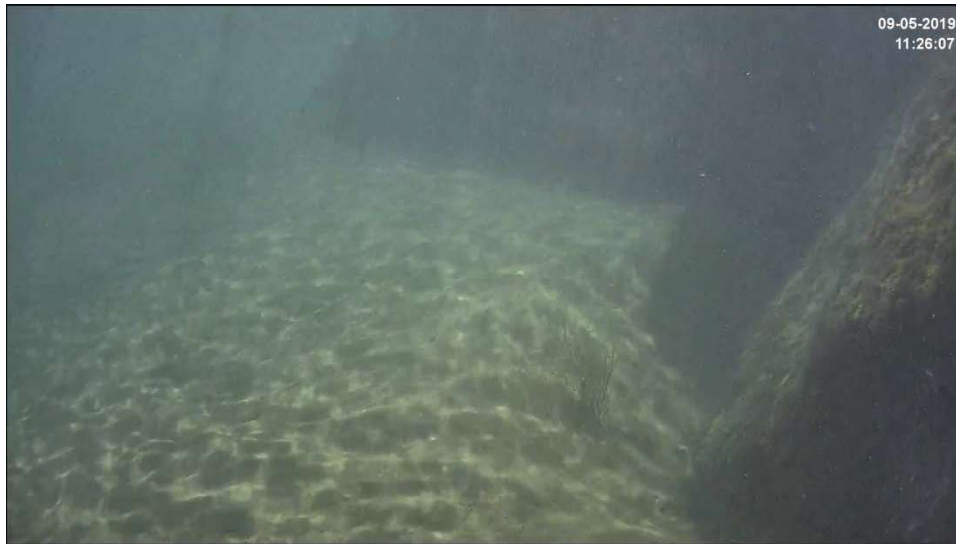
Photo 39 - West Breakwater North Side, Lakebed Adjacent to Stone

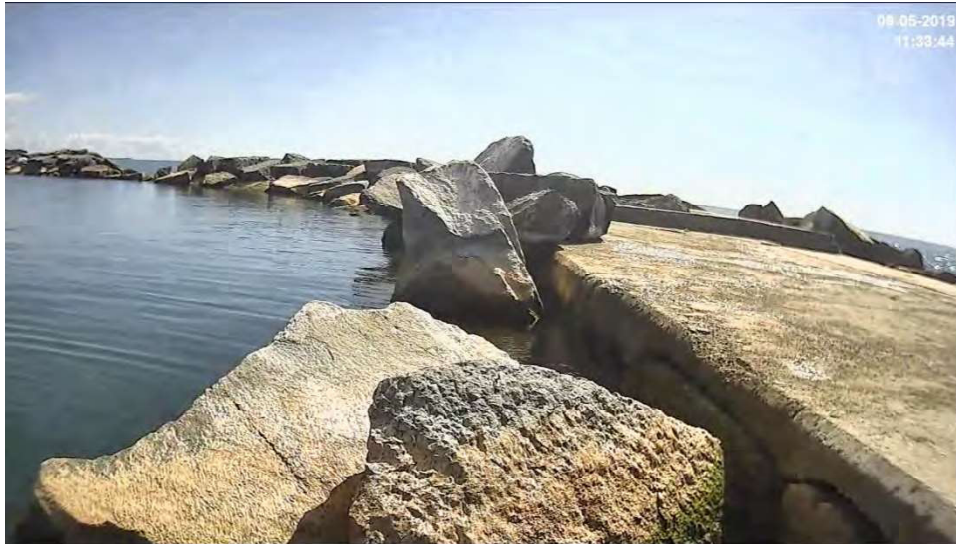
Photo 41 - West Breakwater North Side, Concrete Section with Stones in Front, Change of Direction

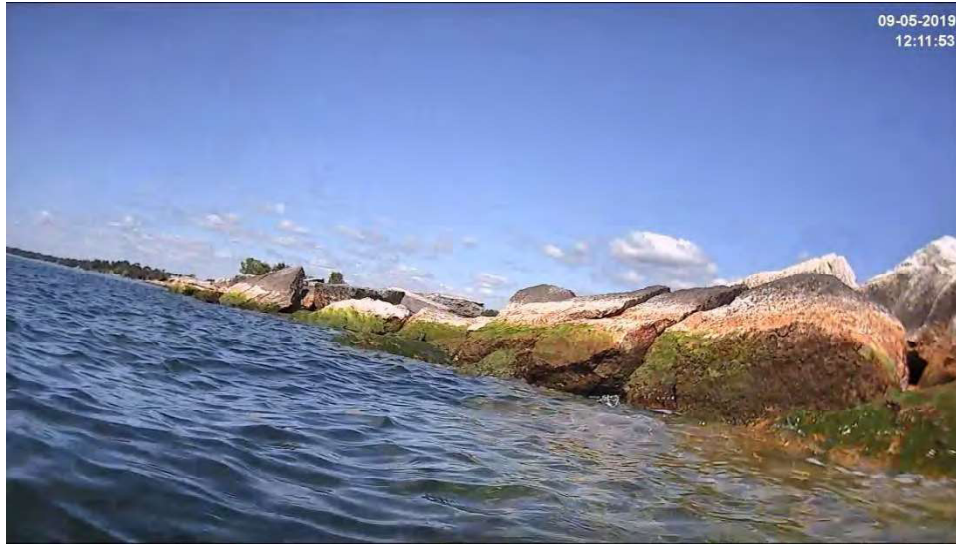
Photo 45 - West Breakwater South Side, 0+175 Looking West

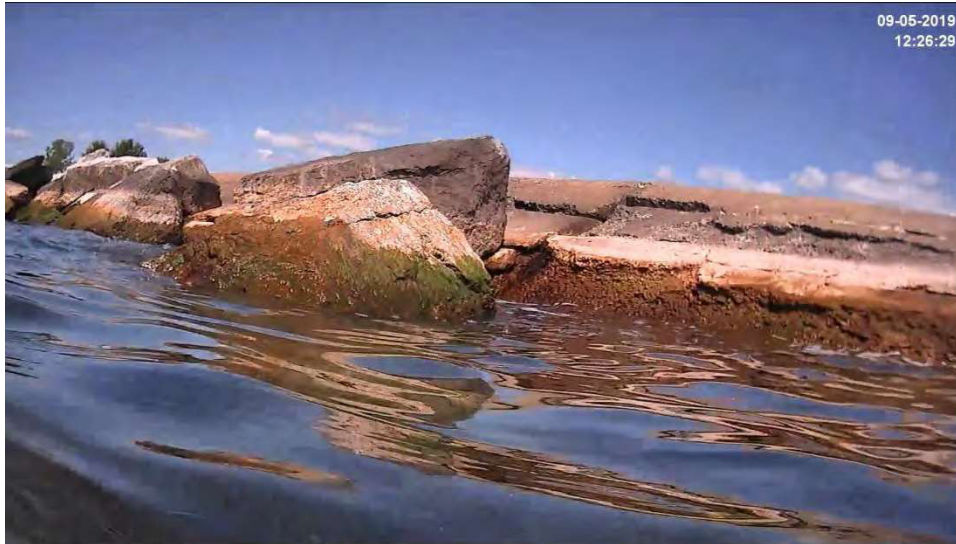
Photo 47 - West Breakwater South Side, Material Piled up Against Sloped Cap

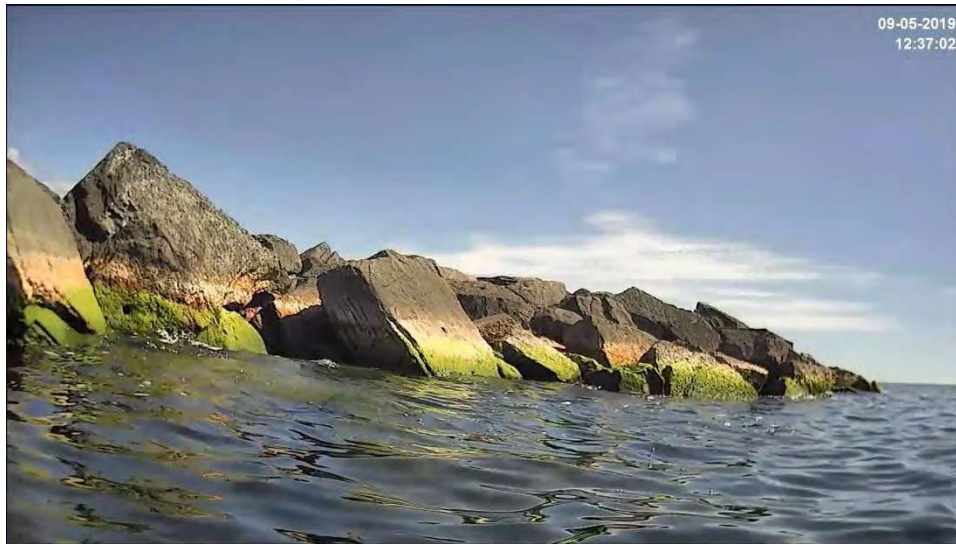
Photo 49 - West Breakwater South Side, West End looking East

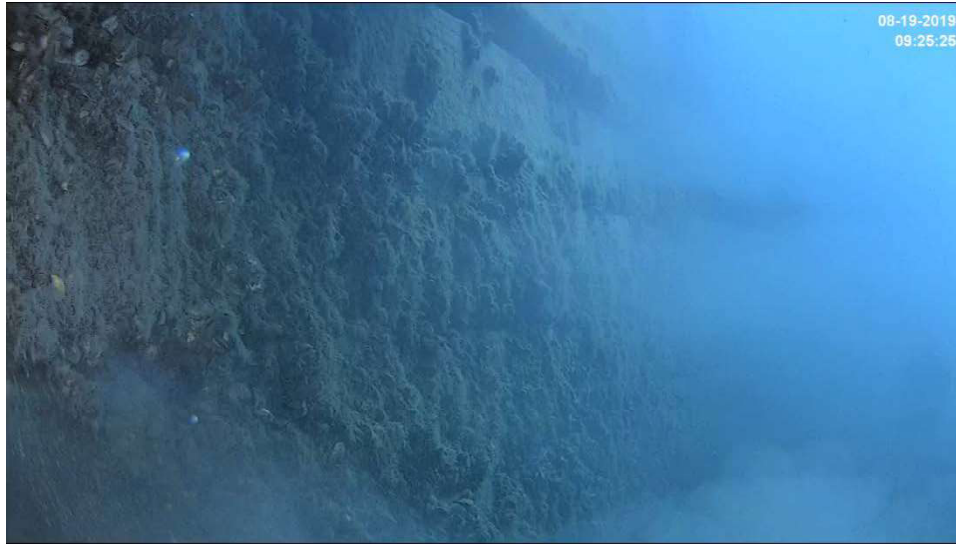
Photo 51 - North Wall Looking East from West End

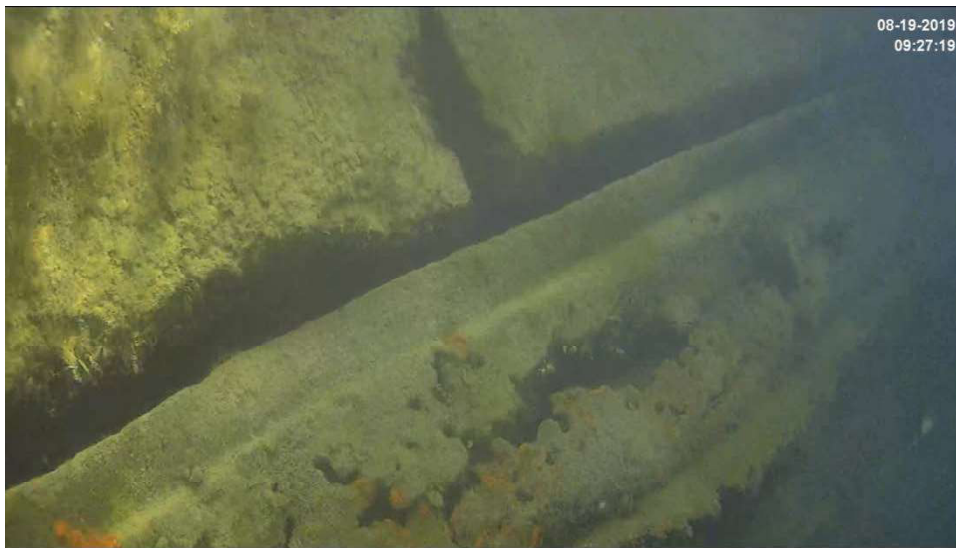
Photo 52 - North Wall Steel Belting Below Cap

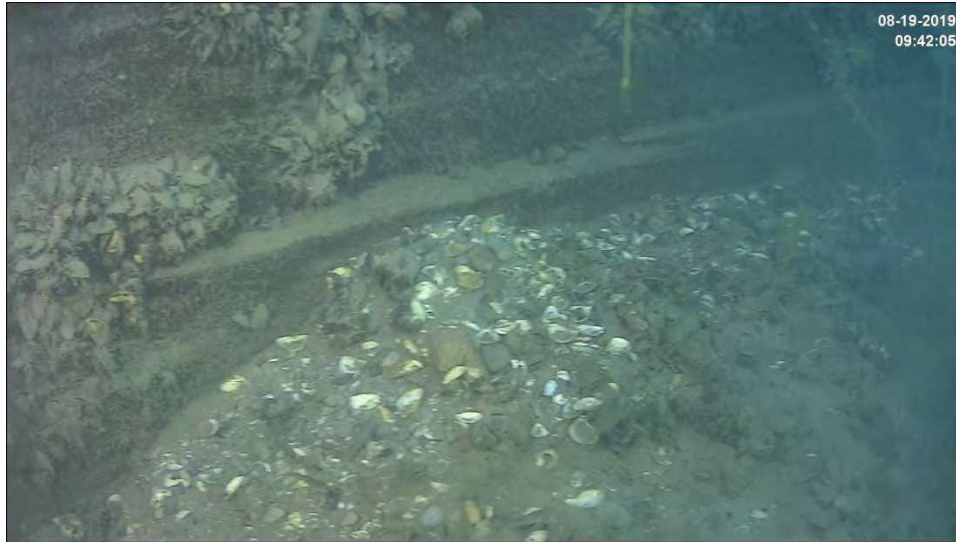
Photo 53 - North Wall Build Up of Material at Toe

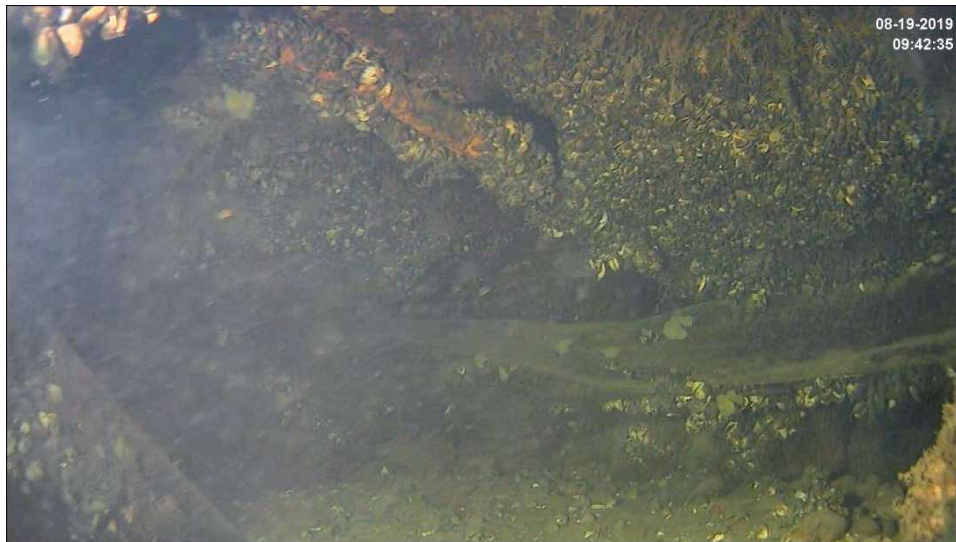
Photo 54 - North Wall Inside Large Void at 0+35

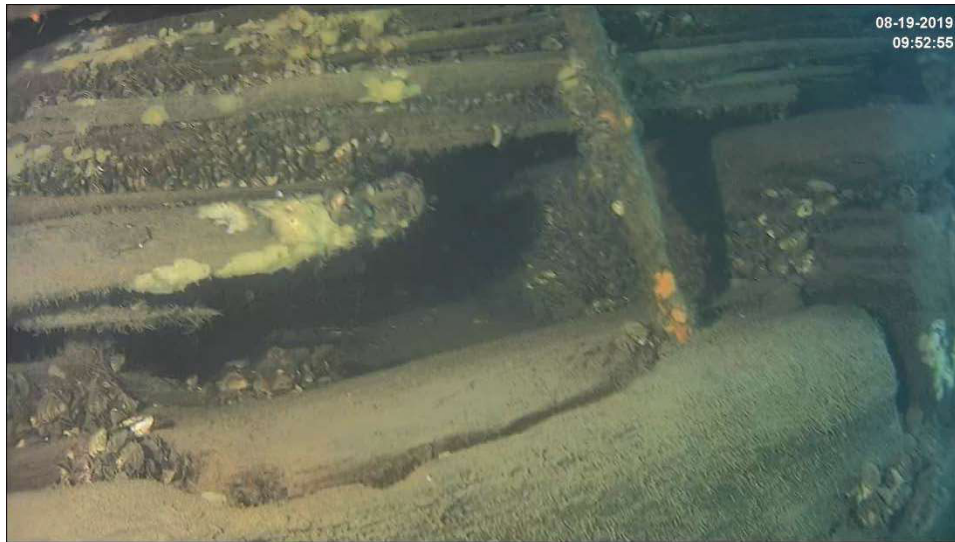
Photo 55 - North Wall Void at 0+41

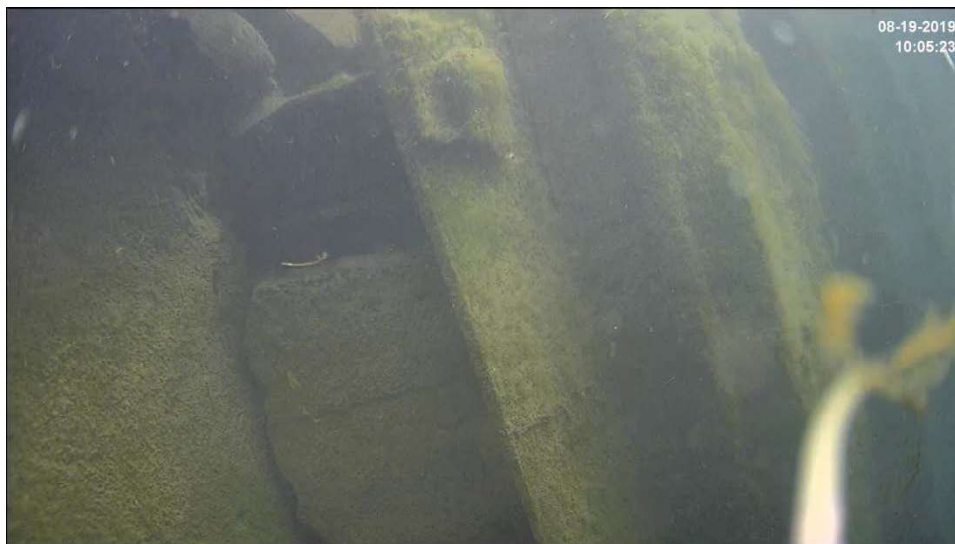
Photo 58 - North Wall Transition to Steel Sheet Pile 0+51

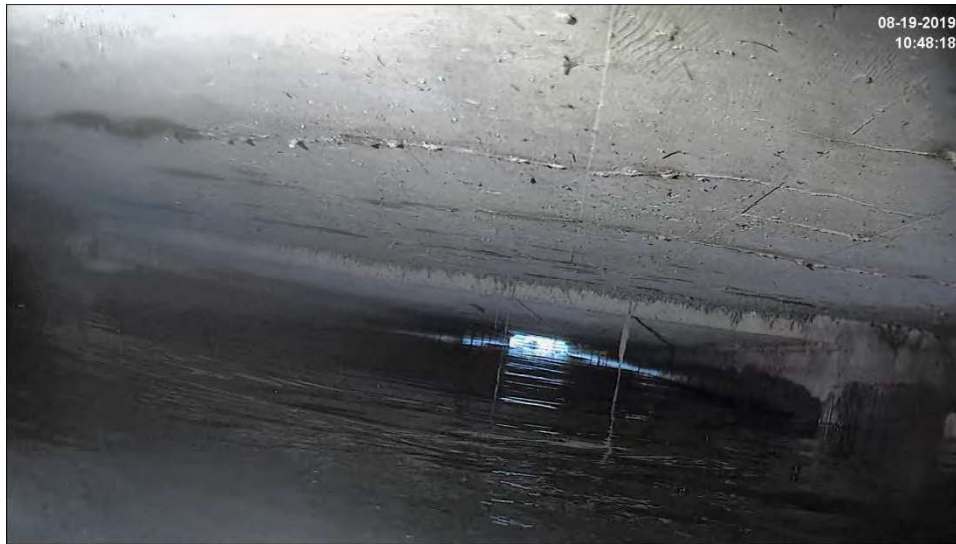
Photo 59 - North Wall Inside Culvert at 0+90

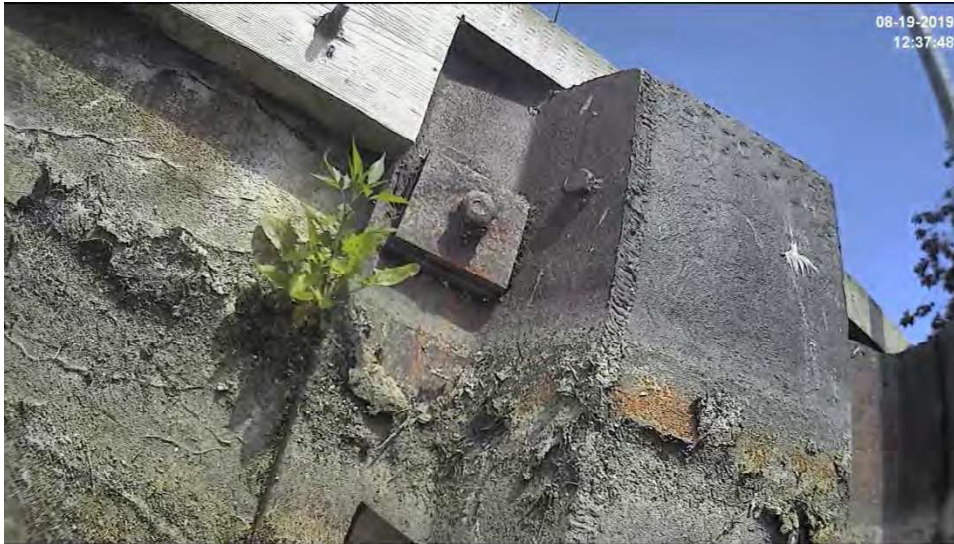
Photo 62 - East Wall Connection to North Wall

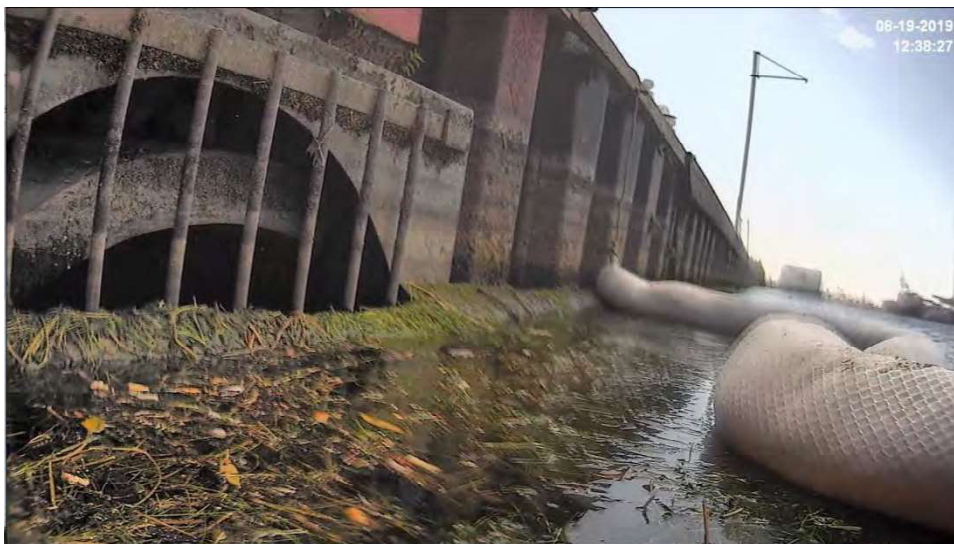
Photo 63 - East Wall Looking South from North End

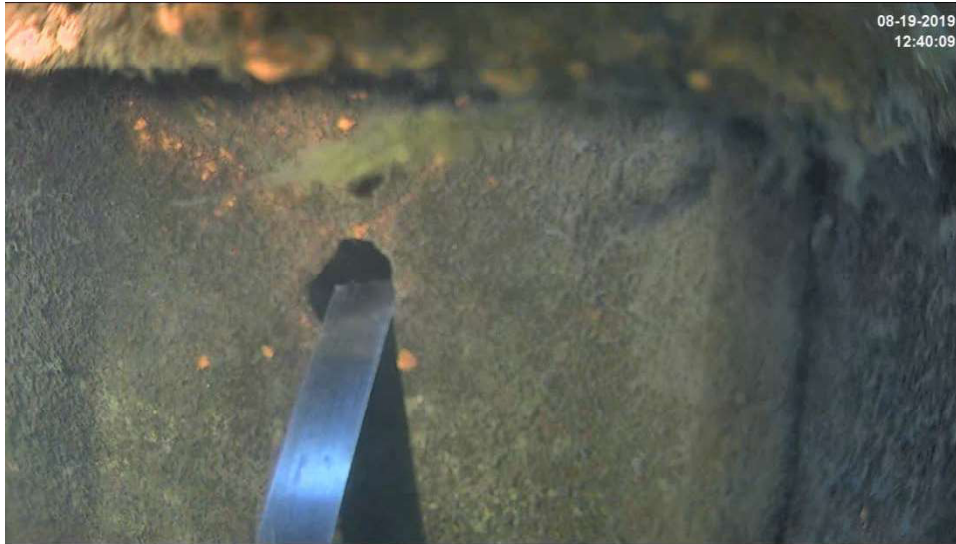
Photo 64 - East Wall Typical Hole

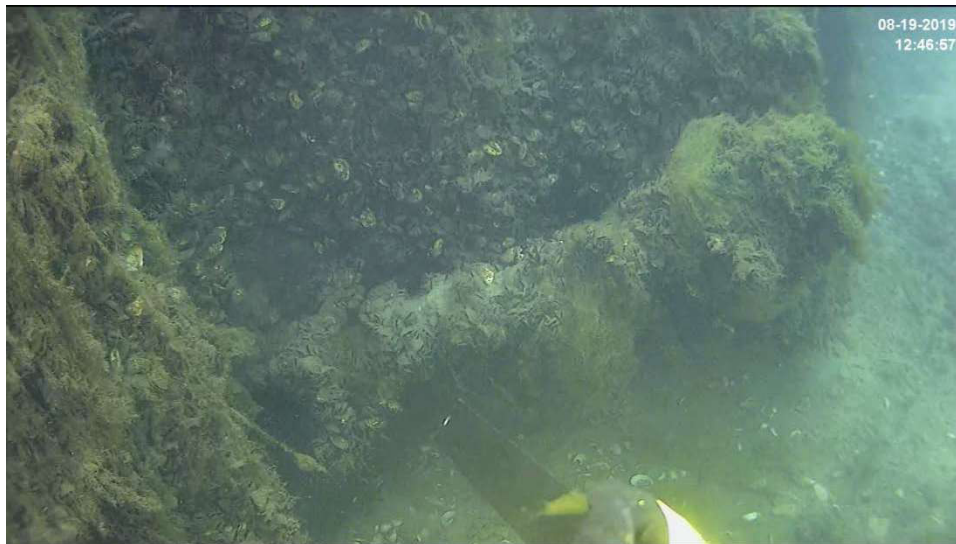
Photo 65 - East Wall Tie and Bolt Pulled Away From Wall at Lakebed

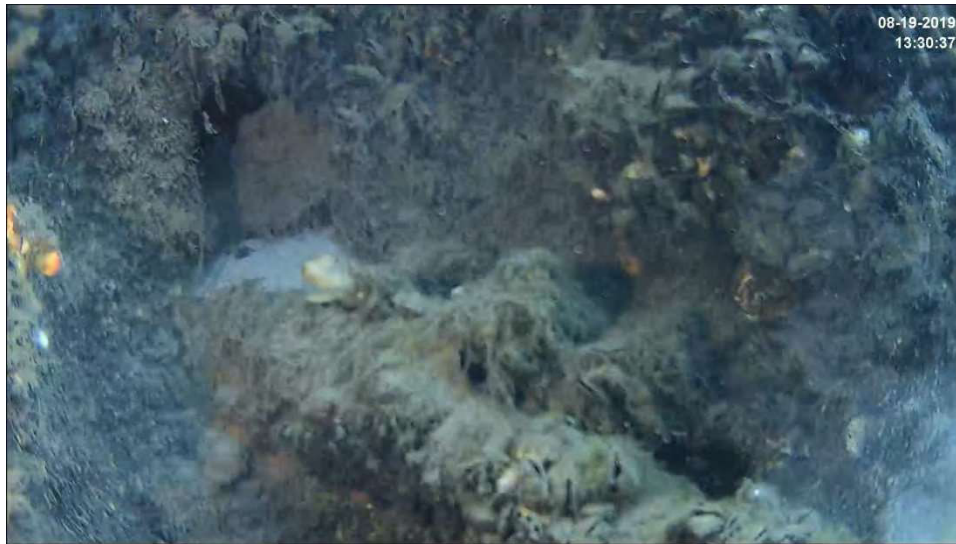
Photo 66 - East Wall Example of Hole Above Tie Back

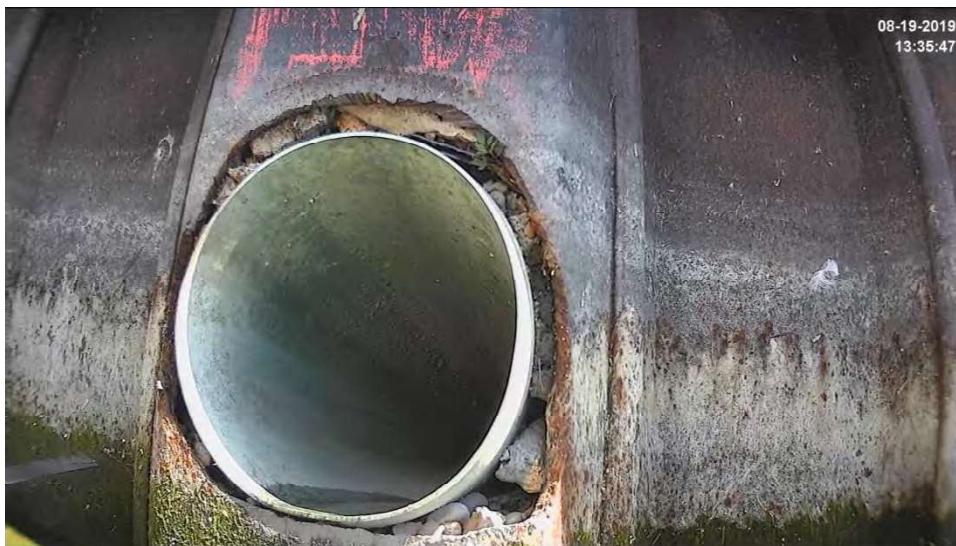
Photo 67 - East Wall Pipe Above Waterline at 0+50

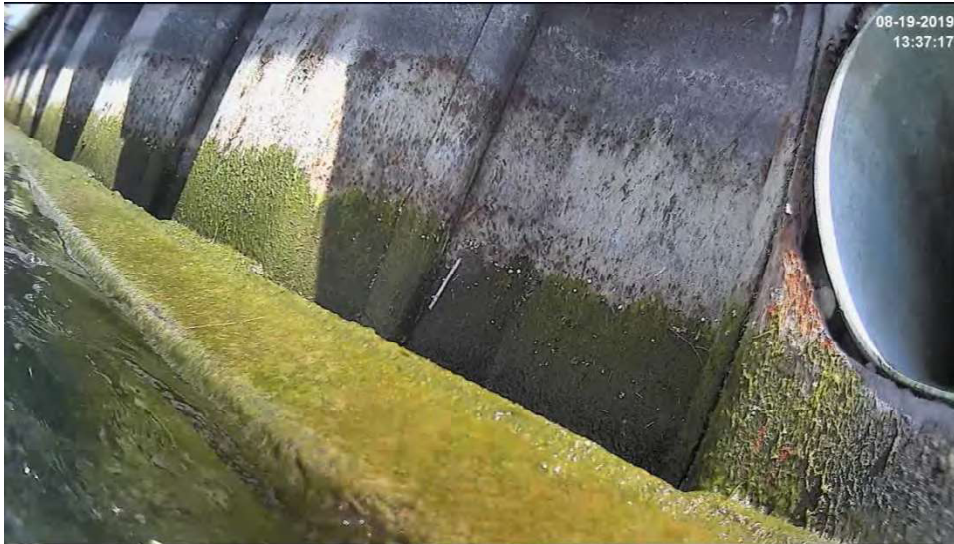
Photo 68 - "Bumper" at Waterline

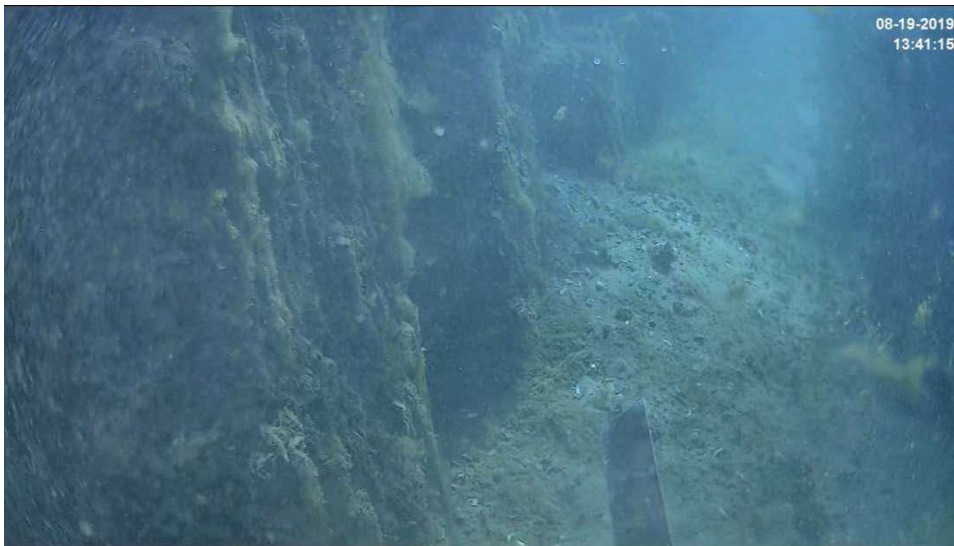
Photo 69 - Buildup of Material in Front of Wall

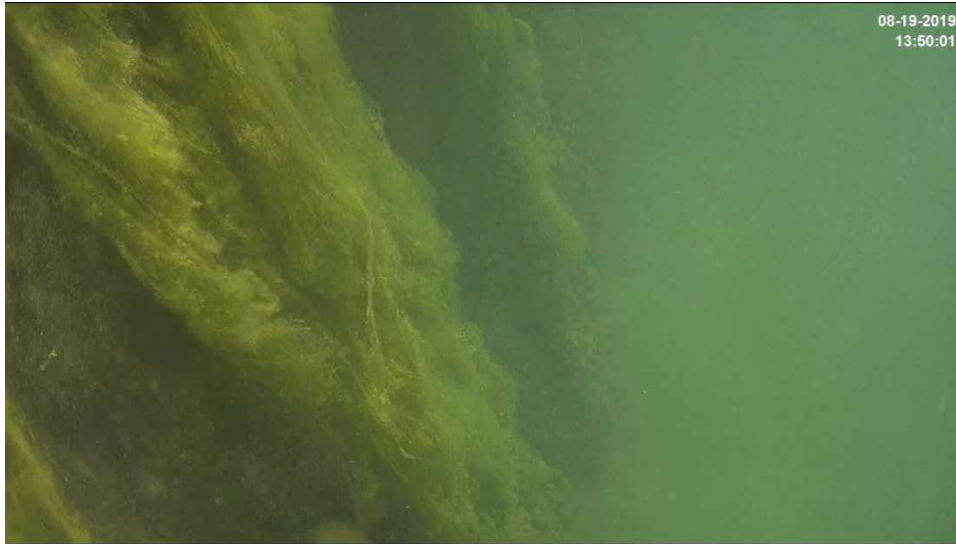
Photo 70 - East Wall Leaning at 0+65

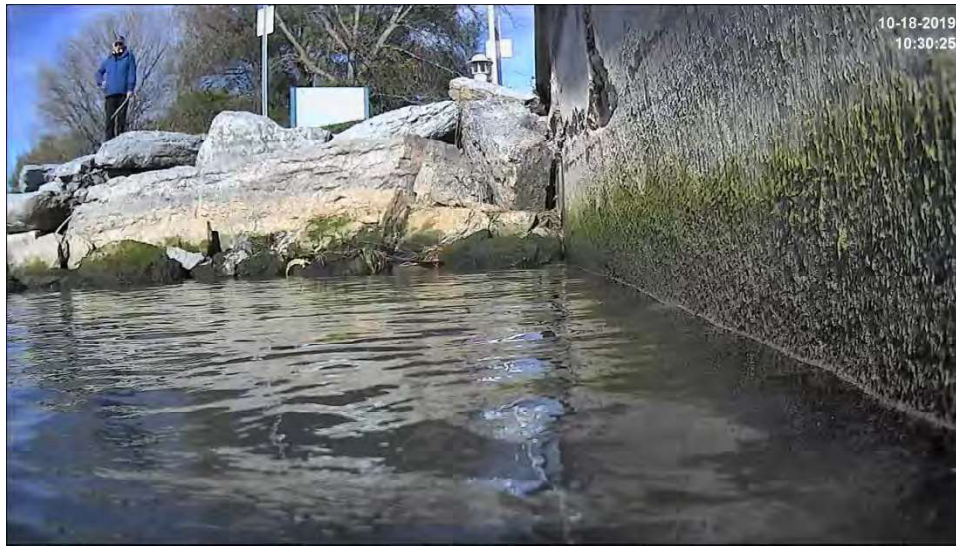
Photo 73 - Centre Pier West Face North End

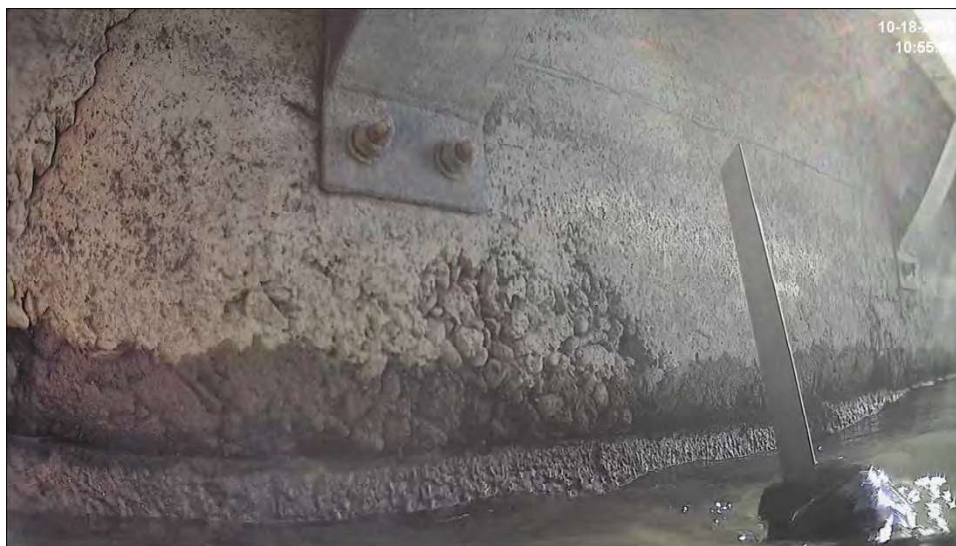
Photo 74 - Centre Pier Cap Condition

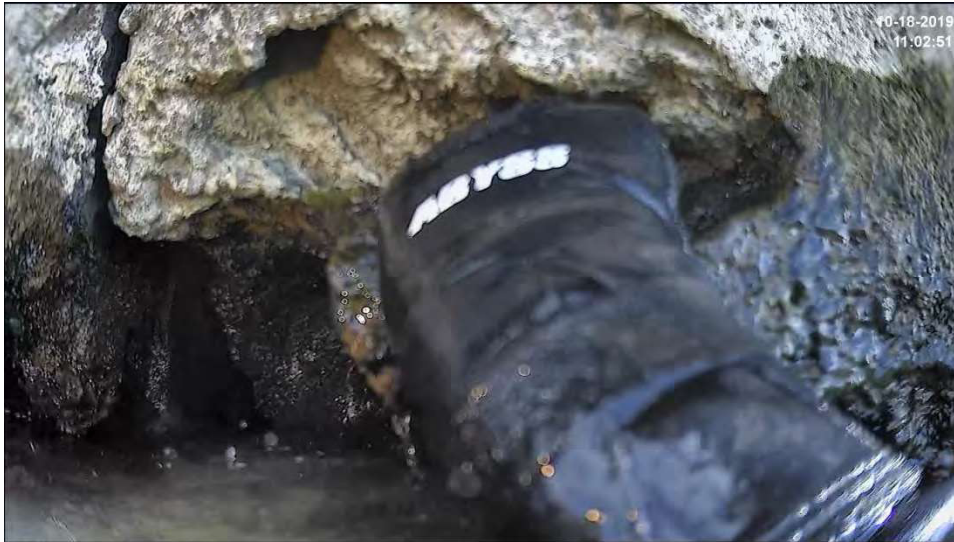
Photo 77 - Centre Pier West Face Spawling 0+61

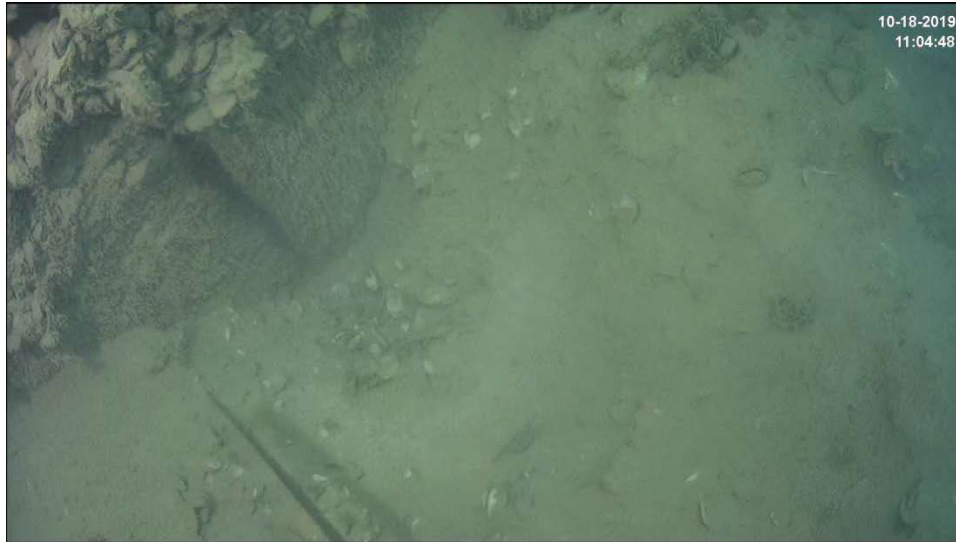
Photo 79 - Centre Pier West Face Typical Scour at Toe Due to Small Gaps

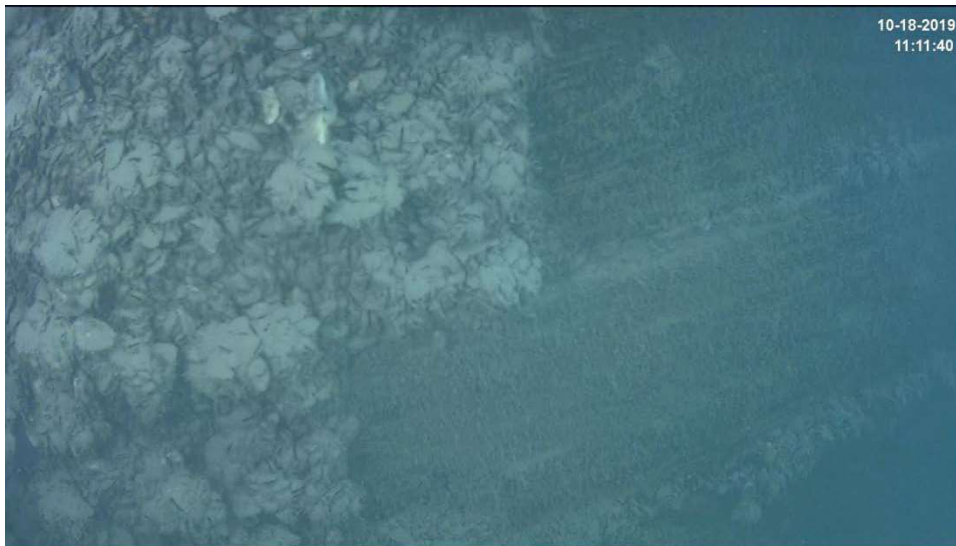
Photo 80 - Centre Pier West Face Sudden Stop of Zebra Mussel Growth 0+105
