Cobourg Harbour

Breakwaters and Basin Walls Condition Assessment

November 2020

**Cobourg Harbour
Breakwaters and Basin Walls Condition Assessment
2019**

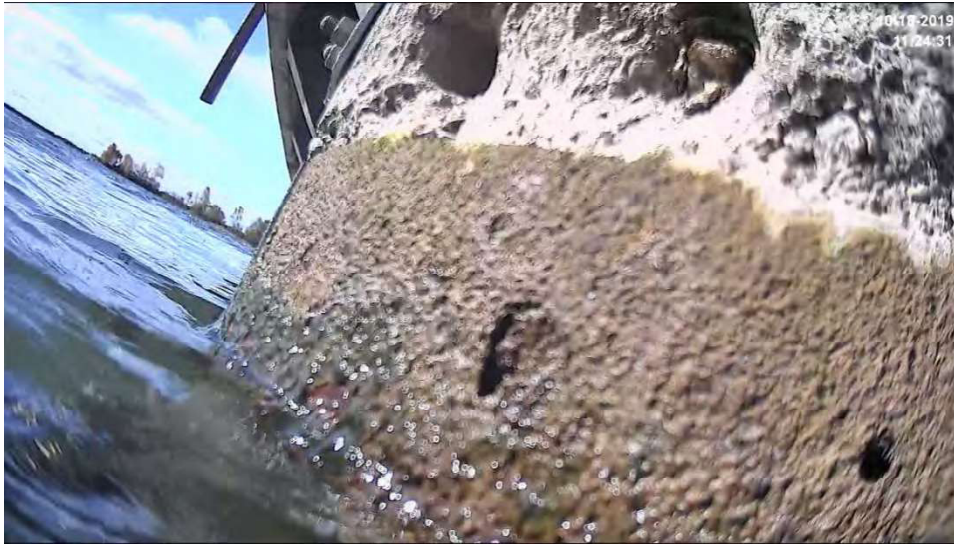
Photo 81 - Centre Pier Steel Belting Around Corners at East End

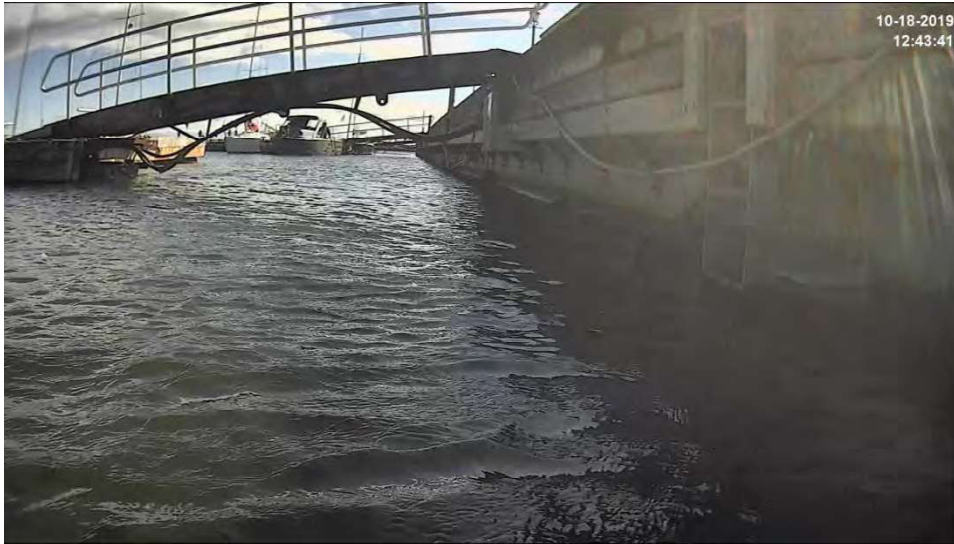
Photo 83 - Centre Pier East Face Looking South

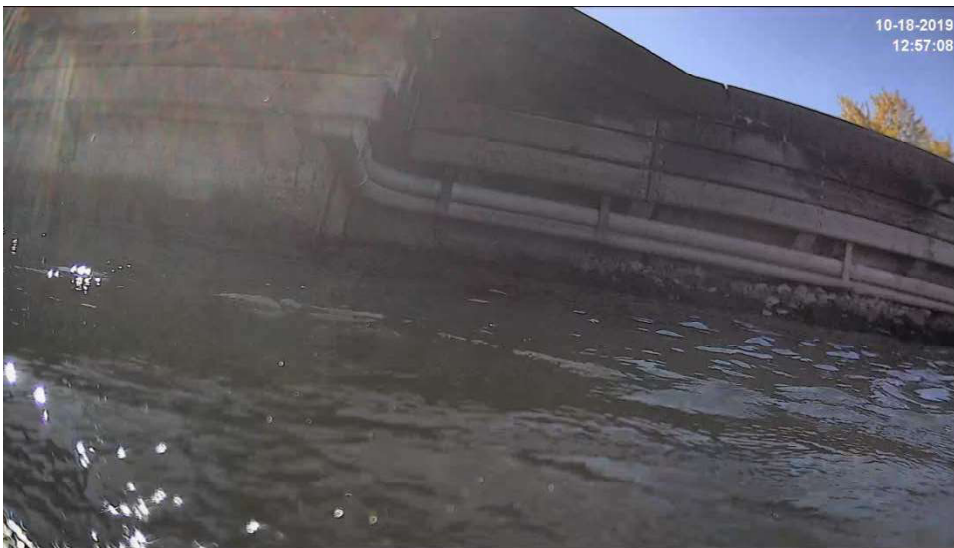
Photo 84 - Centre Pier East Side to Sloped Embankment 0+100
